VOLVO V60: 1KKK885

Limited Technical Inspection

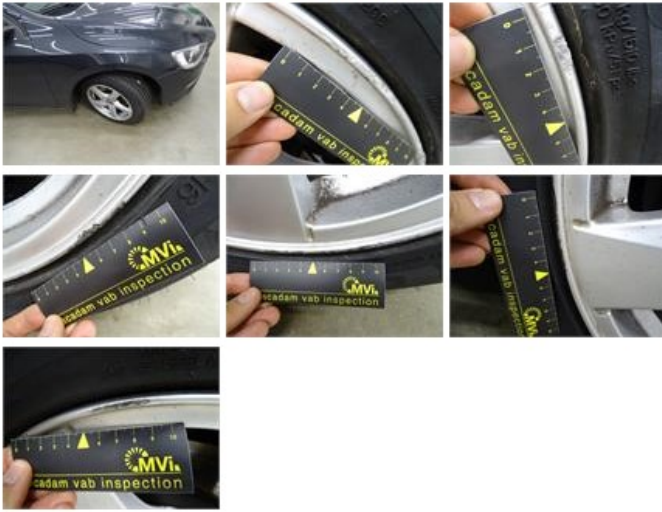
Alloy rim F R, Scratch(es), LI - Repair and paint (complete) 95,00

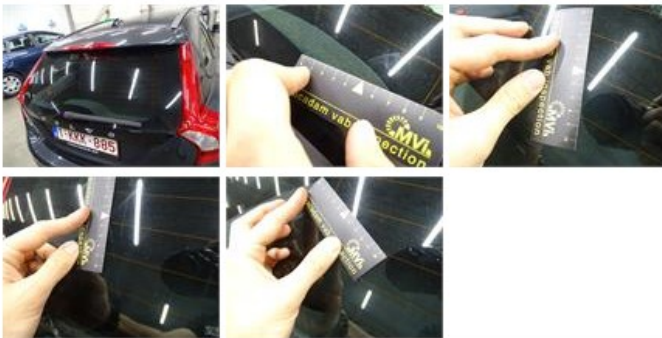
Rear window, Scratch(es), Acceptable 0,00

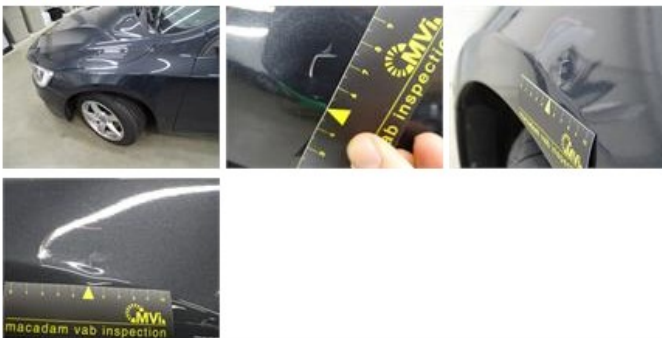
Wing F L, Dent(s) and scratch(es), LI - Repair and paint (complete) 220,18

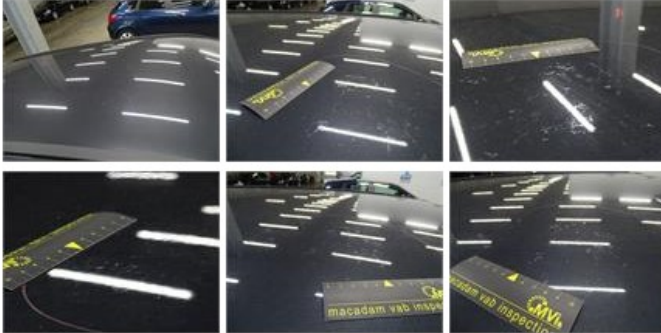
Roof, Chemical pollution, LI - Repair and paint (complete) 481,50

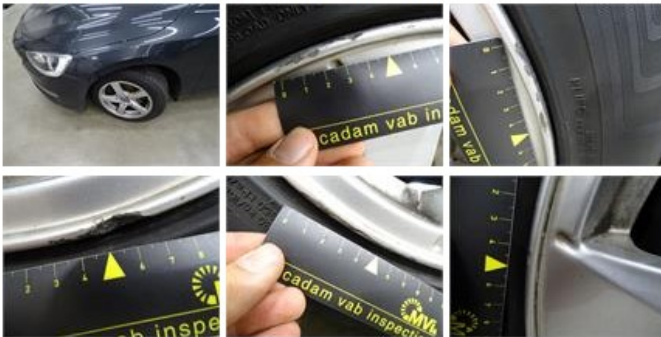
Alloy rim F L, Scratch(es), LI - Repair and paint (complete) 95,00

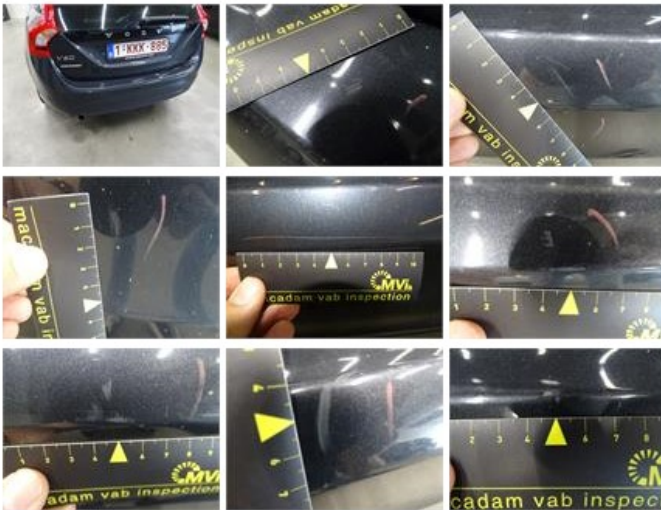
Bumper R, Scratch(es), LI - Repair and paint (complete) 211,80

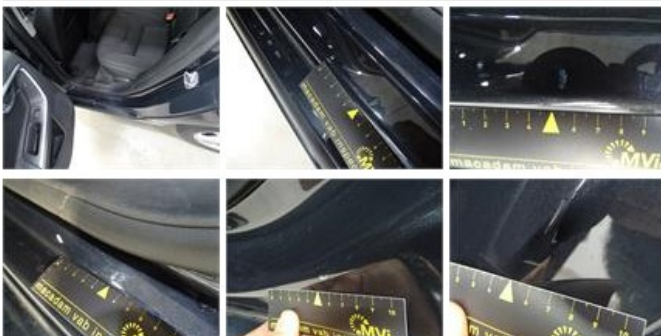
Rocker panel inner R L, Dent(s), LI - Repair and paint (complete) 115,56
