VOLVO V60: 1FTS058

Limited Technical Inspection

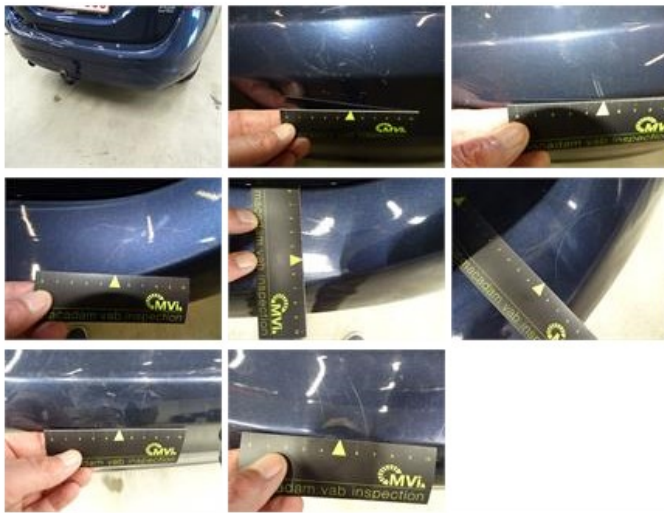
Total cost ex VAT	912,20
Door F L, Scratch(es), Acceptable	0,00
<i>No pictures to display</i>	
Rear window, Scratch(es), Acceptable	0,00
<i>No pictures to display</i>	
Bumper R, Scratch(es), LI - Repair and paint (complete)	211,80

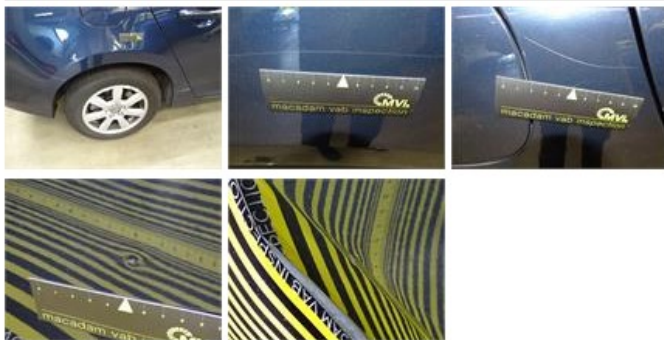
Wing R R, Dent(s) and scratch(es), LI - Repair and paint (complete) 308,20
