**VOLVO V60: 1HGB084**

**Limited Technical Inspection**

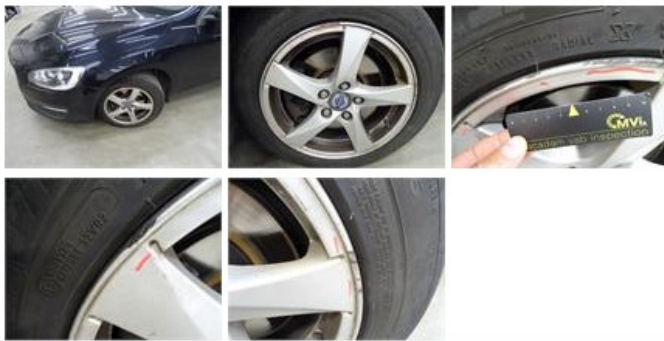
Alloy rim F L, Scratch(es), LI - Repair and paint (complete) 95,00

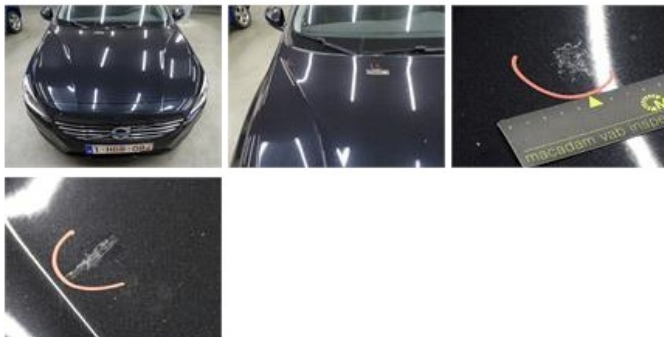
Bonnet, Chemical pollution, LI - Repair and paint (complete) 290,08

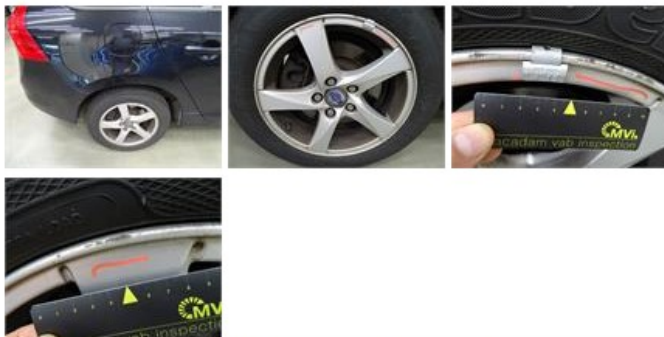
Alloy rim R R, Scratch(es), LI - Repair and paint (complete) 95,00

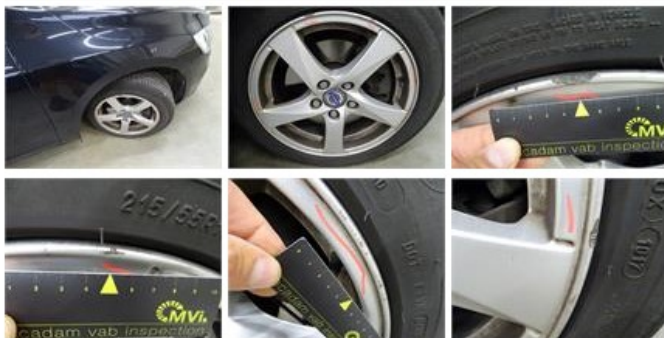
Alloy rim F R, Scratch(es), LI - Repair and paint (complete) 95,00
