**LU Skoda Octavia Combi: SF8399**

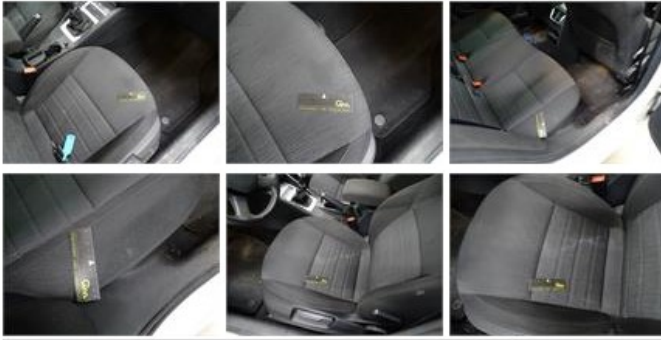
Interior, Dirty, Cleaning

75,00

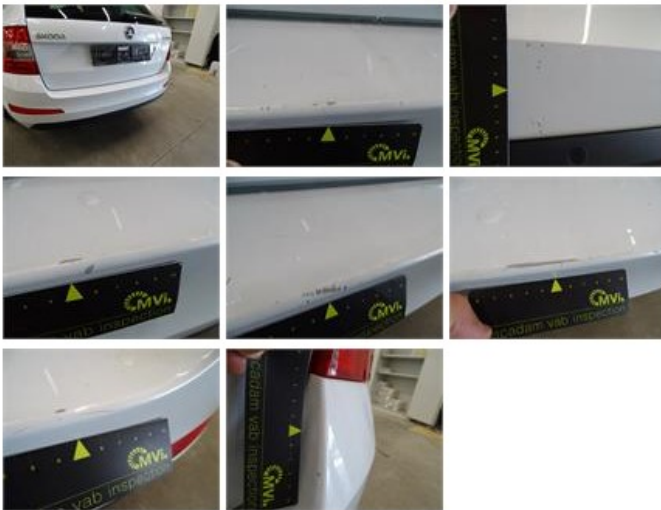
Bumper R, Scratch(es), LI - Repair and paint (complete)

211,80
