**VOLVO V40: 1FRM429**

**Limited Technical Inspection**

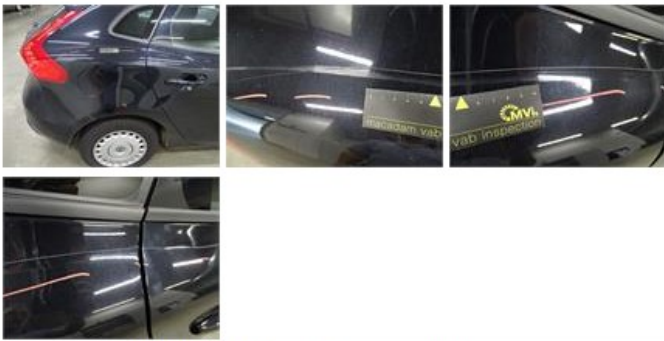
Wing R R, Scratch(es), LI - Repair and paint (complete) 308,20
