BMW 2 ACTIVE TOURER: 1KBB594

Limited Technical Inspection

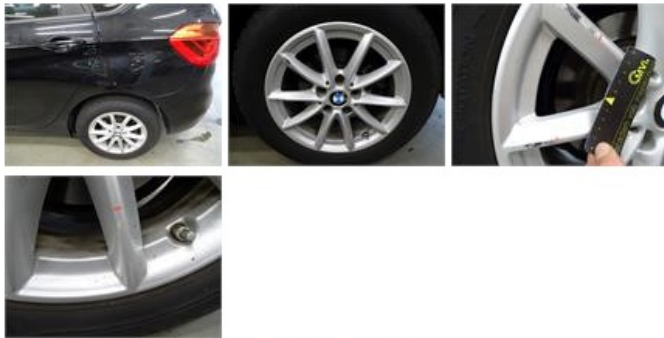
Alloy rim R L, Scratch(es), LI - Repair and paint (complete)

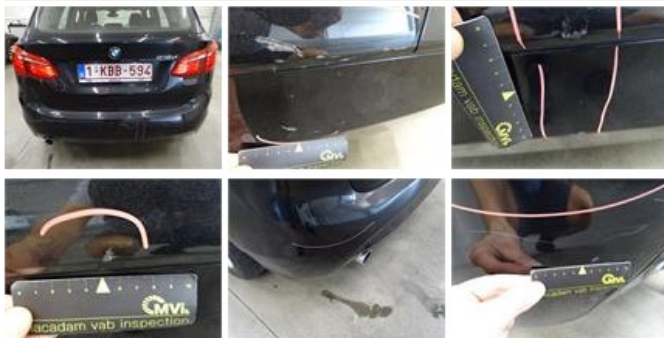
Bumper R, Dent(s) and scratch(es), LI - Repair and paint (complete)
