**FORD Transit Connect LWB: 1GTE228**

**Limited Technical Inspection**

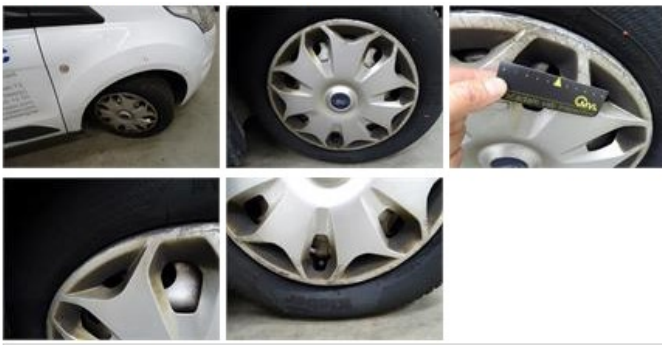
Wheel cover F R, Scratch(es), E - Replace	22,50
---	-------

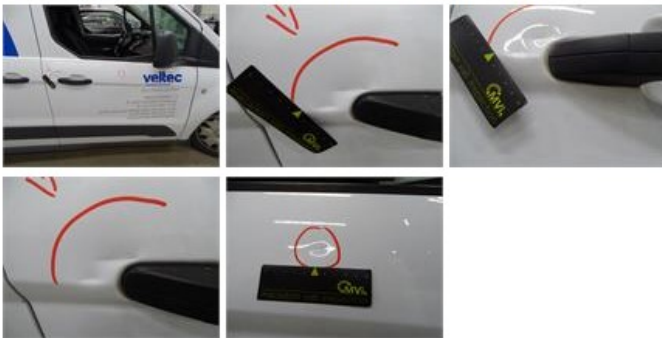
Door F R, Dent(s) and scratch(es), LI - Repair and paint (complete) 238,76
