**BMW 3: 1GHH730**

**Limited Technical Inspection**

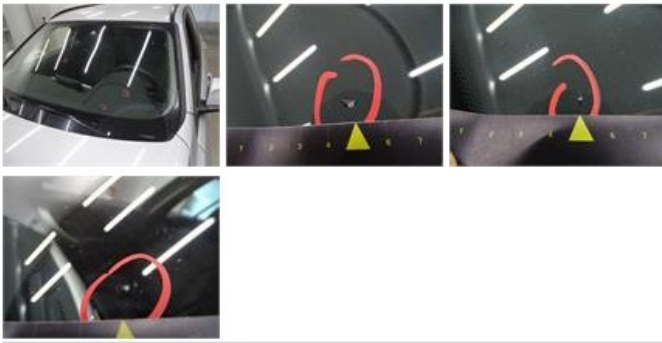
Repair kit	<b>Yes</b>	Compressor	<b>Yes</b>
Total cost ex VAT			<b>501,88</b>
Windscreen, Stone chip(s), Acceptable			<b>0,00</b>

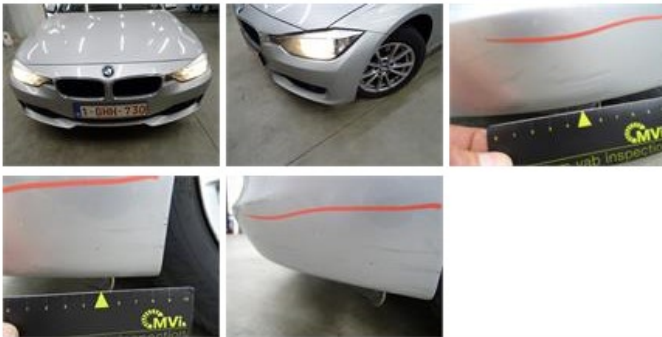
Bumper F, Scratch(es), LI - Repair and paint (complete) 211,80
