BMW 3: HA9585

Limited Technical Inspection

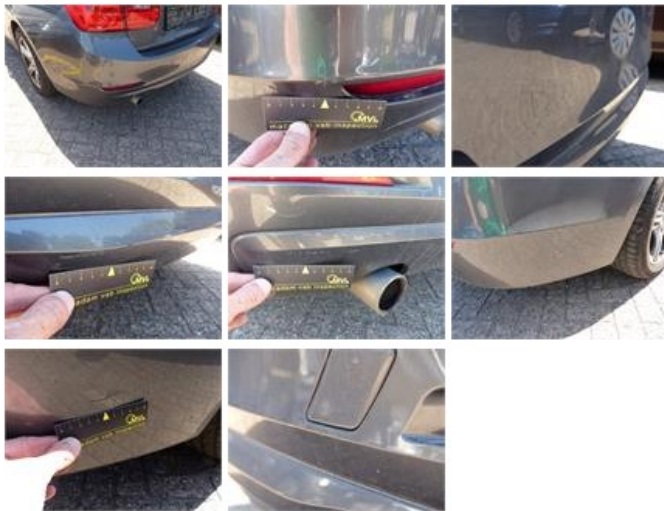
Bumper R, Dent(s) and scratch(es), LI - Repair and paint (complete)	211,80
---	--------
