OPEL ZAFIRA TOURER: 1KKD862

Limited Technical Inspection

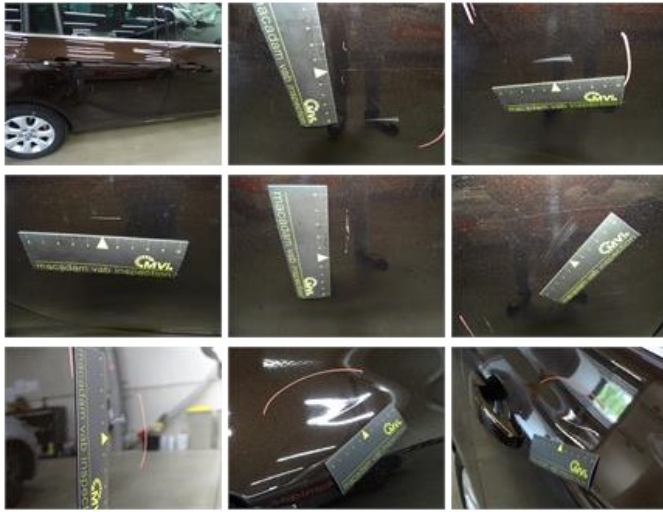
Door R R, Dent(s) and scratch(es), LI - Repair and paint (complete)

318,35

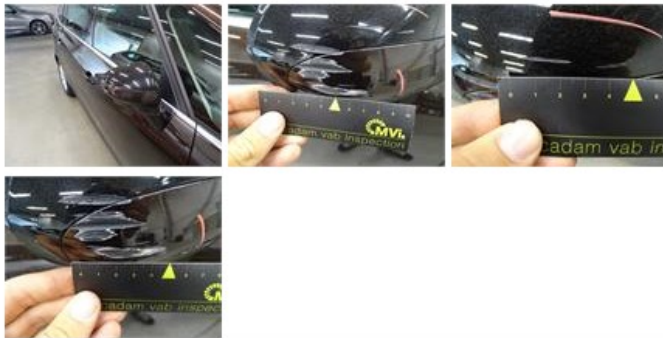
Rearview mirror housing R, Scratch(es), LI - Repair and paint (complete)

115,56

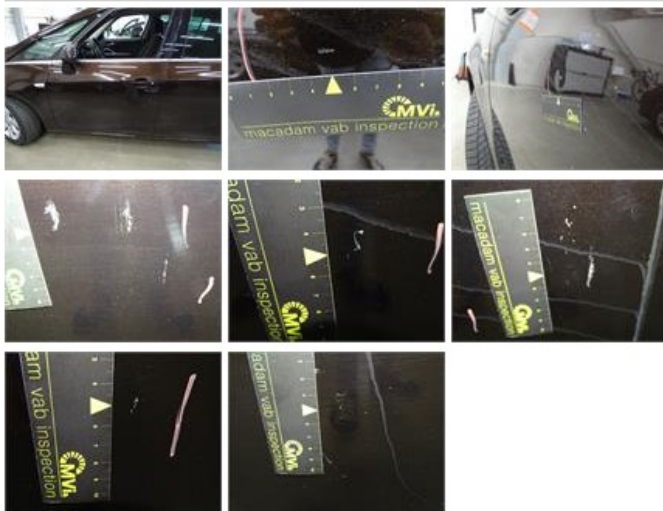
Door F L, Dent(s) and scratch(es), LI - Repair and paint (complete)

318,35

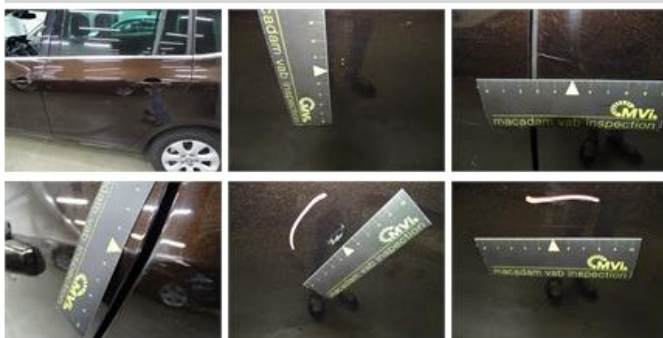
Door R L, Scratch(es), LI - Repair and paint (complete)

318,35

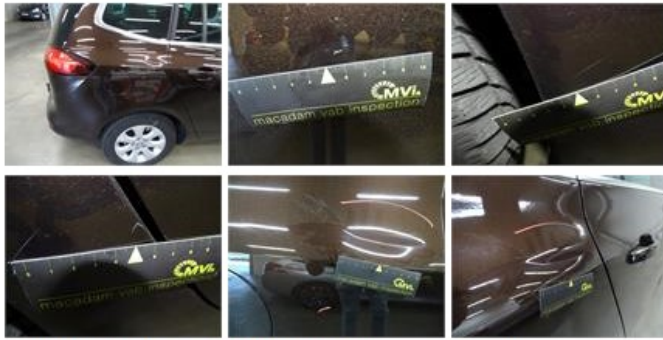
Wing R R, Scratch(es), LI - Repair and paint (complete)

308,20

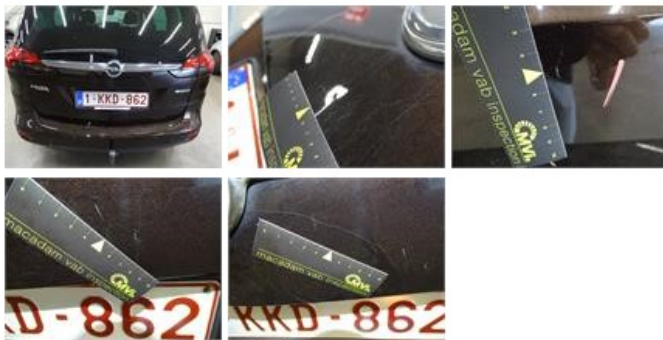
Tailgate, Dent(s) and scratch(es), LI - Repair and paint (complete)

301,68

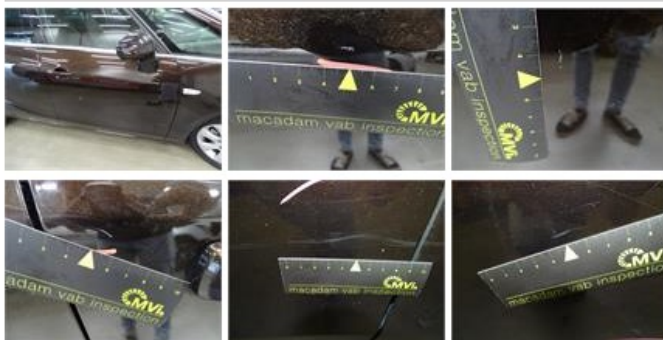
Door F R, Scratch(es), LI - Repair and paint (complete)

318,35

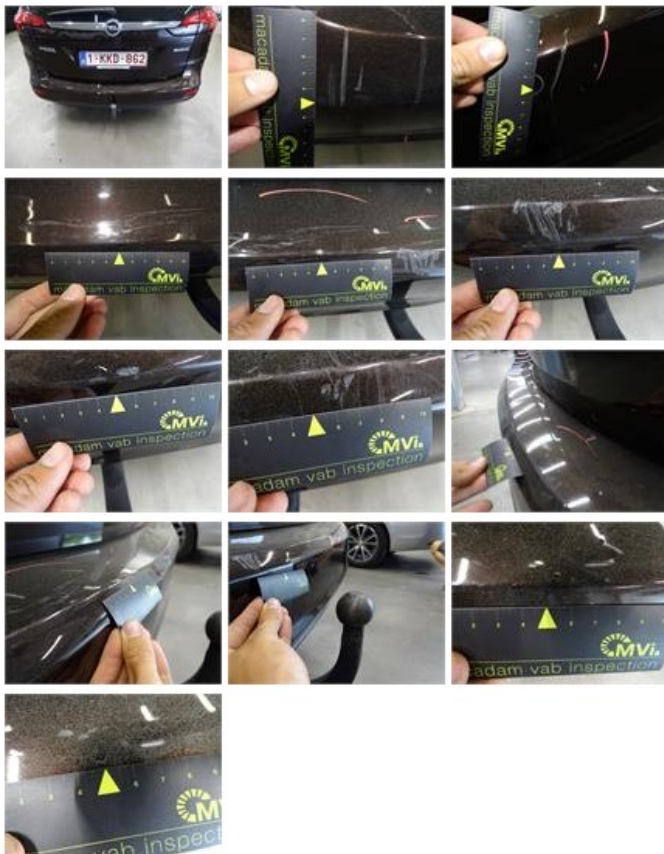
Bumper R, Dent(s) and scratch(es), LI - Repair and paint (complete)

211,80

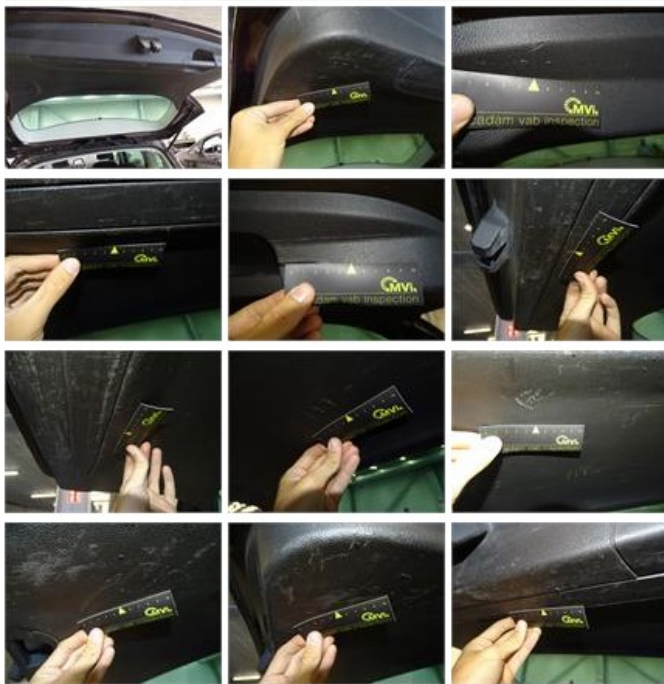
Trunk lid covering R, Scratch(es), Smart repair

110,64

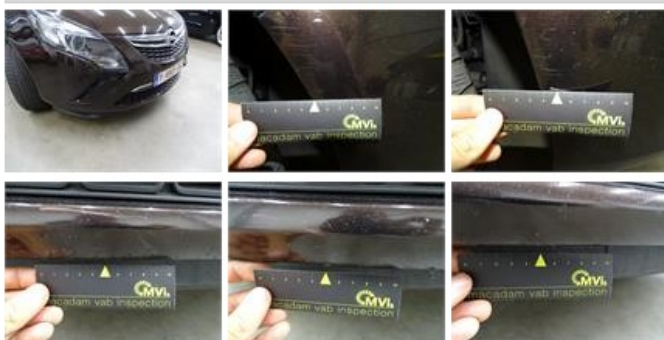
Bumper F, Scratch(es), LI - Repair and paint (complete)

211,80
