**SKODA FABIA: WG6476**

**Limited Technical Inspection**

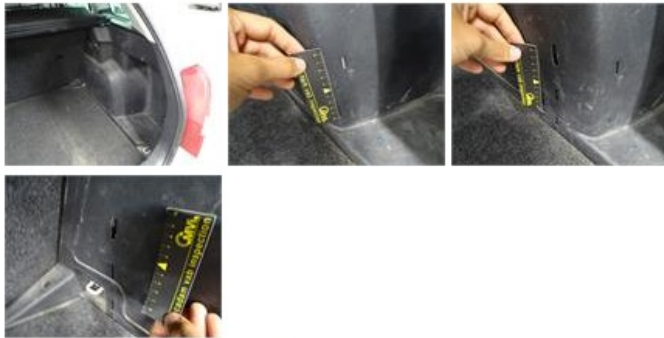
Internal Boot Lining R, Scratch(es), Acceptable

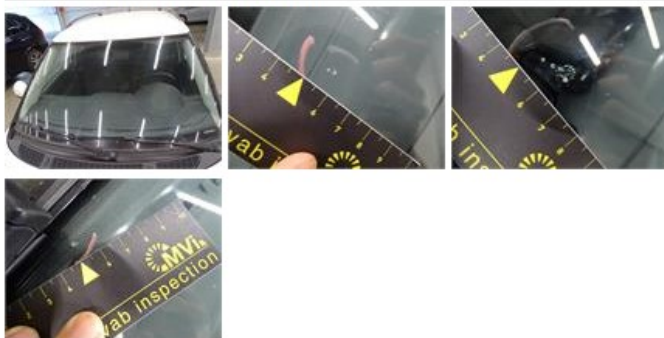
Windscreen, Stone chip(s), Acceptable

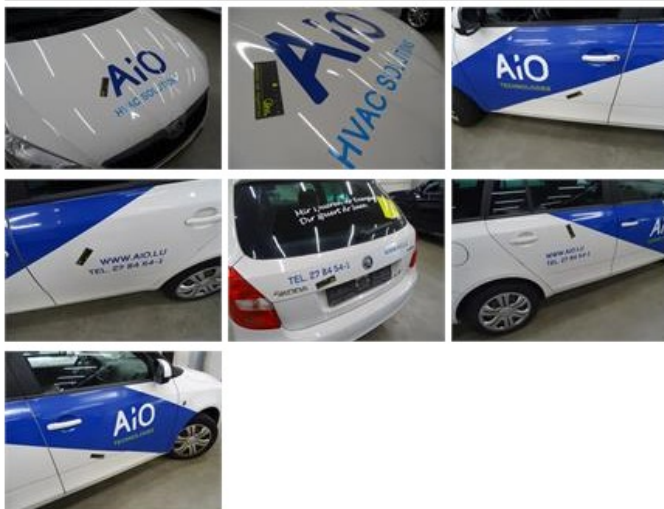
Bodywork, Not original part, Acceptable

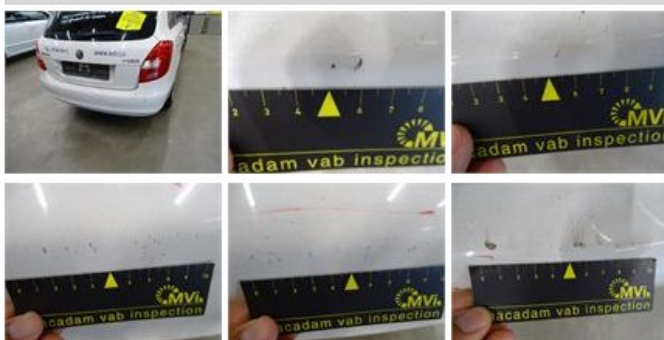
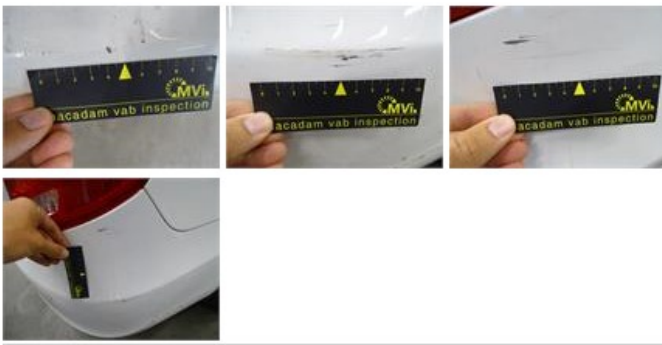
Bumper R, Scratch(es), LI - Repair and paint (complete)

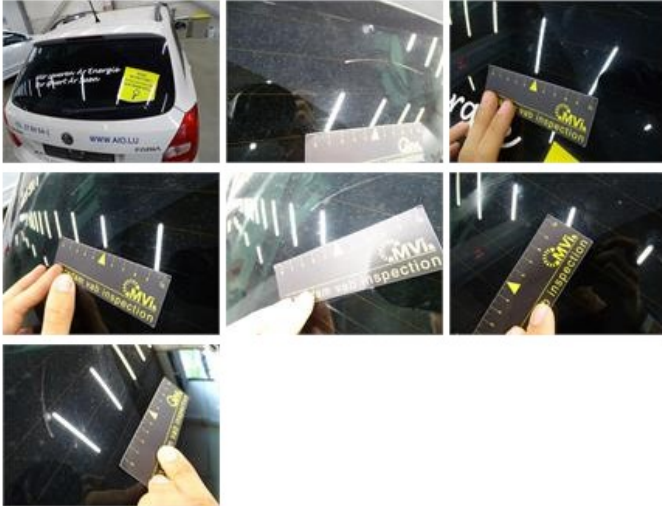
Rear window, Scratch(es), Acceptable 0,00
