VOLKSWAGEN Golf: 1FLX259

Limited Technical Inspection

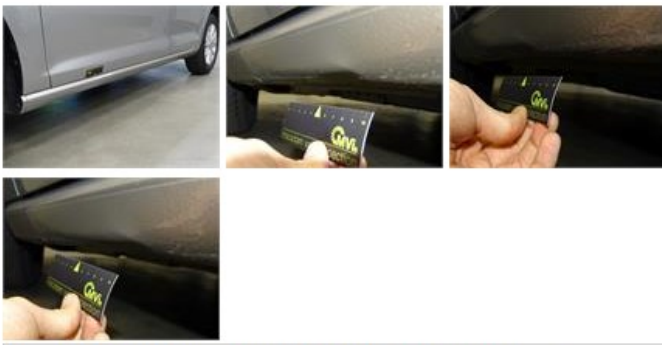
Total cost ex VAT	2482,72
Sill outer L, Dent(s), LI - Repair and paint (complete)	310,50

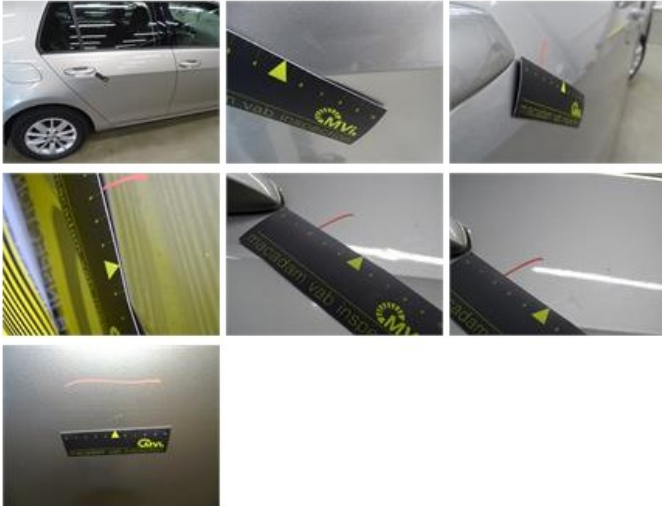
Door R R, Dent(s) and scratch(es), LI - Repair and paint (complete) 318,35

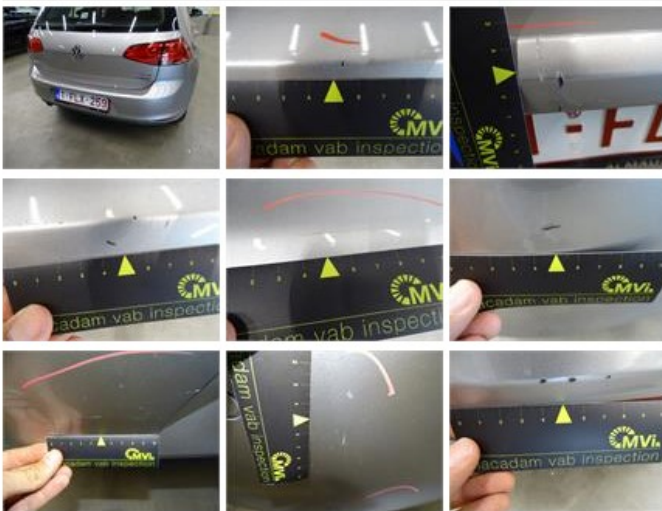
Bumper R, Scratch(es), LI - Repair and paint (complete) 211,80

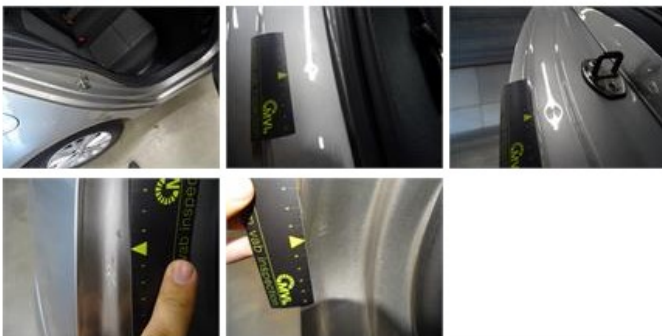
Rocker panel inner R R, Dent(s), LI - Repair and paint (complete) 115,56

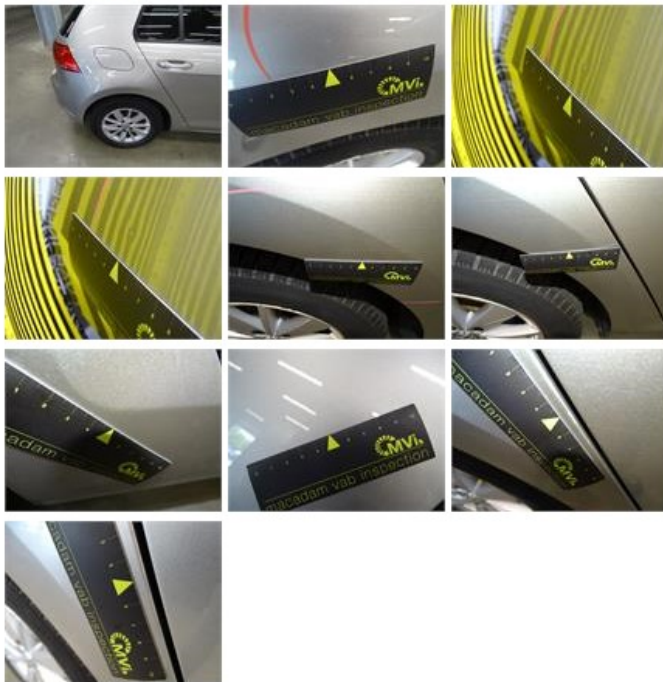
Wing R R, Dent(s) and scratch(es), LI - Repair and paint (complete)

308,20

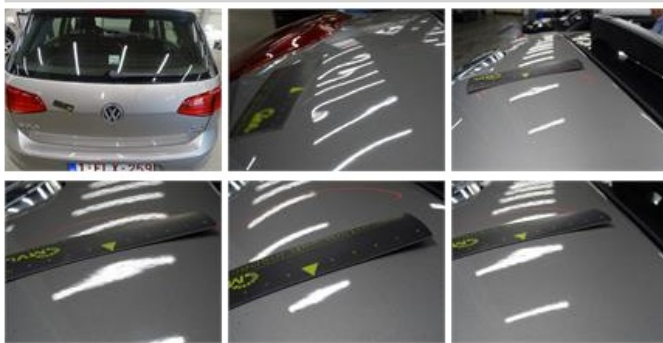
Tailgate, Dent(s), LI - Repair and paint (complete)

301,68

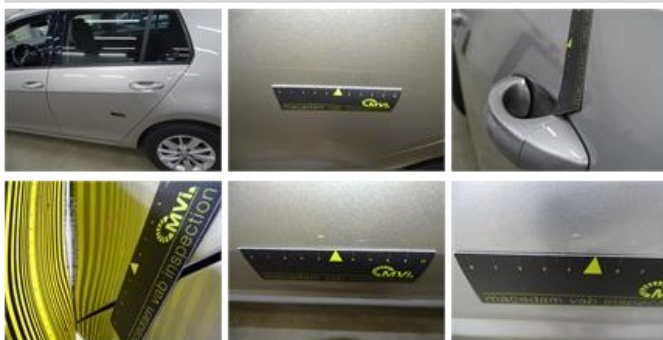
Door R L, Dent(s) and scratch(es), LI - Repair and paint (complete)

318,35

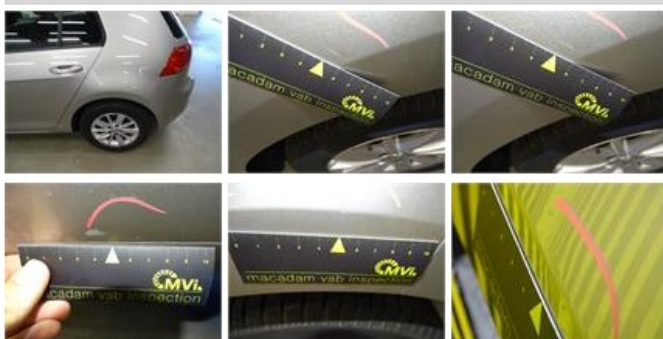
Wing R L, Dent(s) and scratch(es), LI - Repair and paint (complete)

308,20
