MERCEDES CLA: 1HSC087

| Vinnumber: | WDD1173121N139906 | Versionname: | CLA BER 180 CDI 109PK |

Limited Technical Inspection

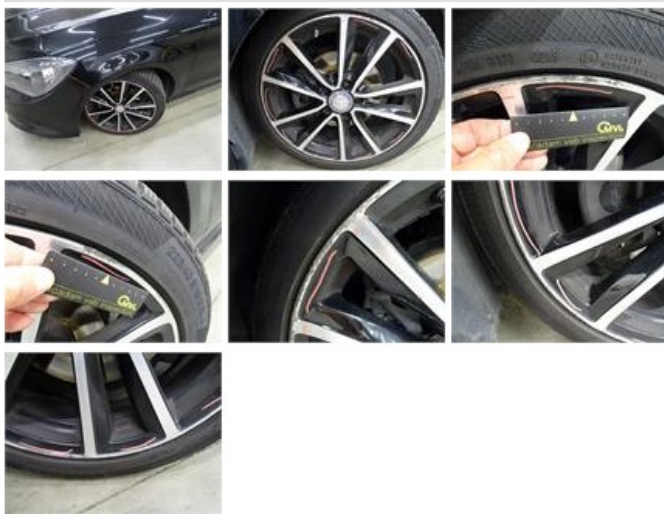
| Alloy rim F L polished, Scratch(es), LI - Repair and paint (complete) | 95,00 |

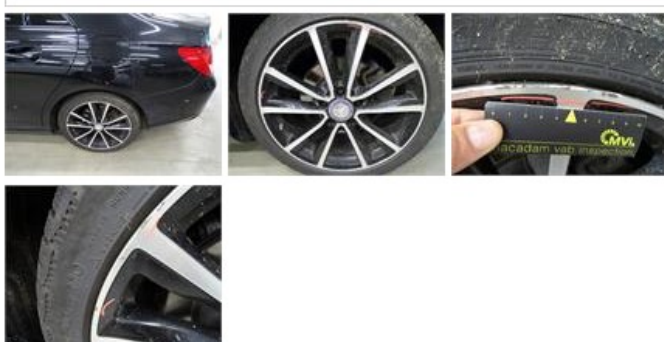
| Alloy rim R L polished, Scratch(es), LI - Repair and paint (complete) | 95,00 |
