**OPEL ZAFIRA TOURER: 1KNR486**

**Limited Technical Inspection**

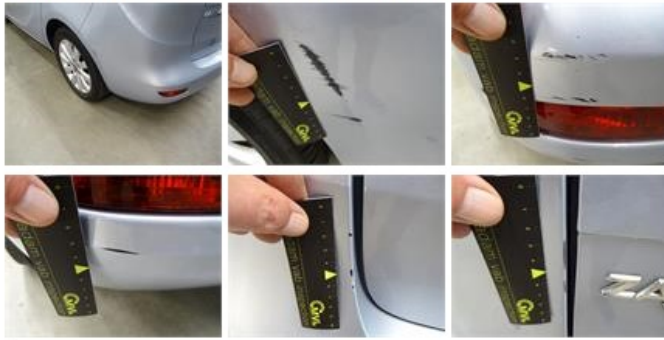
Bumper R, Scratch(es), LI - Repair and paint (complete)

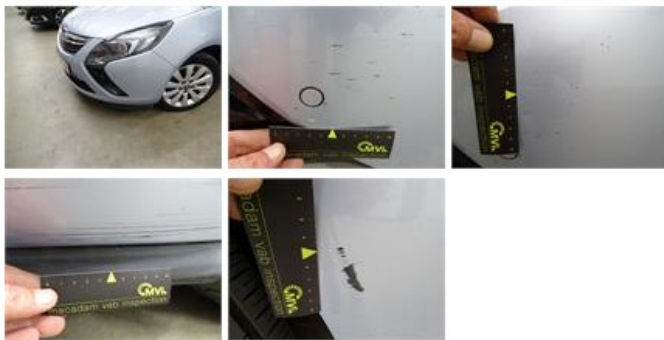
Bumper F, Scratch(es), LI - Repair and paint (complete)
