SKODA Octavia: 1HCG171

Limited Technical Inspection

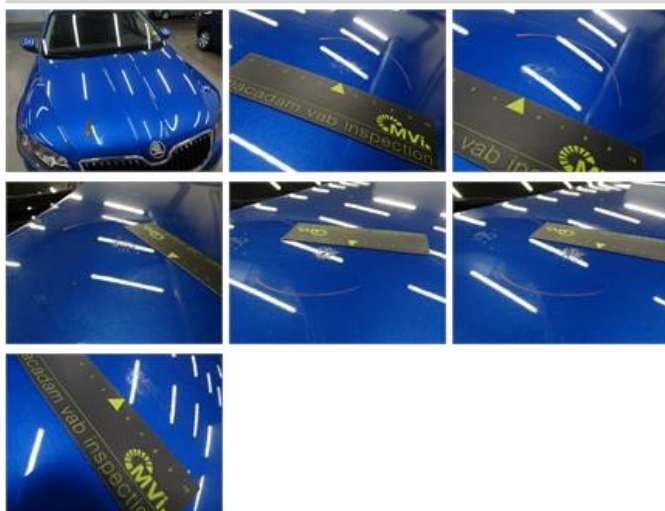
Bonnet, Chemical polution, LI - Repair and paint (complete) 290,08

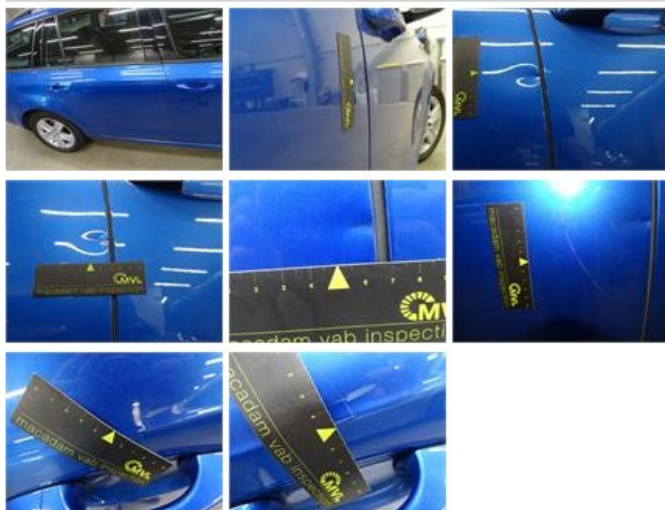
Door R R, Dent(s) and scratch(es), LI - Repair and paint (complete) 318,35

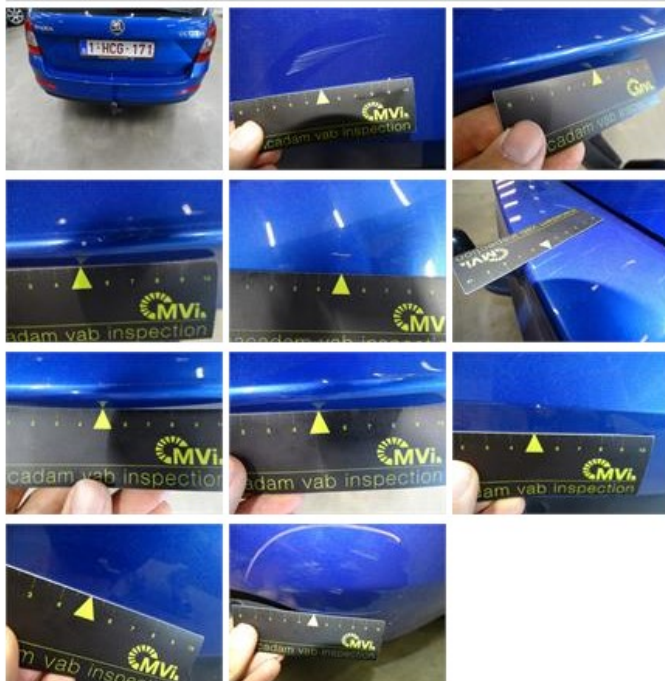
Bumper R, Scratch(es), LI - Repair and paint (complete) 211,80

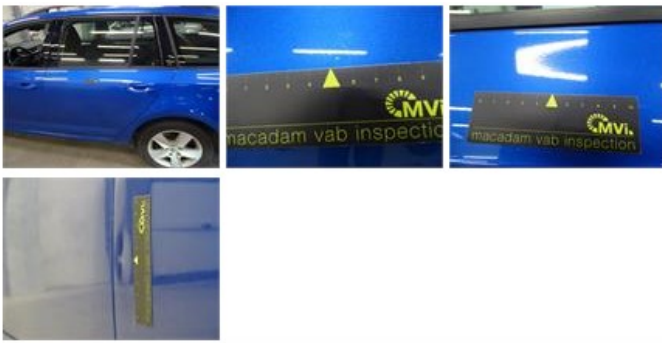
Door R L, Dent(s), PDR - Paintless dent repair 63,00

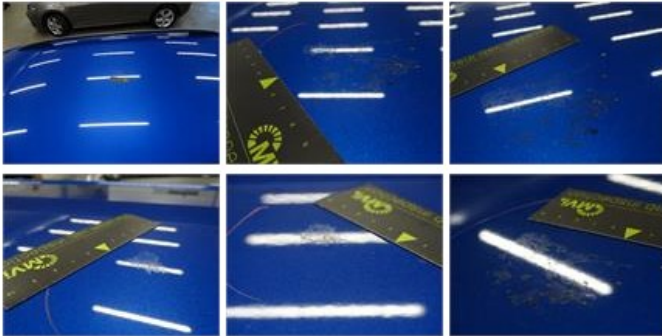
Roof, Chemical polution, LI - Repair and paint (complete) 481,50

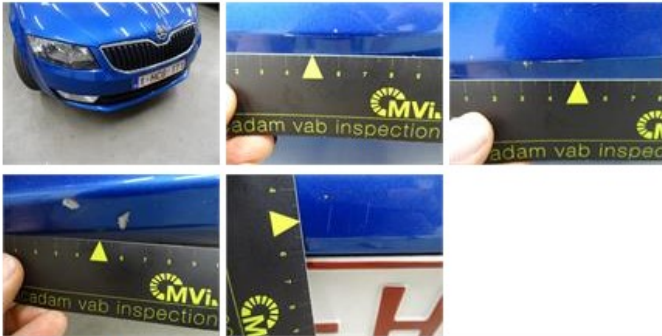
Bumper F, Scratch(es), LI - Repair and paint (complete) 211,80
