**MERCEDES B: 1FDR644**

**Limited Technical Inspection**

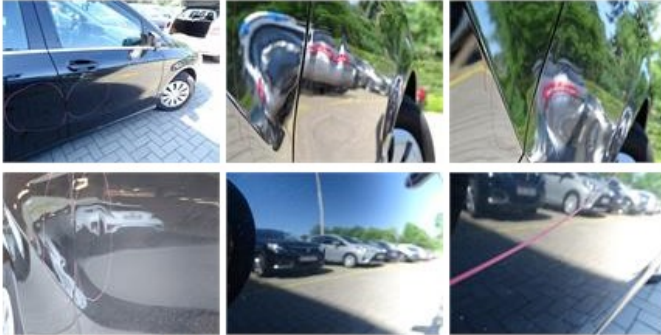
Door F R, Bad repair, LI - Repair and paint (complete) 366,35

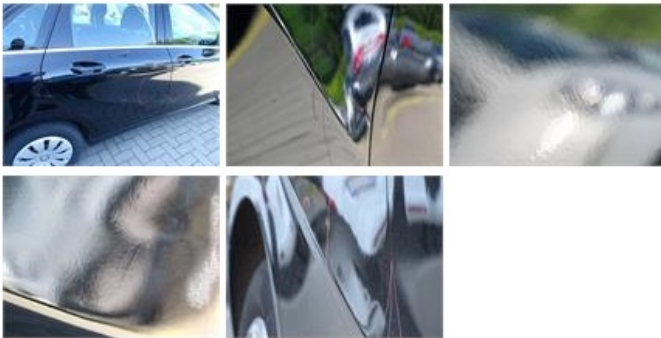
Door R R, Bad repair, LI - Repair and paint (complete) 318,35

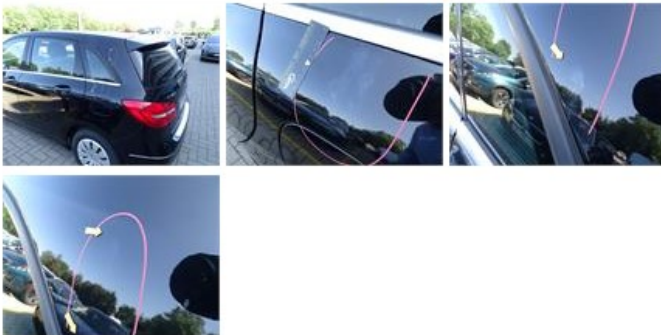
Wing R L, Chemical pollution, LI - Repair and paint (complete) 308,20
