MERCEDES A: 1ERT493

Vinnumber:	WDD1760121J063938	Versionname:	A 180 CDI BE 109PK
First Registrationdate:	4/03/2013	Fiscalpower:	
Expertise Mileage:	154752	Power Kw:	80
Bodytype:	Hatchback	Body color:	Grey
Gearbox:	MAN 6 VIT	Paint type:	Metalic
Transmission:	Front	Rims summer:	Aluminium
Fueltype:	Diesel	Oil level:	OK
Battery functioning:	Yes	Parking lot:	2102
Number of doors:	5		
Number of seats:	5		
Number head rests:	1		
Rims summer:	Aluminium		
Category:	Passenger Car		
Oil level:	OK

Limited Technical Inspection

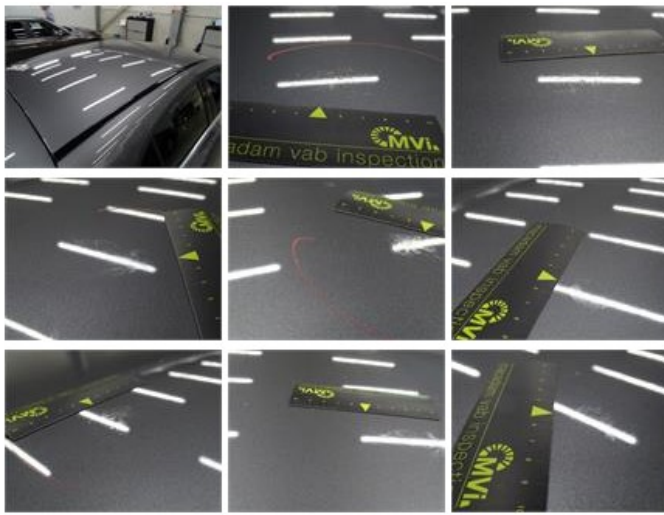
Total cost ex VAT	1353,38
Roof, Chemical polution, LI - Repair and paint (complete)	481,50

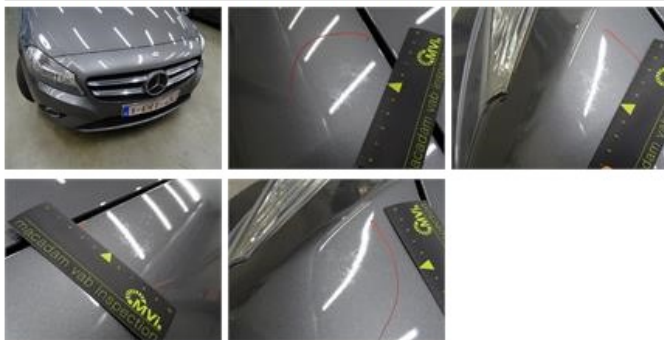
Bumper F, Chemical polution, LI - Repair and paint (complete) 211,80

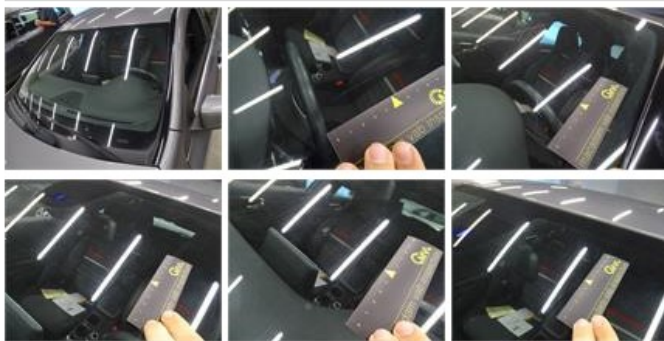
Windscreen, Scratch(es), Acceptable 0,00

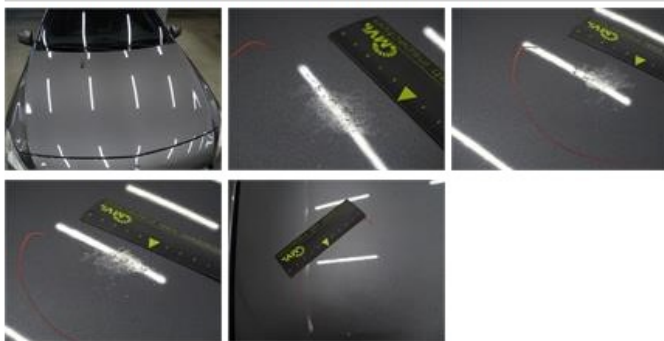
Bonnet, Chemical polution, LI - Repair and paint (complete) 290,08

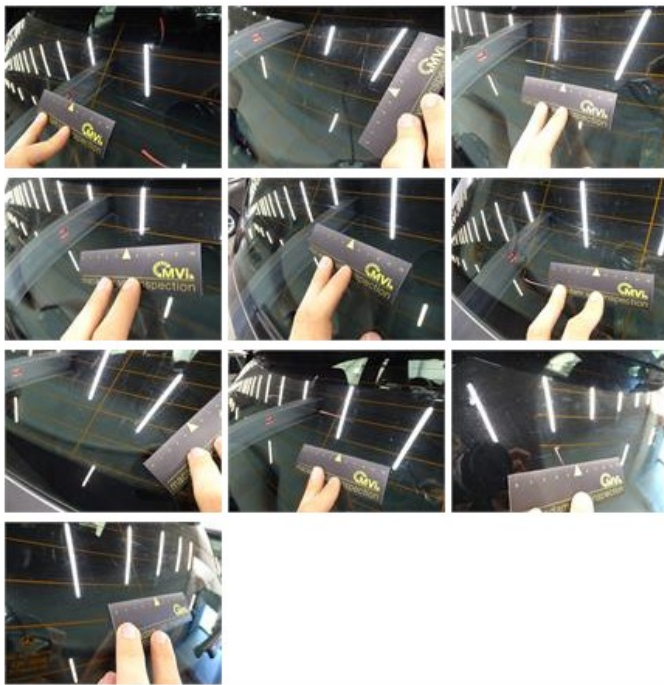
Rear window, Scratch(es), E - Replace 370,00
