OPEL ZAFIRA TOURER: 1JNL526

| Vinnumber: | W0LPE9E36F2026461 | Versionname: | 1.6 CDTI ECOFLEX 100KW S/S COSMO |

Limited Technical Inspection

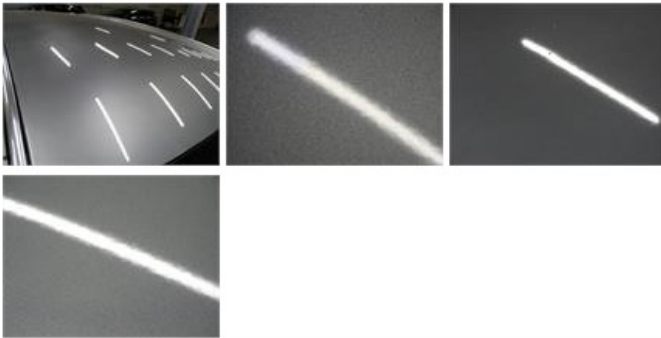
Roof, Bad repair, Acceptable

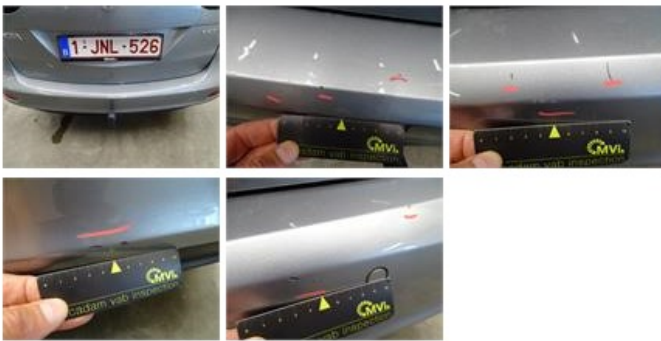
Bumper R, Scratch(es), LI - Repair and paint (complete)

211,80
