**SKODA FABIA COMBI: 1KSJ267**

**Limited Technical Inspection**

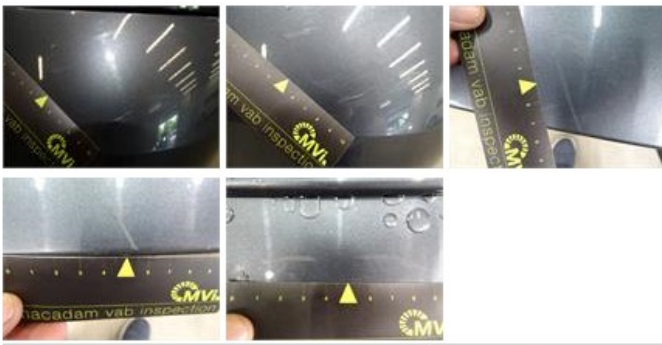
<b>Total cost ex VAT</b>	<b>1310,56</b>
<b>Bumper R, Scratch(es), LI - Repair and paint (complete)</b>	<b>169,44</b>

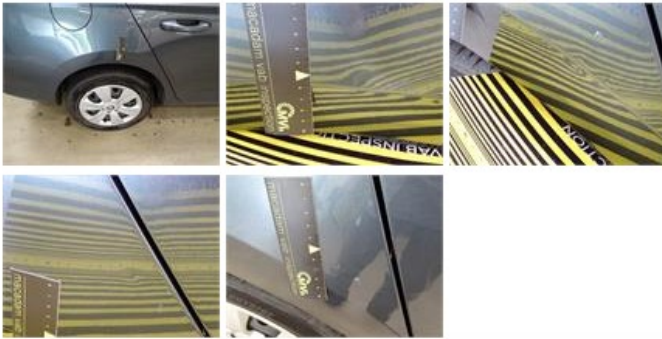
Wing R R, Dent(s) and scratch(es), LI - Repair and paint (complete) 246,56

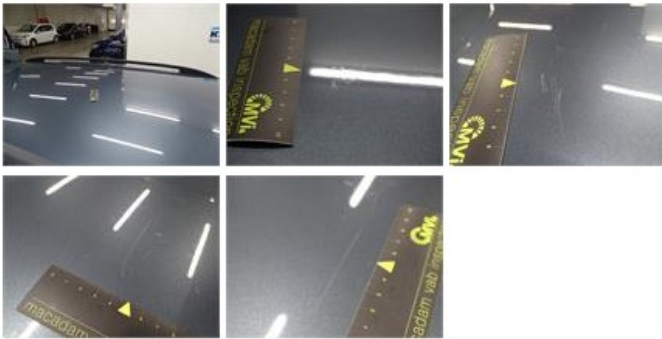
Roof, Chemical pollution, LI - Repair and paint (complete) 385,20
