VOLVO V60: 1KSA313

Limited Technical Inspection

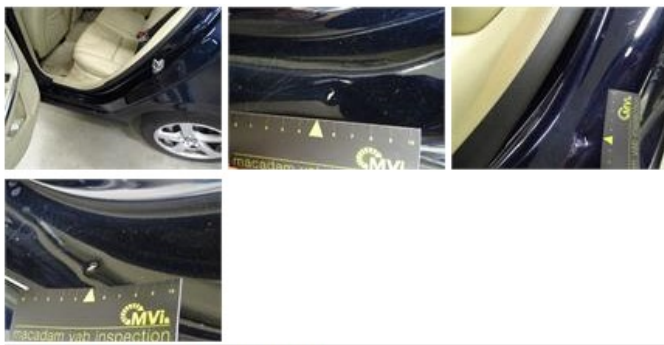
Total cost ex VAT	2101,68
Rocker panel inner R L, Dent(s), Acceptable	0,00

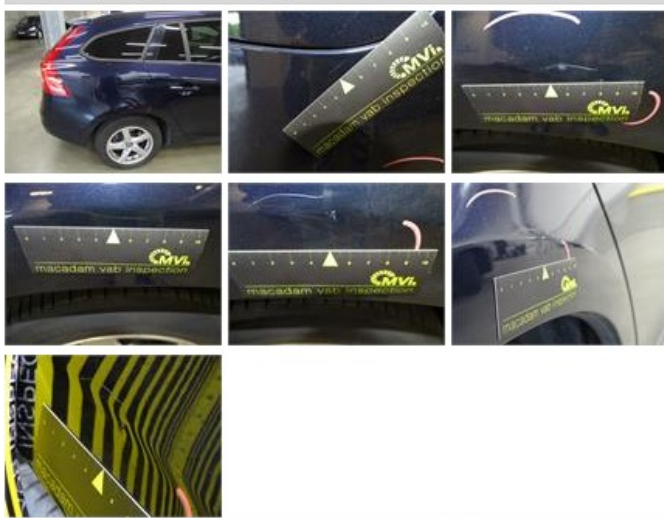
Alloy rim F L, Scratch(es), Acceptable	0,00
<i>No pictures to display</i>	
Door F R, Scratch(es), Acceptable	0,00
<i>No pictures to display</i>	
Wing R R, Dent(s) and scratch(es), LI - Repair and paint (complete)	308,20

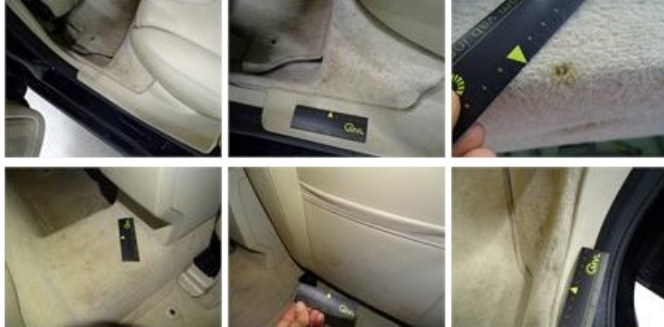
Interior, Dirty, Cleaning	0,00
---------------------------	------

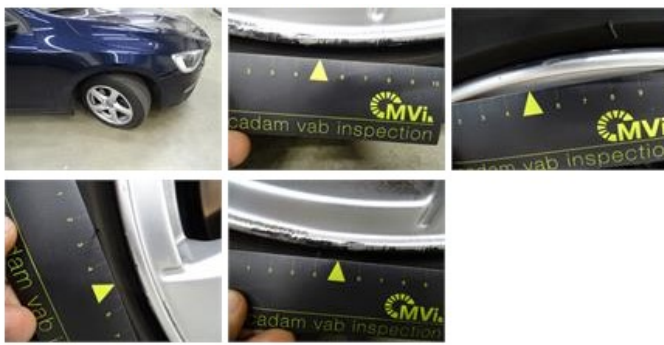
Alloy rim F R, Scratch(es), LI - Repair and paint (complete)	95,00
--	-------

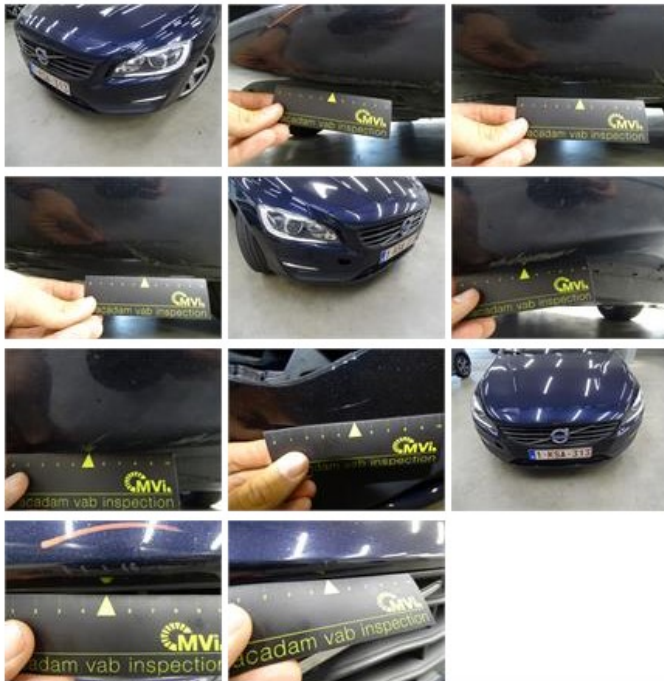
Bumper F, Scratch(es), LI - Repair and paint (complete)

211,80

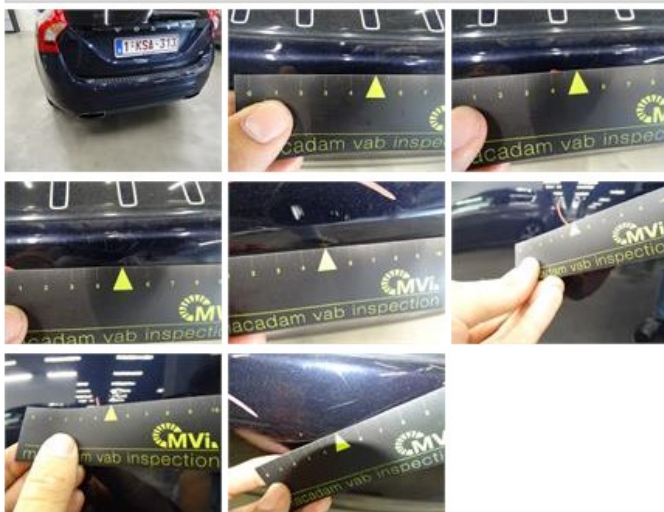
Bumper R, Scratch(es), LI - Repair and paint (complete)

211,80

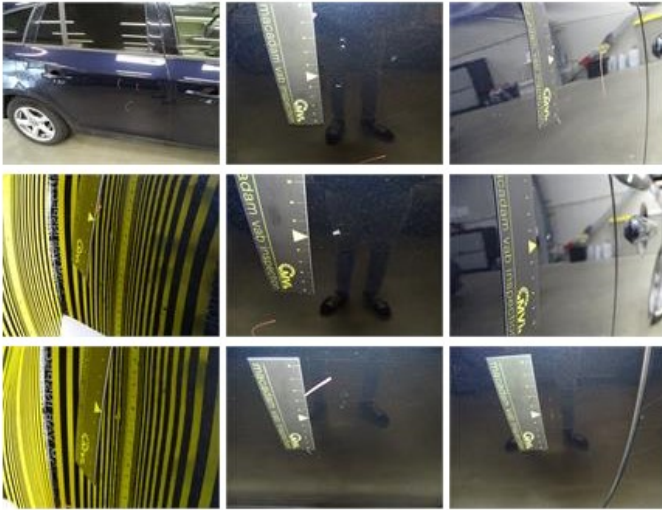
Door R R, Dent(s) and scratch(es), LI - Repair and paint (complete)

318,35
