## VOLVO V40: 1GVV716

## Limited Technical Inspection

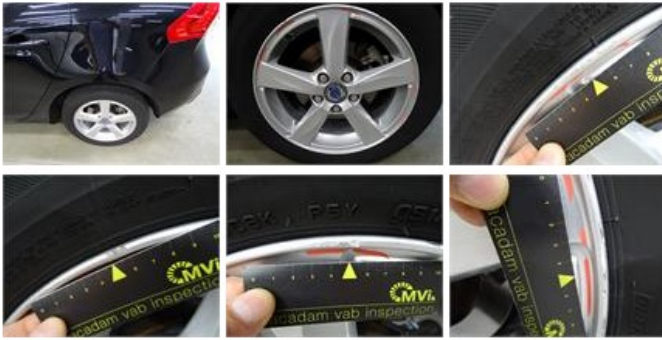
Alloy rim R L, Scratch(es), LI - Repair and paint (complete) 95,00

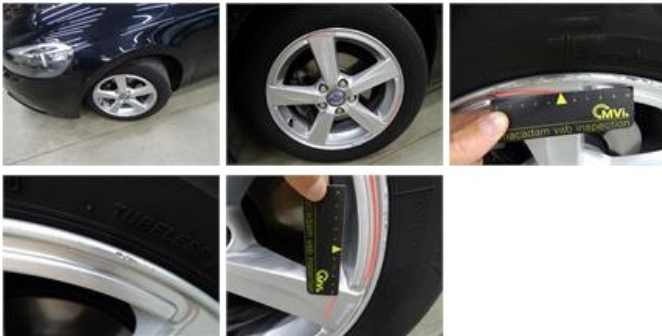
Alloy rim F L, Scratch(es), LI - Repair and paint (complete) 95,00

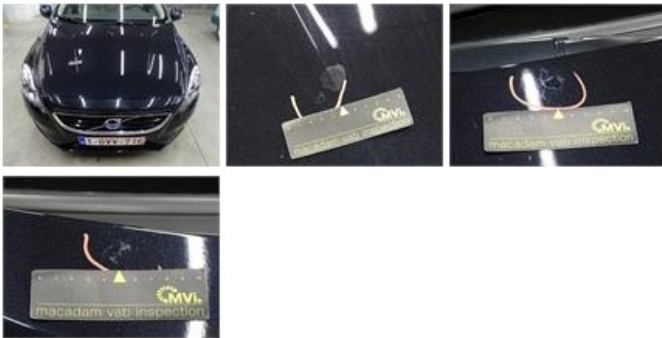
Bonnet, Chemical polution, LI - Repair and paint (complete) 290,08

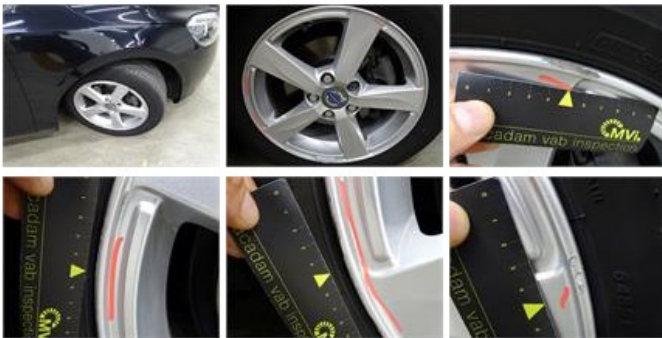
Alloy rim F R, Scratch(es), LI - Repair and paint (complete) 95,00
