VOLVO V40: 1KCG287

Limited Technical Inspection

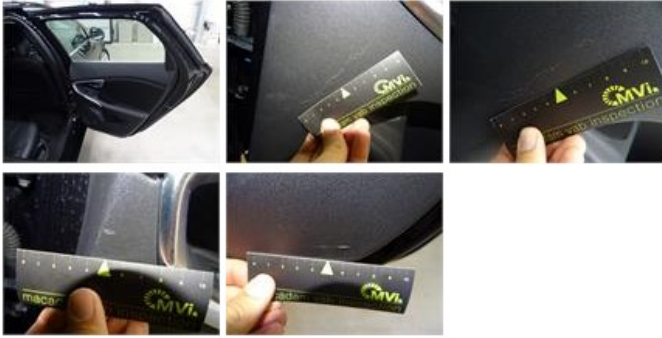
Door panel R R, Scratch(es), Smart repair 110,64

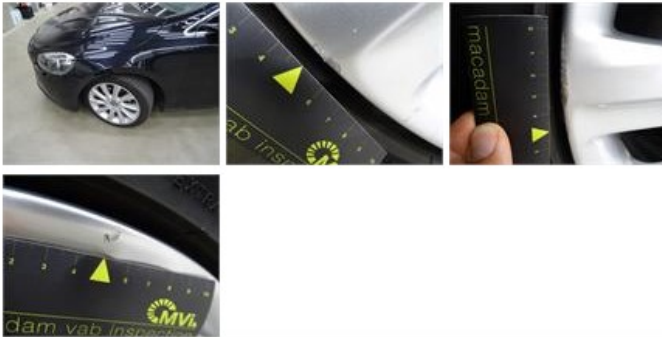
Alloy rim F L, Scratch(es), LI - Repair and paint (complete) 95,00

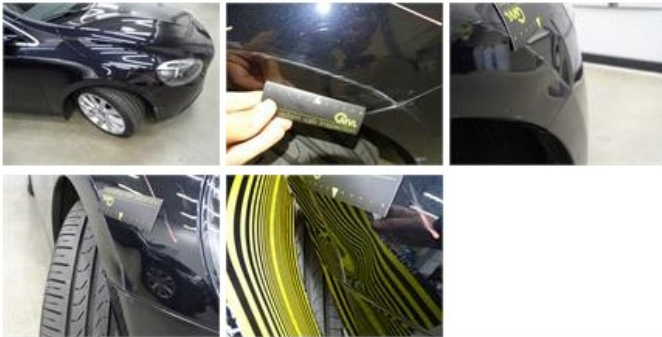
Wing F R, Dent(s) and scratch(es), LI - Repair and paint (complete) 220,18

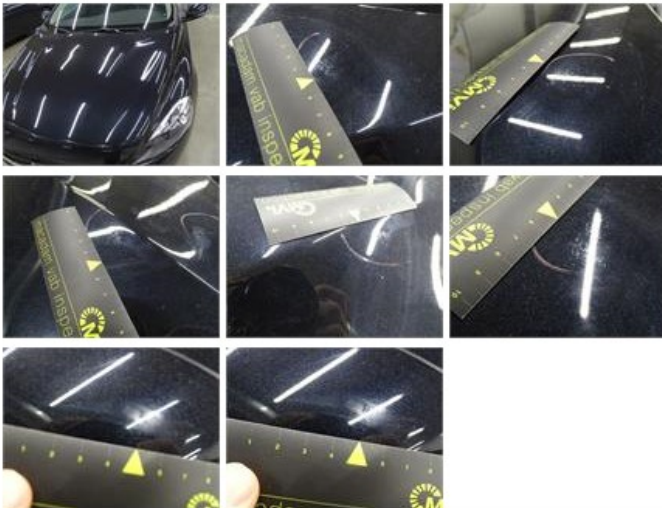
Bonnet, Chemical polution, LI - Repair and paint (complete) 290,08

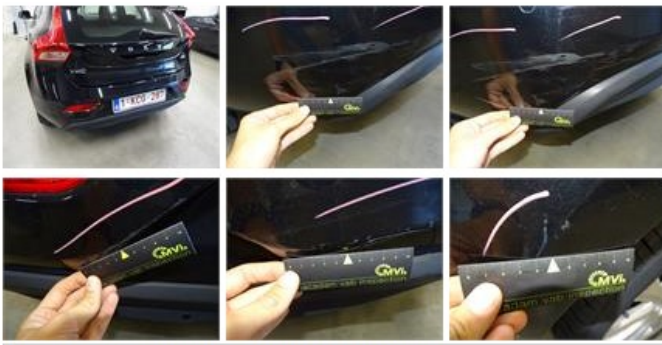
Bumper R, Scratch(es), LI - Repair and paint (complete) 211,80

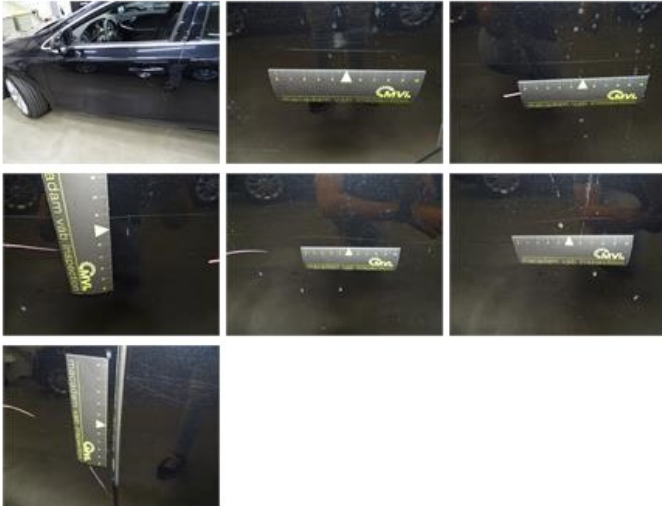
Door F L, Scratch(es), LI - Repair and paint (complete)

318,35

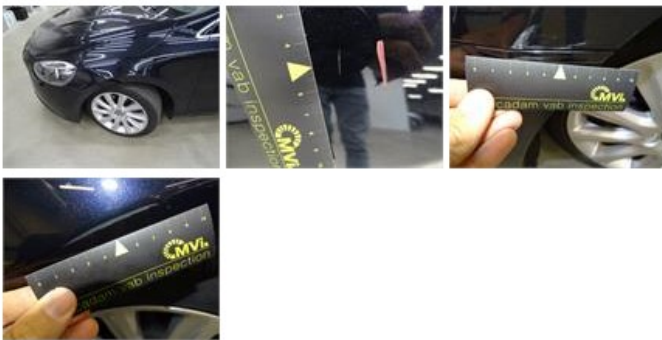
Wing F L, Scratch(es), LI - Repair and paint (complete)

220,18

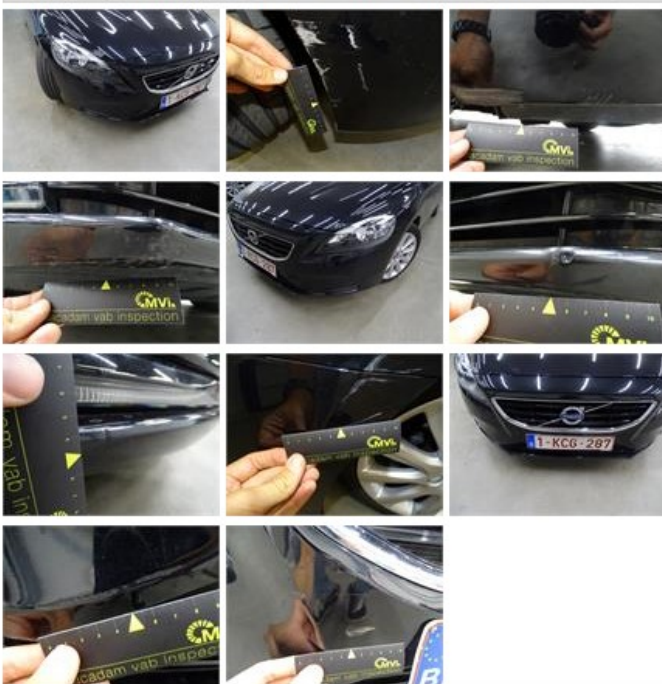
Bumper F, Dent(s) and scratch(es), LI - Repair and paint (complete)

211,80

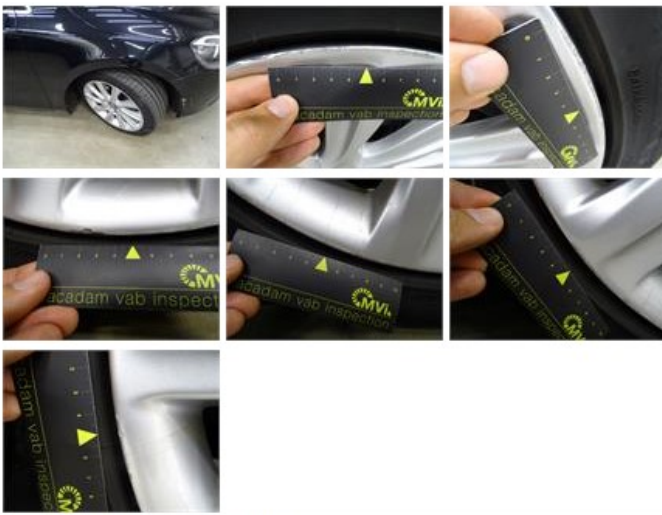
Alloy rim F R, Scratch(es), LI - Repair and paint (complete)

95,00

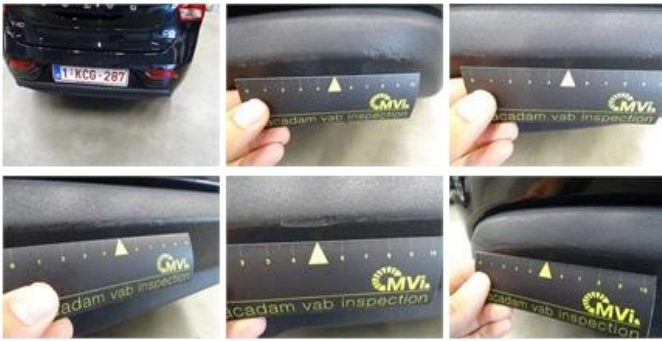
Bumper cover R M, Scratch(es), Smart repair 110,64
