PEUGEOT 308 SW: 1KND638

Limited Technical Inspection

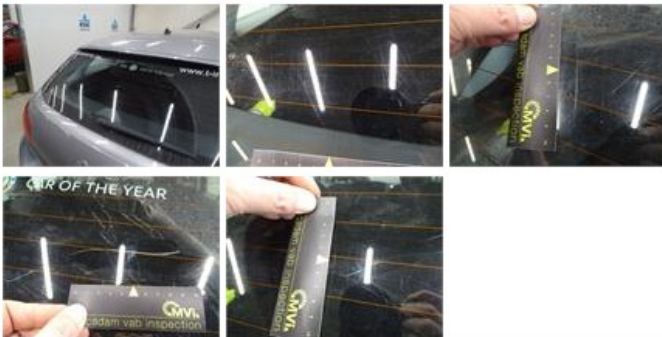
Rear window, Scratch(es), E - Replace 370,00
