VOLVO V60: 1JTG457

Limited Technical Inspection

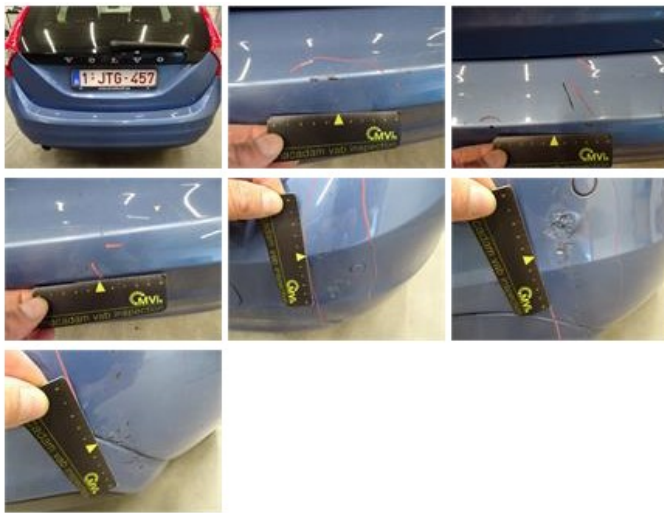
Repair kit	Yes	Compressor	Yes
Total cost ex VAT			881,88
Bumper R, Dent(s) and scratch(es), LI - Repair and paint (complete)			211,80

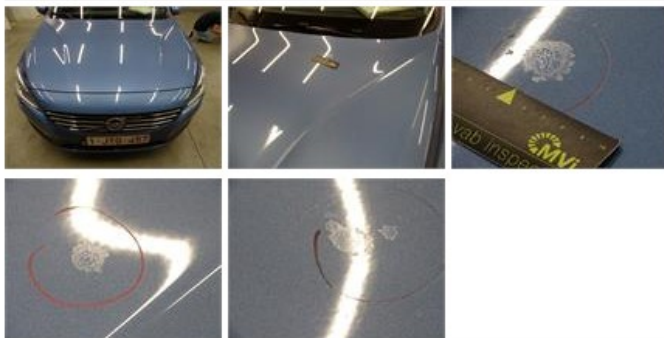
Bonnet, Chemical polution, LI - Repair and paint (complete) 290,08

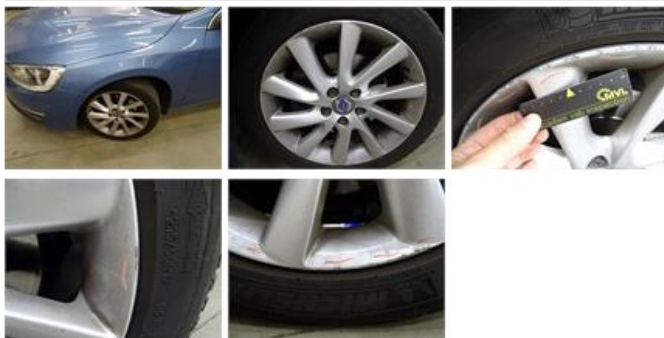
Alloy rim F L, Scratch(es), LI - Repair and paint (complete) 95,00

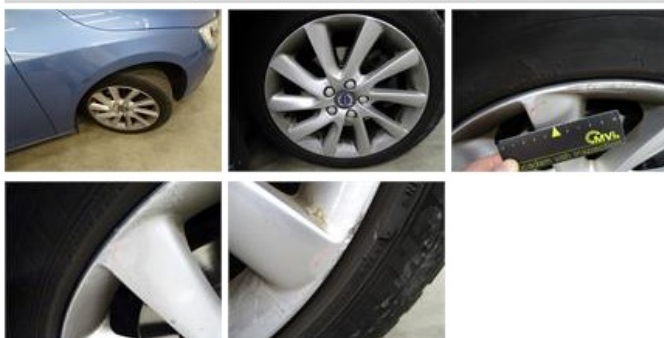
Alloy rim F R, Scratch(es), LI - Repair and paint (complete) 95,00

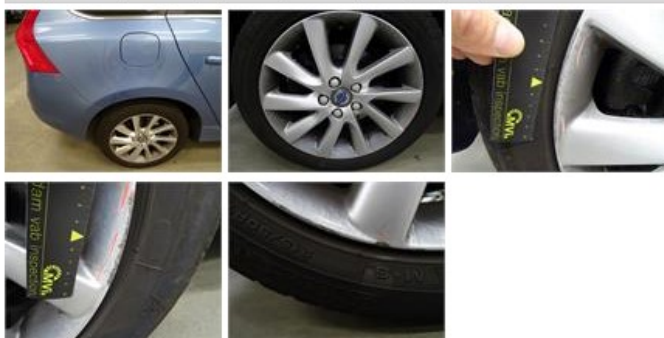
Alloy rim R R, Scratch(es), LI - Repair and paint (complete) 95,00
