## VOLKSWAGEN CADDY: 1PSX484

## Limited Technical Inspection

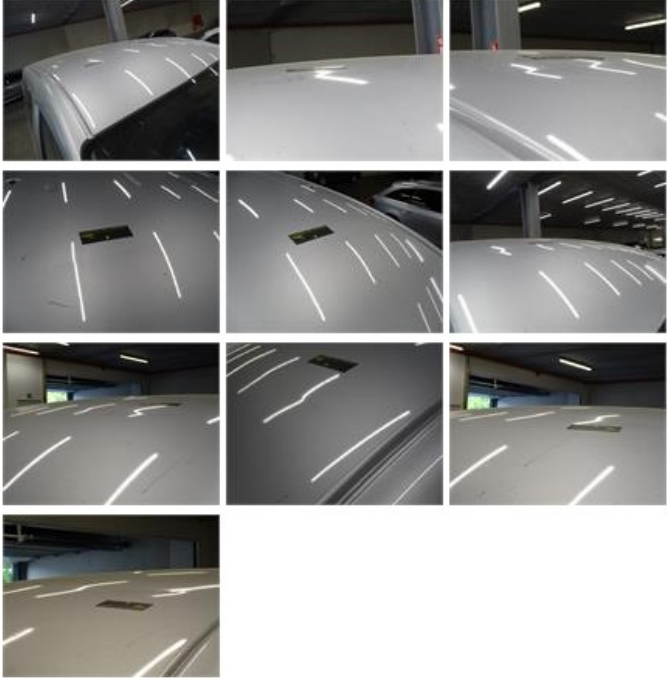
Roof, Dent(s) and scratch(es), LI - Repair and paint (complete) 409,13

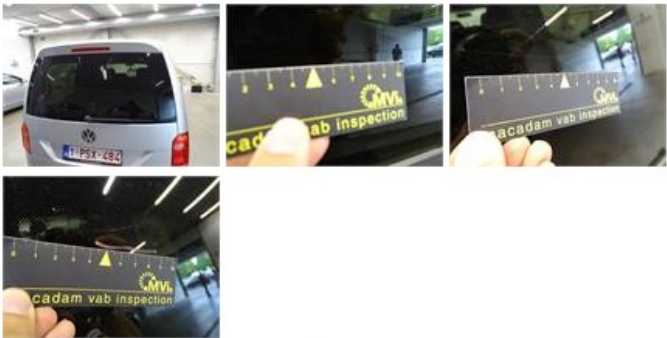
Rear window, Scratch(es), Acceptable 0,00

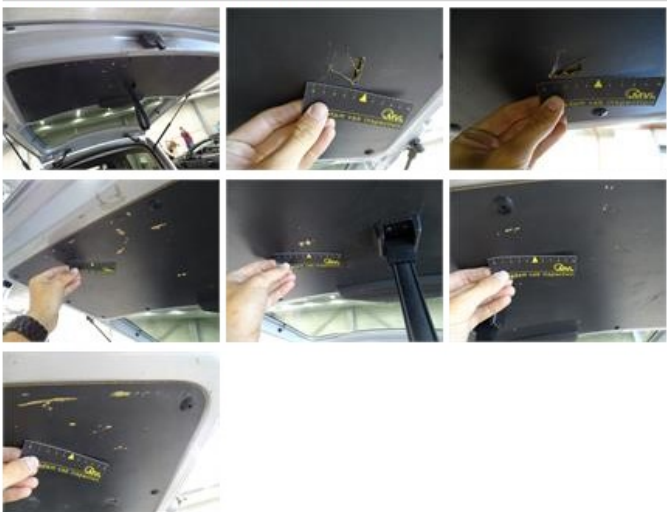
Trunk lid covering R, Hole, Smart repair 110,64

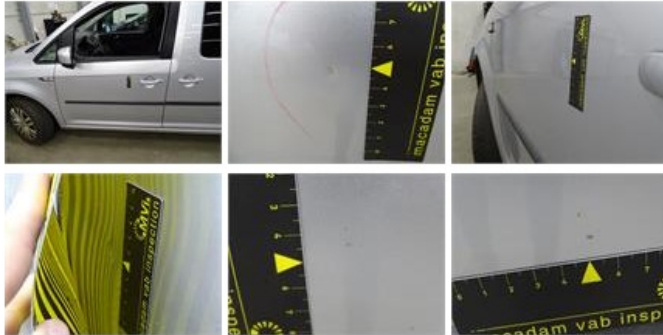
Door F L, Dent(s) and scratch(es), LI - Repair and paint (complete) 238,76

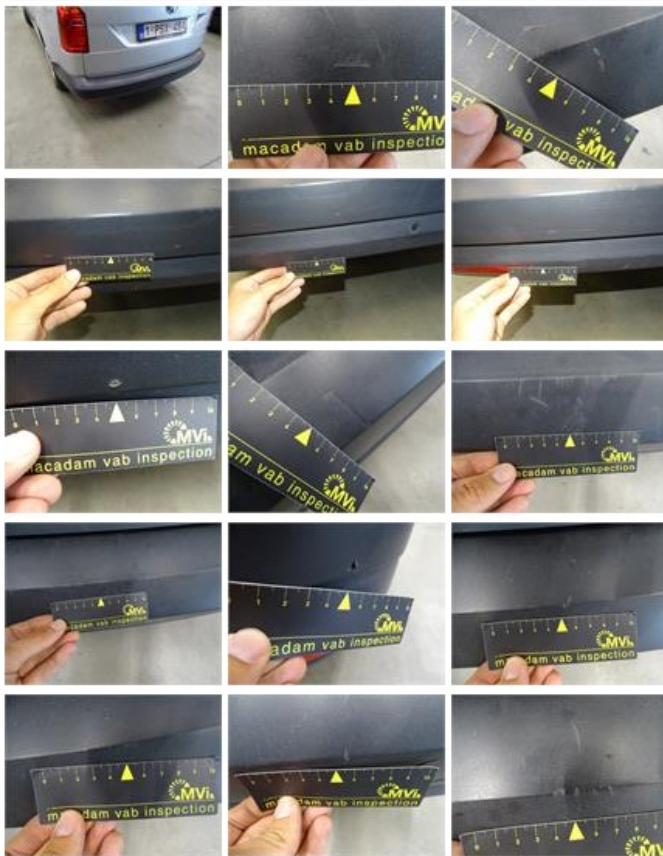
Bumper R, Scratch(es), LI - Repair and paint (complete) 158,85
