NISSAN QASHQAI: 1JHS180

Limited Technical Inspection

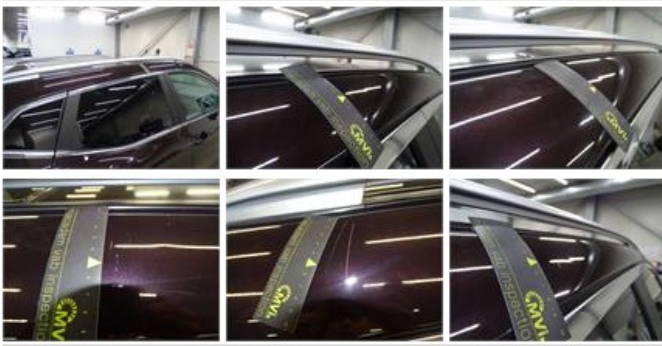
Roof pillar R, Hail damage, PDR - Hail 0,00

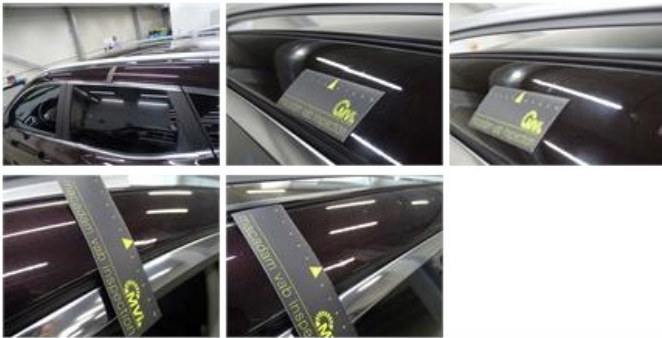
Roof pillar L, Hail damage, PDR - Hail

150,00

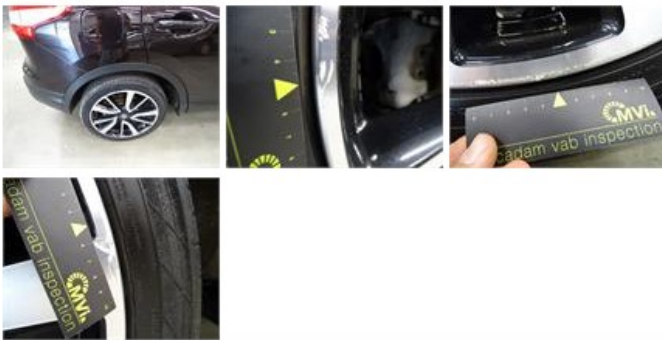
Alloy rim R R polished, Scratch(es), LI - Repair and paint (complete)

95,00

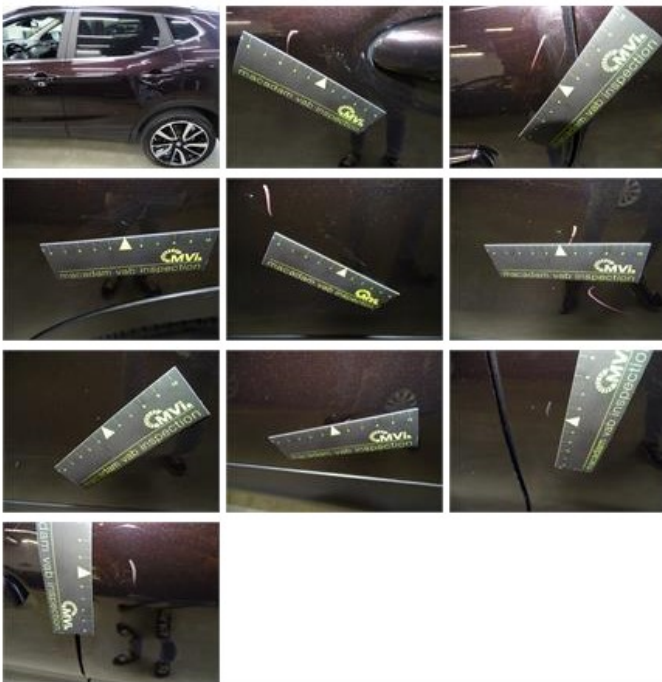
Door R L, Scratch(es), LI - Repair and paint (complete)

318,35

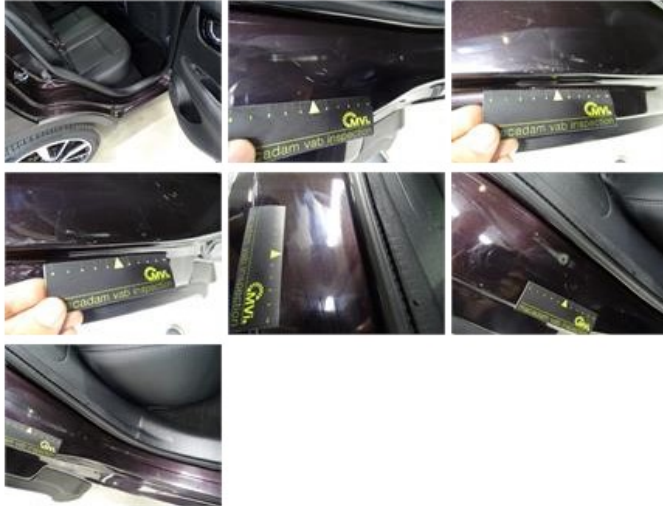
Rocker panel inner R R, Dent(s), LI - Repair and paint (complete) 115,56

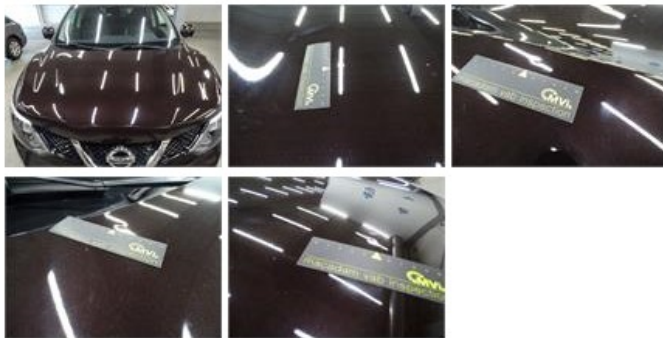
Bonnet, Hail damage, Le - Replace and paint 0,00

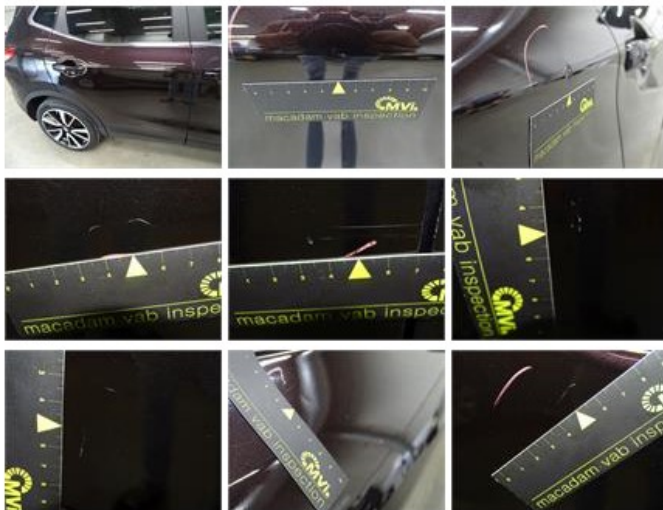
Door R R, Dent(s) and scratch(es), LI - Repair and paint (complete) 318,35

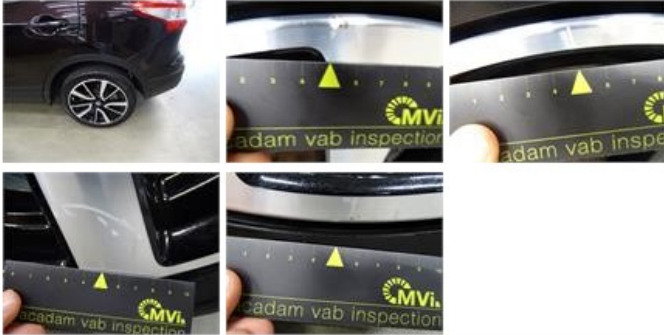
Alloy rim R L polished, Scratch(es), LI - Repair and paint (complete) 95,00

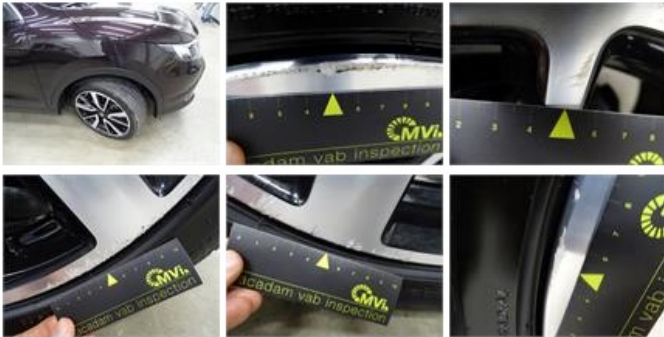
Alloy rim F R polished, Scratch(es), LI - Repair and paint (complete) 95,00

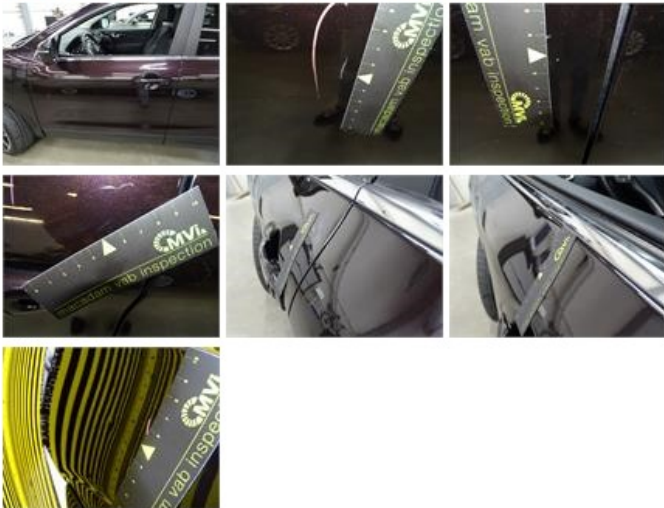
Door F L, Dent(s) and scratch(es), LI - Repair and paint (complete) 318,35

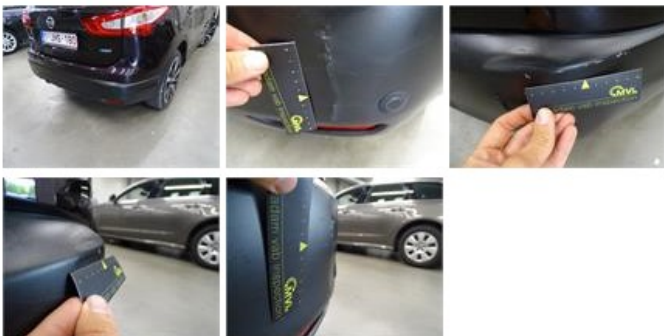
Bumper cover R M, Dent(s) and scratch(es), Smart repair 110,64

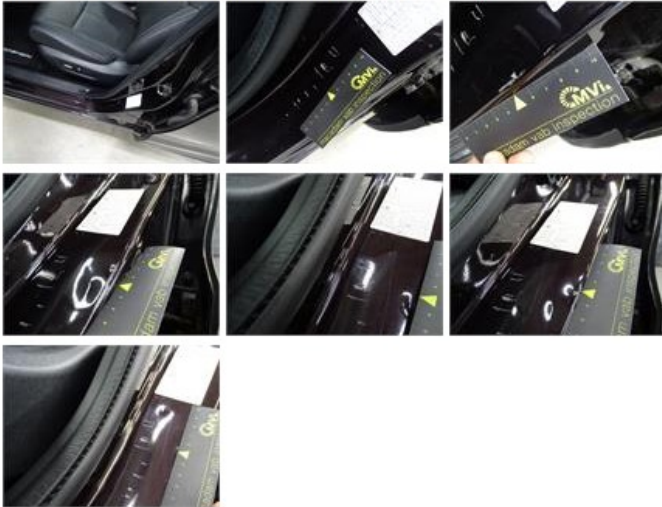
Rocker panel inner F L, Dent(s), LI - Repair and paint (complete) 115,56

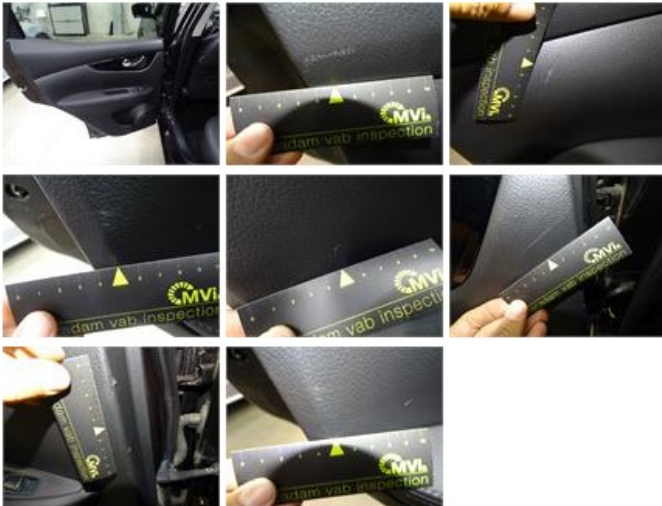
Door panel R L, Scratch(es), Smart repair 110,64

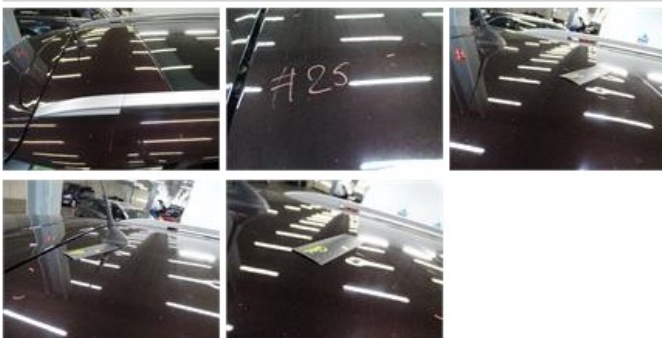
Roof, Hail damage, PDR - Hail 0,00

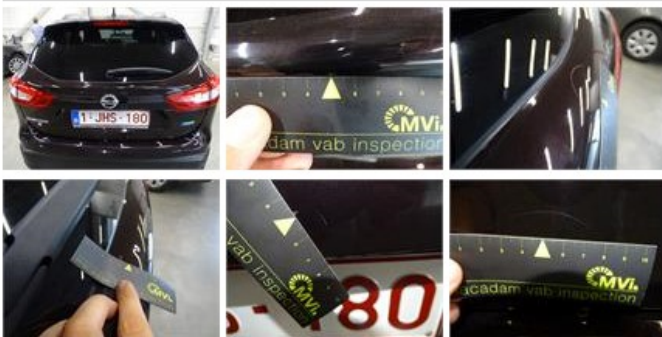
Tailgate, Dent(s) and scratch(es), LI - Repair and paint (complete) 301,68

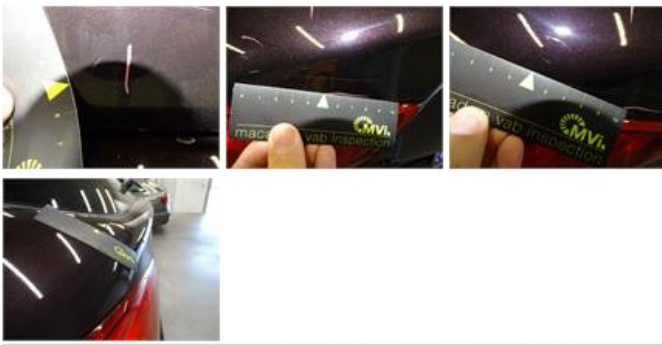
Rearview mirror housing R, Scratch(es), LI - Repair and paint (complete)

115,56

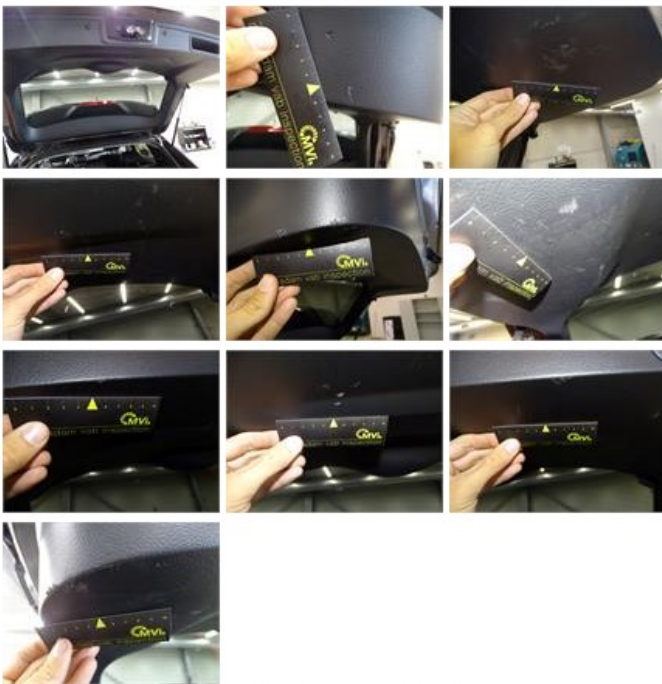
Trunk lid covering R, Scratch(es), Smart repair

110,64

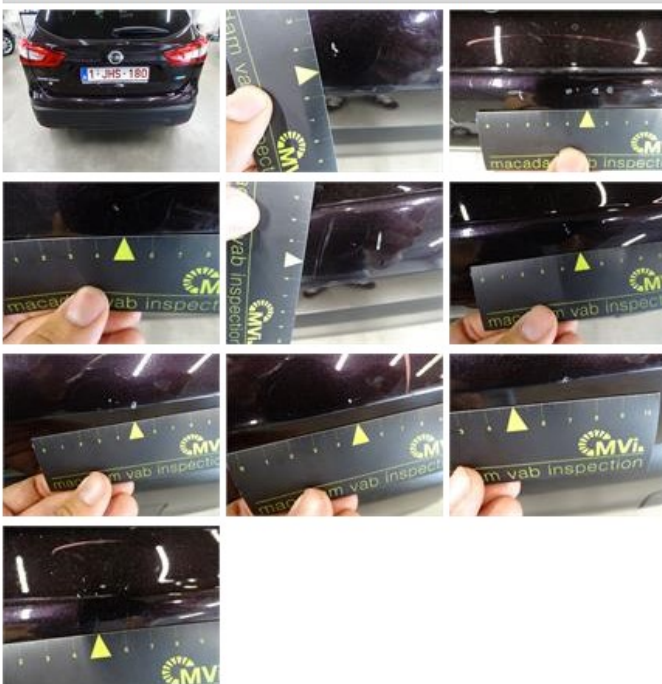
Bumper R, Scratch(es), LI - Repair and paint (complete)

211,80

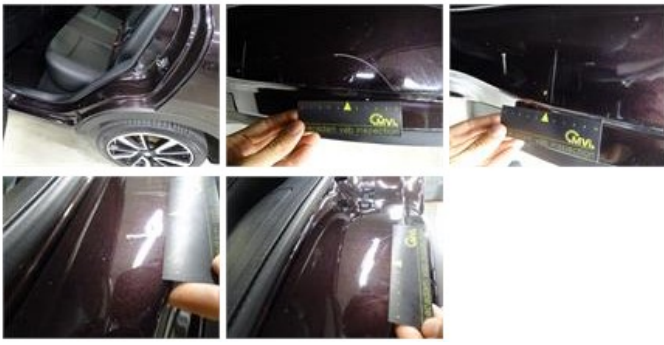
Rocker panel inner R L, Dent(s), LI - Repair and paint (complete)

115,56
