AUDI A3: 1GWN833

Limited Technical Inspection

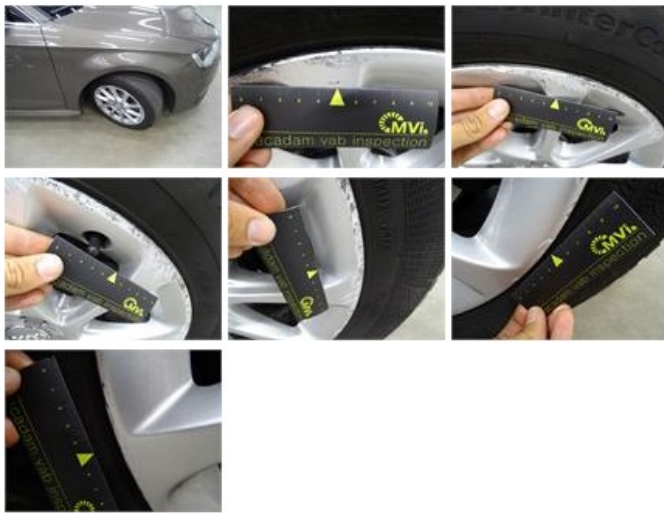
Alloy rim F R, Scratch(es), LI - Repair and paint (complete)	95,00
---	--------------

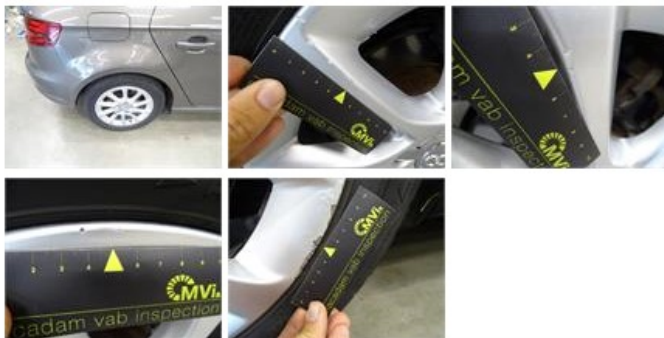
Alloy rim R R, Scratch(es), LI - Repair and paint (complete) 95,00

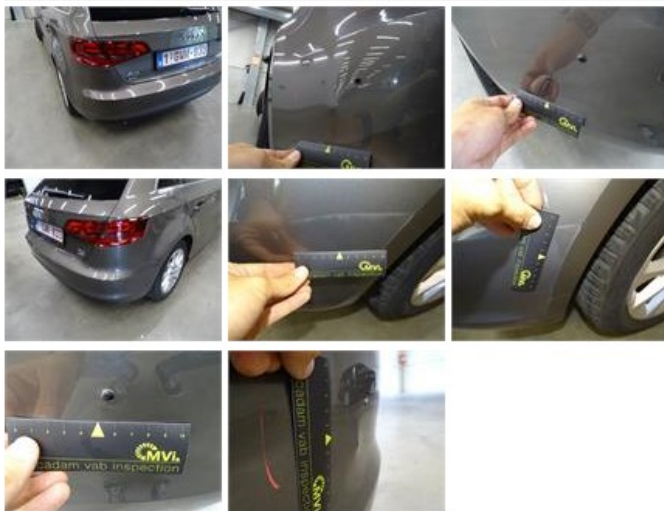
Bumper R, Dent(s) and scratch(es), LI - Repair and paint (complete) 259,80

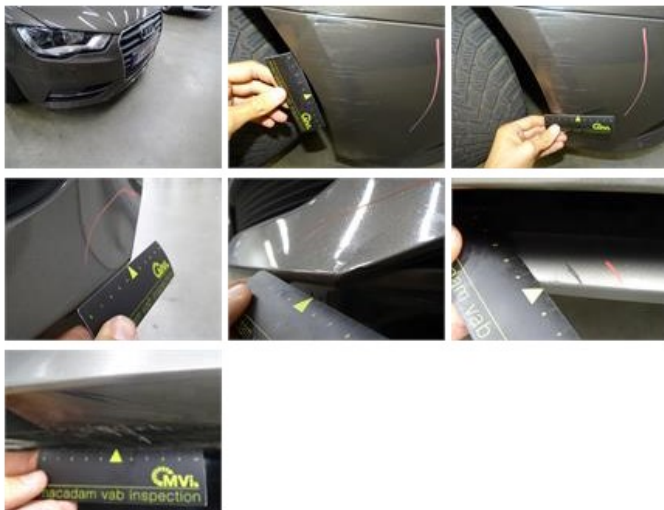
Bumper F, Dent(s) and scratch(es), LI - Repair and paint (complete) 211,80
