BMW 1: 1GXX932

Limited Technical Inspection

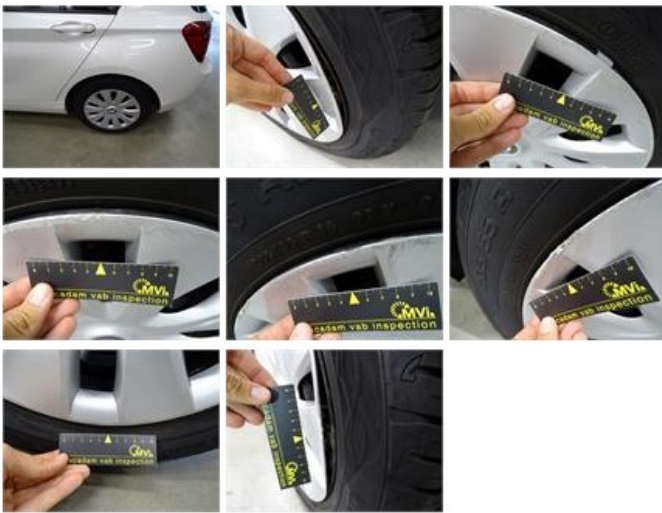
Total cost ex VAT	1374,92
Wheel cover R L, Deformed / Strained, E - Replace	30,00

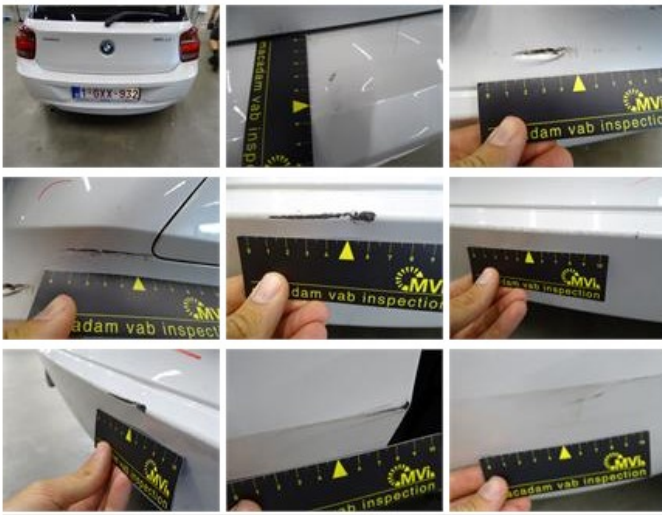
Bumper R, Dent(s) and scratch(es), LI - Repair and paint (complete)

211,80

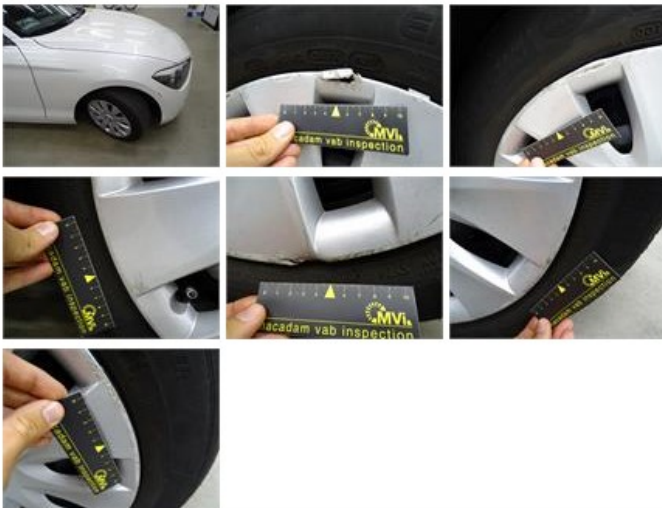
Wheel cover F R, Deformed / Strained, E - Replace

30,00

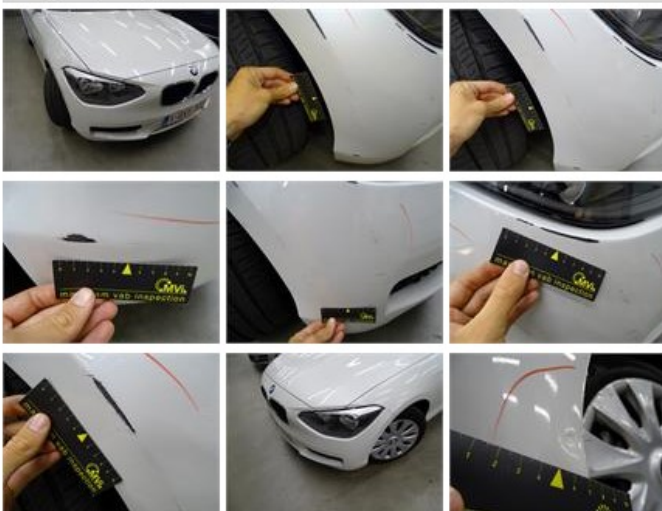
Bumper F, Dent(s) and scratch(es), LI - Repair and paint (complete)

211,80

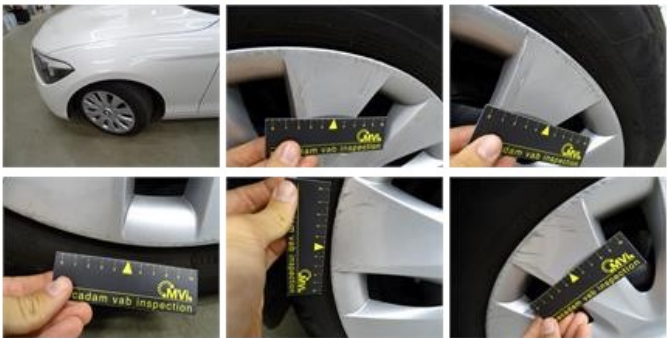
Wing F L, Scratch(es), Acceptable	0,00
<i>No pictures to display</i>	
Wheel cover F L, Scratch(es), E - Replace	30,00

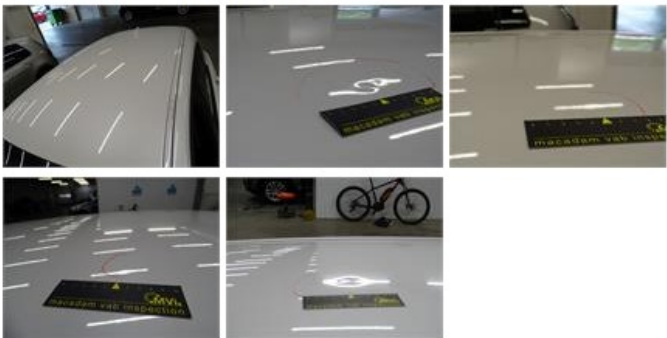
Wing F R, Dent(s) and scratch(es), Acceptable	0,00
<i>No pictures to display</i>	
Roof, Dent(s), PDR - Paintless dent repair	122,40

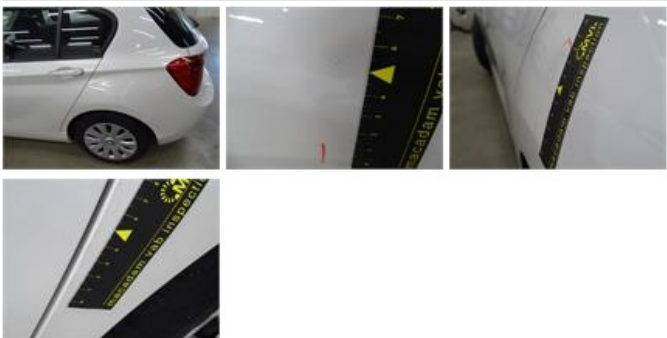
Wing R L, Dent(s) and scratch(es), LI - Repair and paint (complete)	308,20

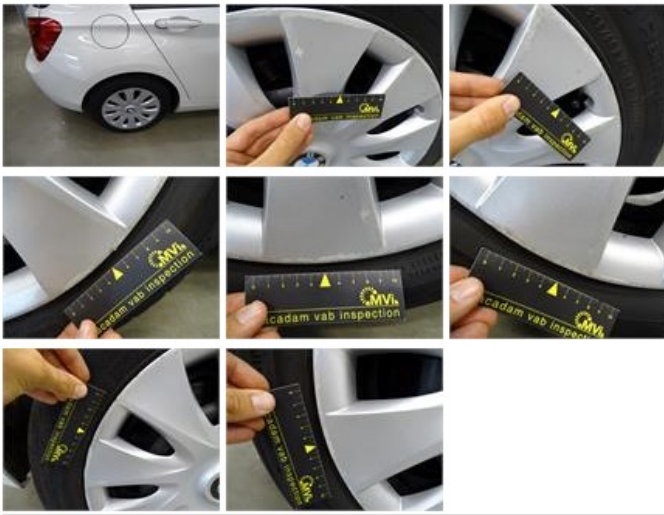
Wheel cover R R, Scratch(es), E - Replace	30,00
