CITROEN GRAND C4 PICASSO: 1JLY724

Vinnumber:	VF73A9HC8EJ862952	Versionname:	1.6 E-HDI 115 MAN6 BUSINESS GPS
First Registrationdate:	20/01/2015	Fiscalpower:	
Expertise Mileage:	153712	Power Kw:	85
Bodytype:	MPV	Body color:	Black
Gearbox:	MAN 6 VIT	Paint type:	Metalic
Transmission:	Front	Rims summer:	Aluminium
Fueltype:	Diesel	Oil level:	OK
Battery functioning:	Yes	Parking lot:	LCV
Number of doors:	5		
Number of seats:	7		
Number head rests:	7		
Rims summer:	Aluminium		
Category:	Passenger Car		
Oil level:	OK		
Registration Certificate Car (BE):	Yes

Limited Technical Inspection

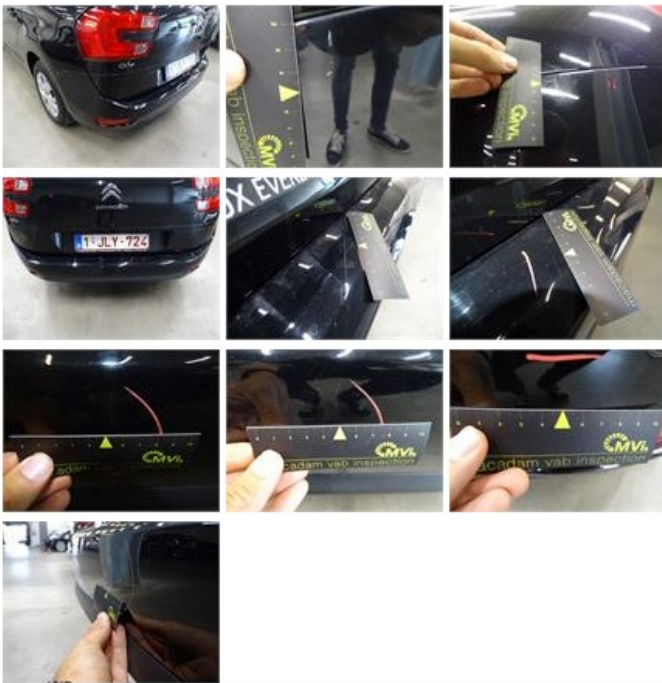
Total cost ex VAT	4079,16
Bumper R, Dent(s) and scratch(es), LI - Repair and paint (complete)	211,80

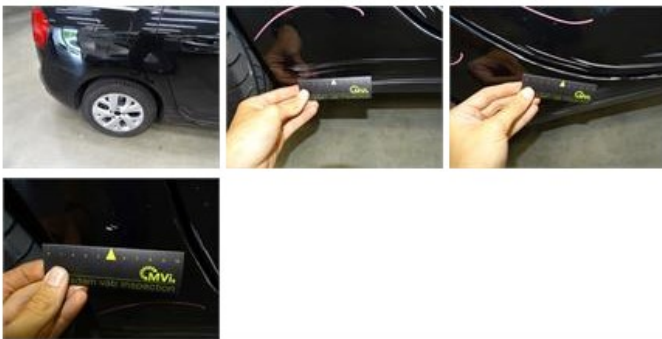
Wing R R, Dent(s) and scratch(es), LI - Repair and paint (complete)

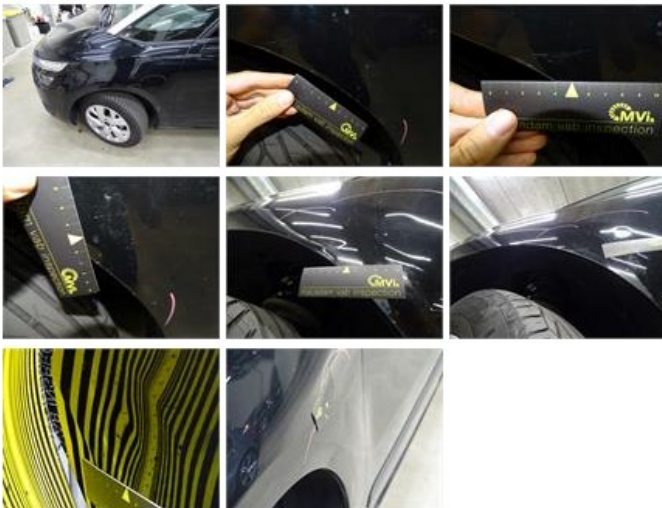
Wing F L, Dent(s) and scratch(es), LI - Repair and paint (complete)

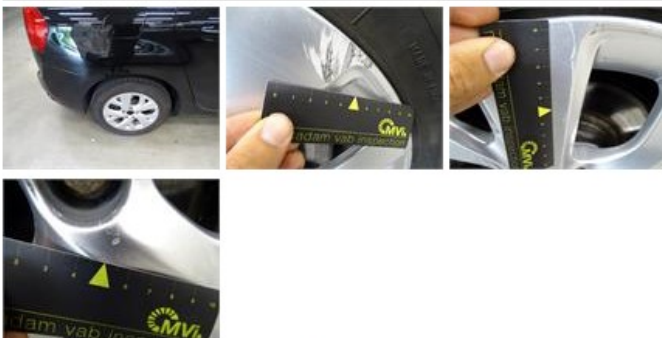
Alloy rim R R, Scratch(es), LI - Repair and paint (complete)

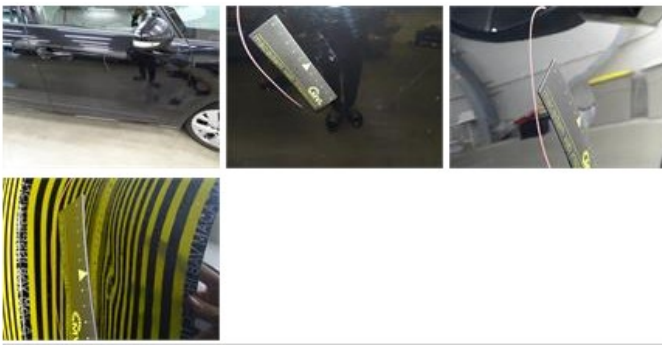
Door F R, Dent(s) and scratch(es), LI - Repair and paint (complete)

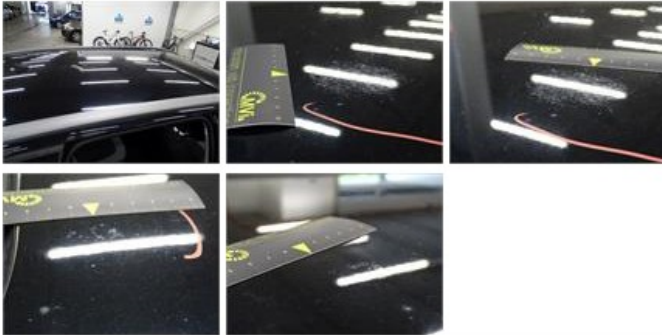
Roof, Chemical polution, LI - Repair and paint (complete) 481,50

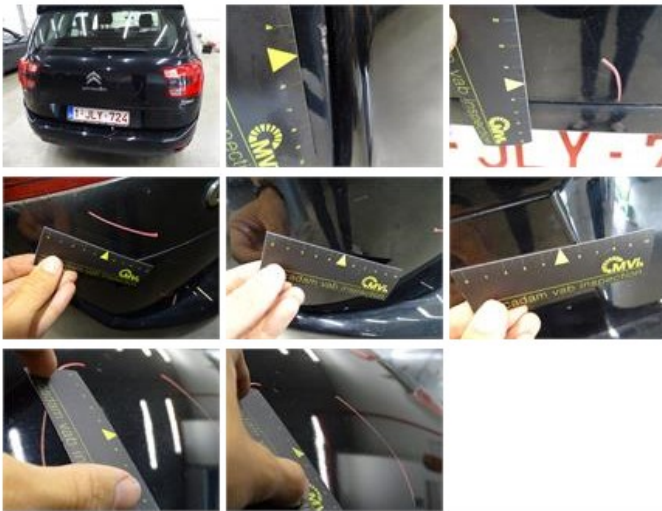
Tailgate, Dent(s) and scratch(es), LI - Repair and paint (complete) 301,68

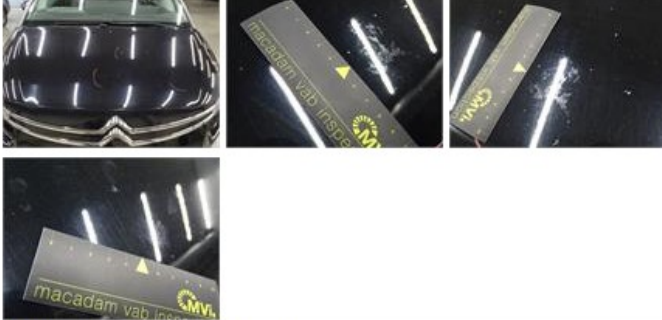
Bonnet, Chemical polution, LI - Repair and paint (complete) 290,08

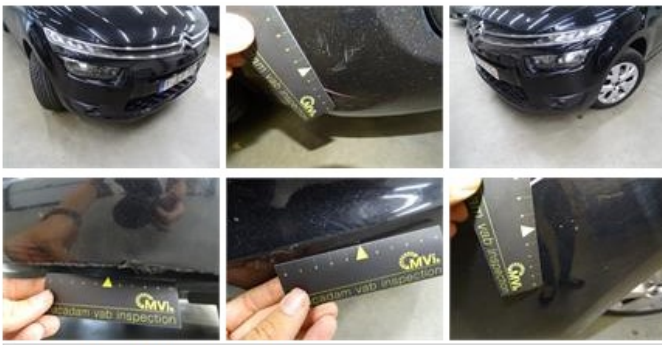
Bumper F, Scratch(es), LI - Repair and paint (complete) 211,80

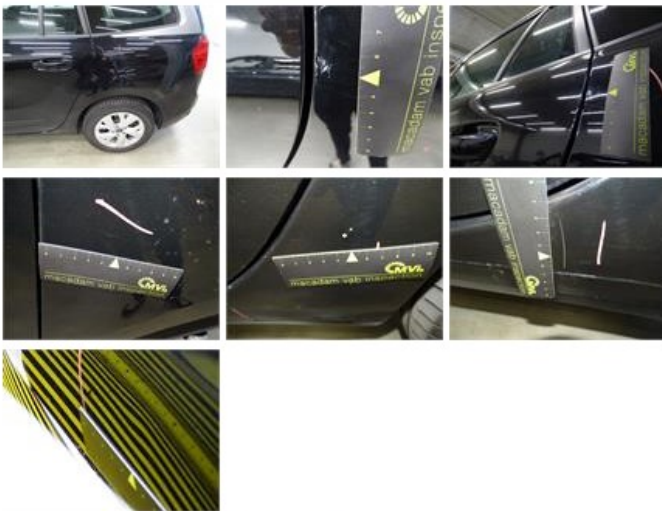
Wing R L, Dent(s) and scratch(es), LI - Repair and paint (complete)

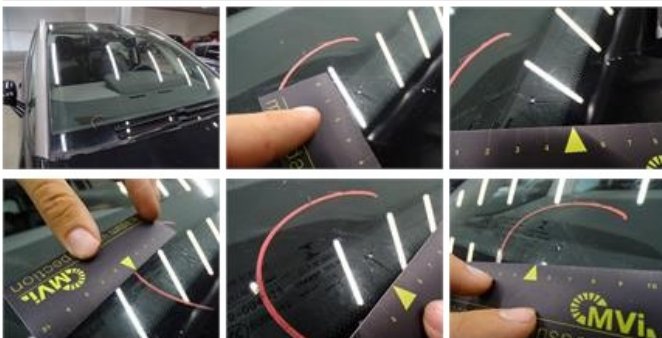
Windscreen, Stone chip(s), E - Replace

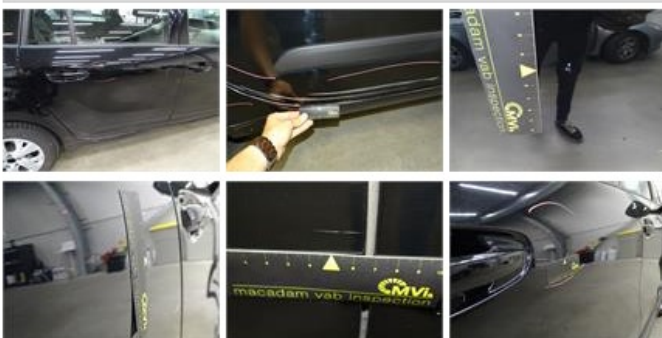
Door R R, Dent(s) and scratch(es), LI - Repair and paint (complete)
