**MERCEDES CLA: 1LFB553**

**Limited Technical Inspection**

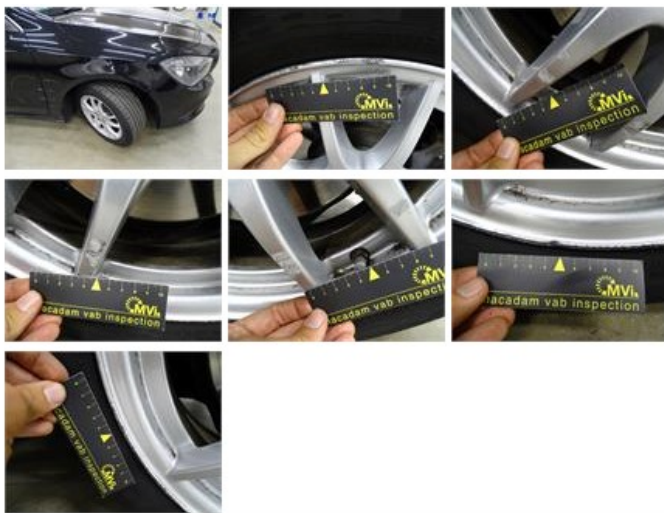
Total cost ex VAT	<b>2909,63</b>
Ignition key, Missing, E - Replace	<b>150,00</b>
<i>No pictures to display</i>	
Alloy rim F R, Scratch(es), LI - Repair and paint (complete)	<b>95,00</b>

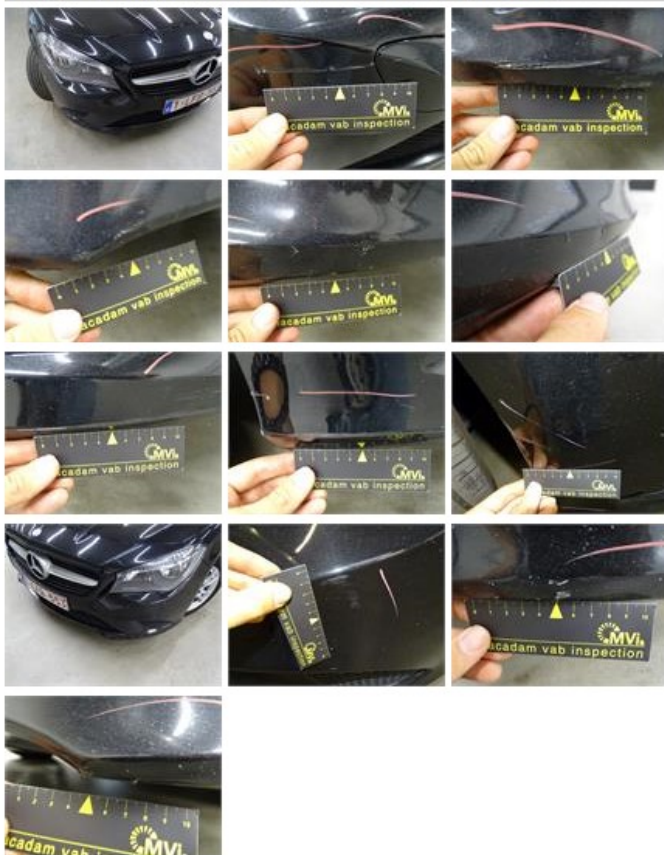
Bumper F, Dent(s) and scratch(es), LI - Repair and paint (complete)

211,80

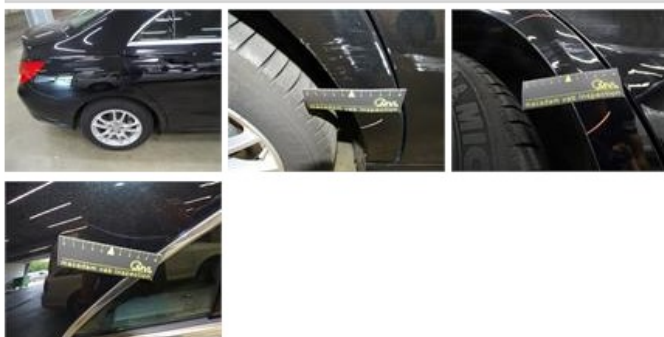
Wing R R, Dent(s) and scratch(es), LI - Repair and paint (complete)

308,20

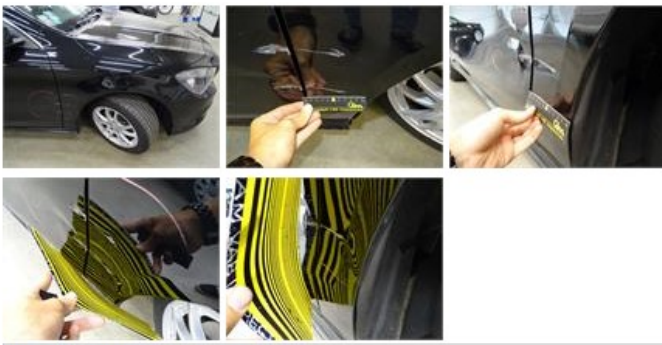
Wing F R, Dent(s) and scratch(es), LI - Repair and paint (complete)

220,18

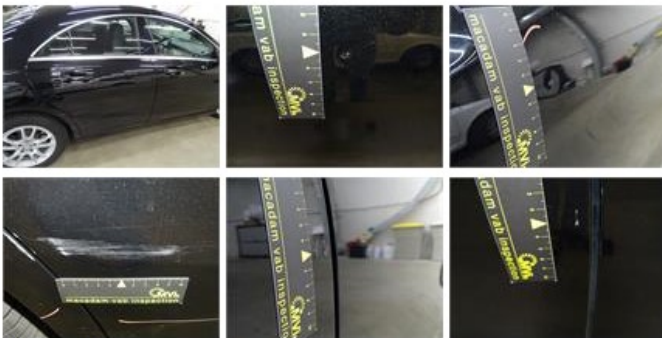
Door R R, Dent(s) and scratch(es), LI - Repair and paint (complete) 318,35

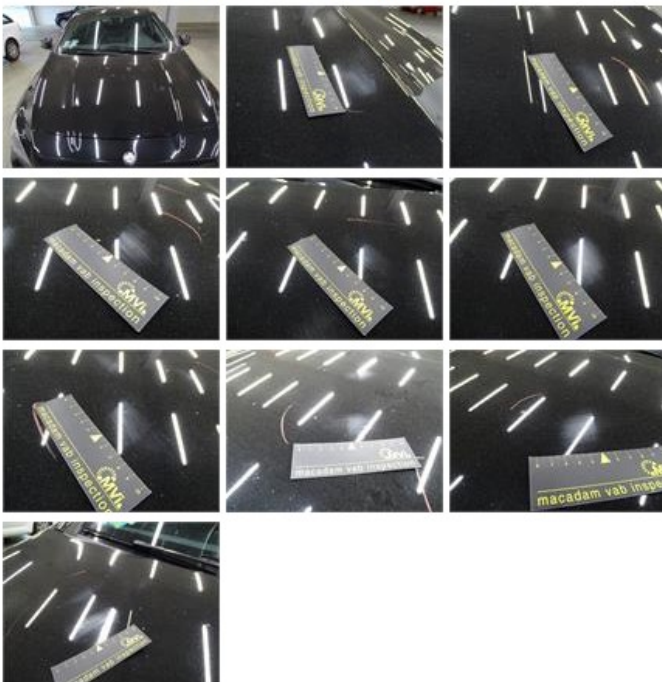
Bonnet, Chemical polution, LI - Repair and paint (complete) 290,08

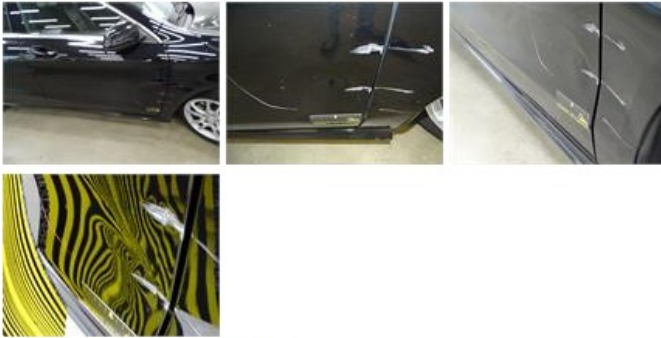
Door F R, Dent(s) and scratch(es), LI - Repair and paint (complete)

318,35

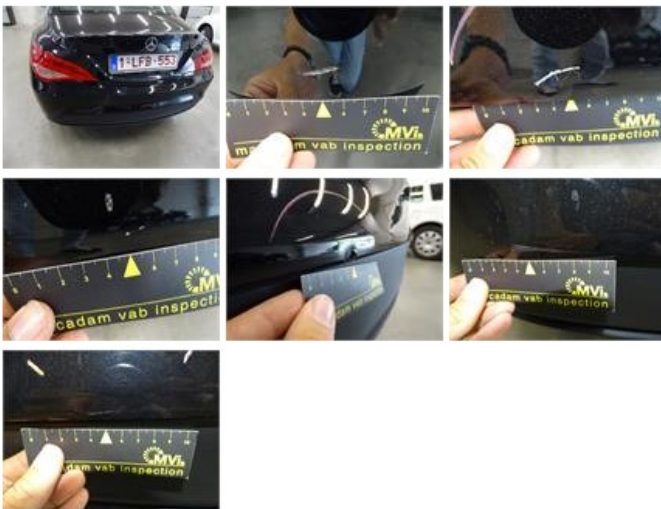
Bumper R, Dent(s) and scratch(es), LI - Repair and paint (complete)

211,80

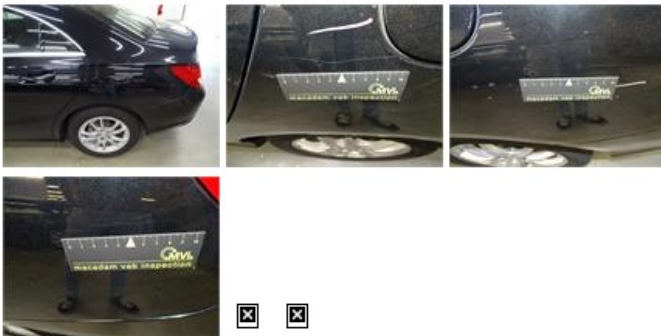
Wing R L, Scratch(es), LI - Repair and paint (complete)

308,20
