MERCEDES C: 1KRZ777

Vinnumber:	WDD2050371R074808	Versionname:	
First Registrationdate:	19/06/2015	Fiscalpower:	
Expertise Mileage:	98739	Power Kw:	100
Bodytype:		Body color:	Black
Gearbox:	Automatic	Paint type:	Metalic
Transmission:	Back	Rims summer:	Aluminium
Fueltype:	Diesel	Oil level:	OK
Battery functioning:	Yes	Parking lot:	3631
Number of doors:	5		
Number of seats:	5		
Number head rests:	5		
Rims summer:	Aluminium		
Category:	Passenger Car		
Oil level:	OK		
Registration Certificate Car (BE):	Yes

Limited Technical Inspection

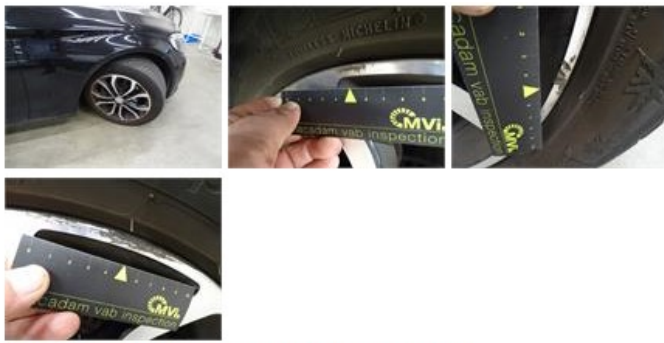
Alloy rim F R polished, Scratch(es), LI - Repair and paint (complete)	95,00
--	--------------

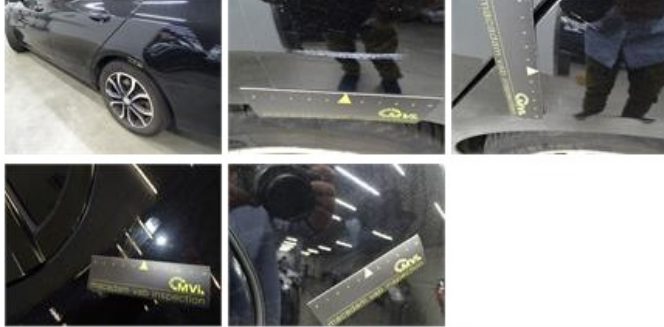
Wing R L, Scratch(es), LI - Repair and paint (complete) 308,20

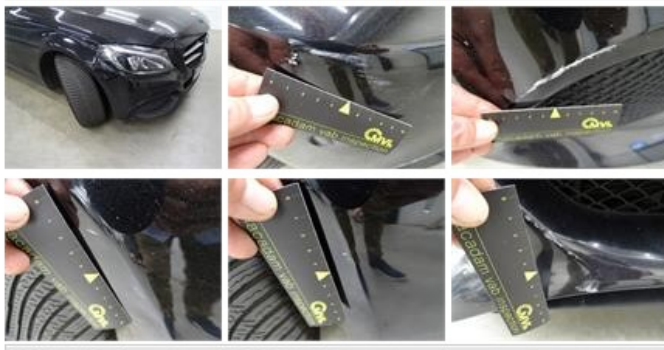
Bumper F, Scratch(es), LI - Repair and paint (complete) 211,80
