PEUGEOT 2008: 1HCY199

Limited Technical Inspection

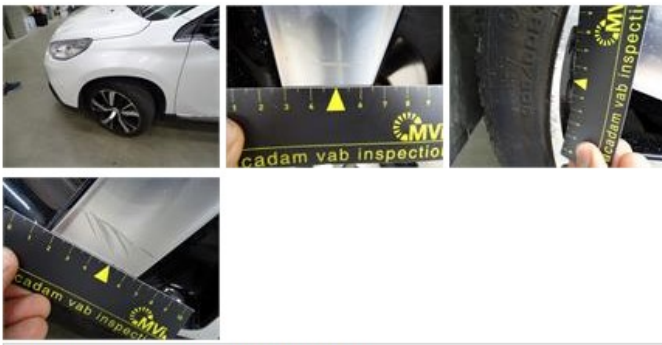
Alloy rim F L polished, Scratch(es), LI - Repair and paint (complete) 95,00

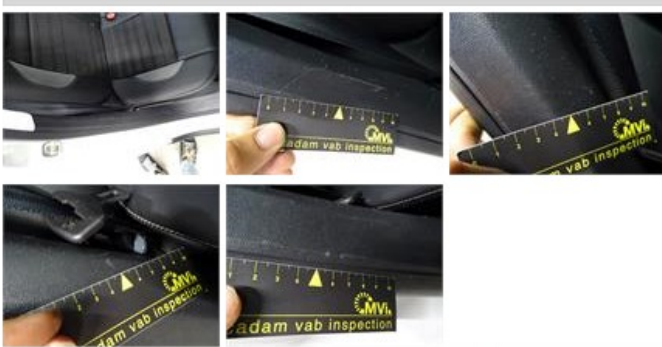
Sill trim R R, Scratch(es), Smart repair 110,64

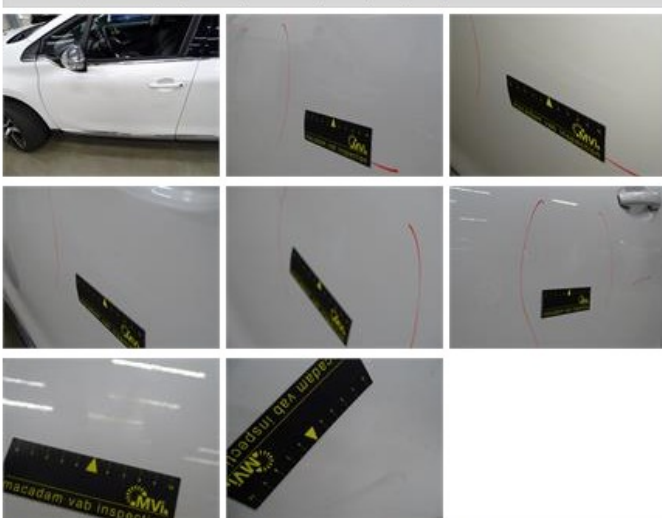
Door F L, Scratch(es), LI - Repair and paint (complete) 318,35

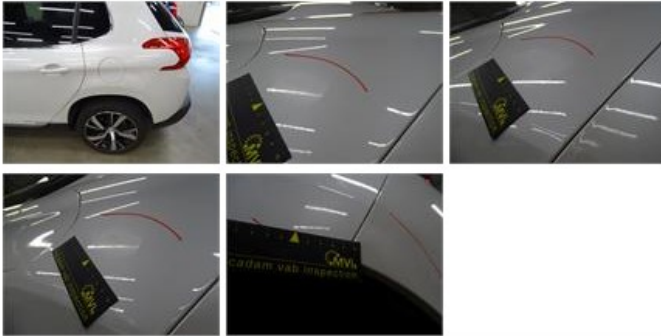
Wing R L, Scratch(es), LI - Repair and paint (complete)

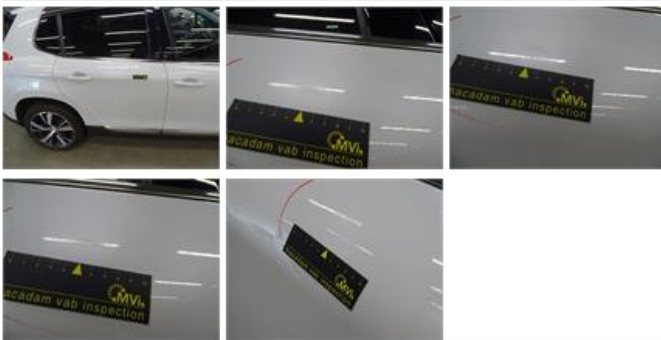
Door R R, Scratch(es), LI - Repair and paint (complete)

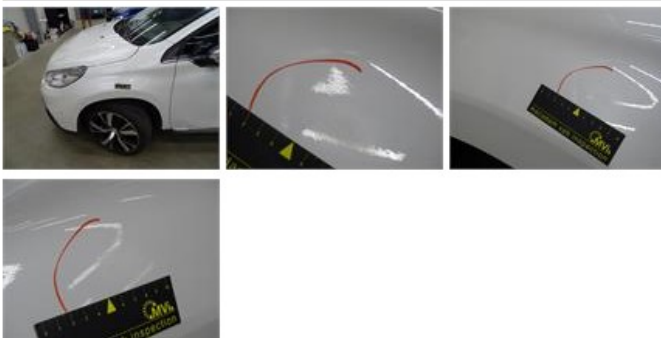
Wing F L, Scratch(es), LI - Repair and paint (complete)

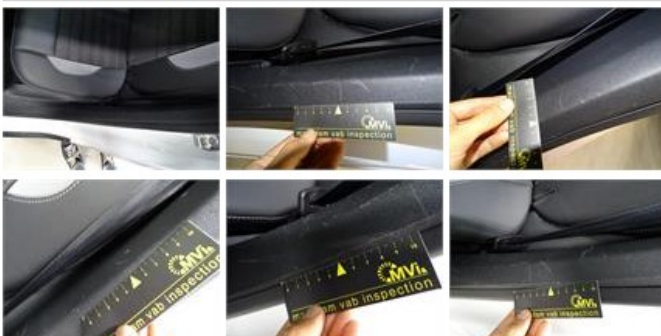
Sill trim R L, Scratch(es), Smart repair

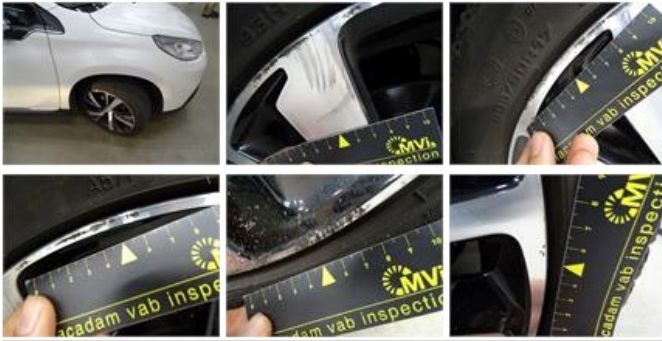
Alloy rim F R polished, Scratch(es), LI - Repair and paint (complete)
