OPEL Insignia: 1FCT051

Limited Technical Inspection

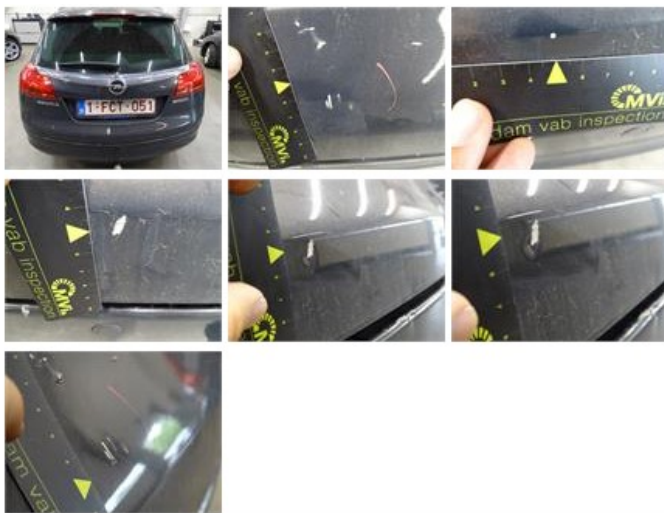
Total cost ex VAT	2415,68
Alloy rim F R polished, Scratch(es), Acceptable	0,00
<i>No pictures to display</i>	
Tailgate, Dent(s) and scratch(es), LI - Repair and paint (complete)	301,68

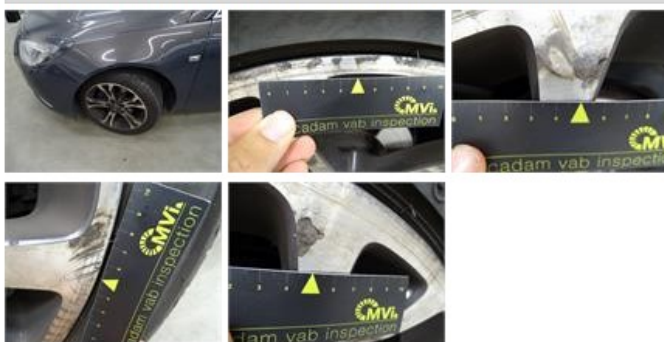
Alloy rim F L polished, Scratch(es), LI - Repair and paint (complete) 95,00

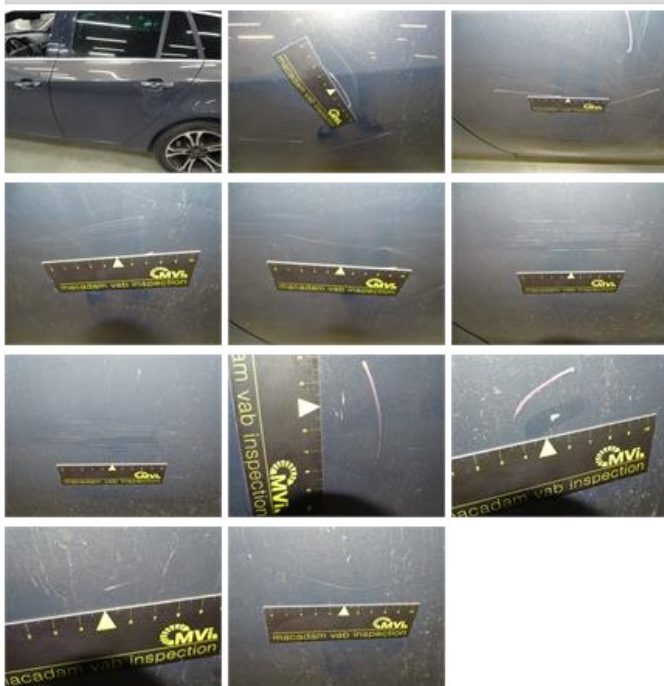
Door R L, Scratch(es), LI - Repair and paint (complete) 318,35

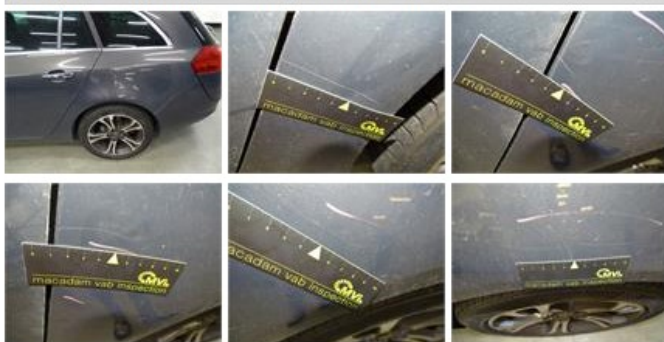
Wing R L, Scratch(es), LI - Repair and paint (complete) 308,20
