OPEL COMBO: 1PFL524

Limited Technical Inspection

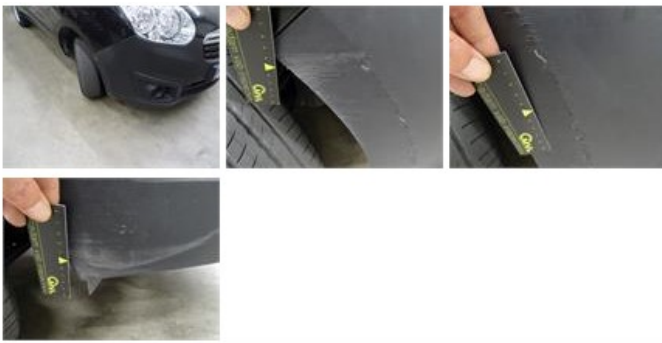
Total cost ex VAT	1358,66
Roof, Chemical polution, Acceptable	0,00
<i>No pictures to display</i>	
Bumper F, Scratch(es), Smart repair	110,64

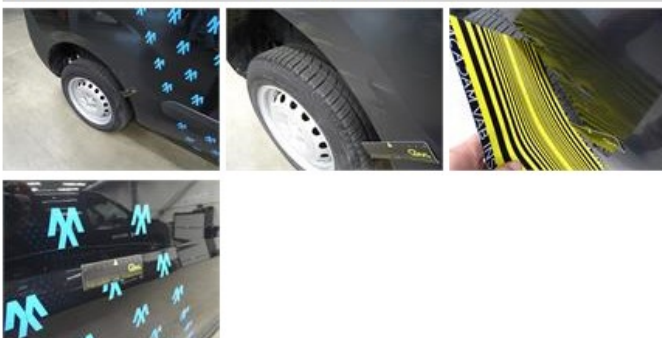
Wing R R, Scratch(es), LI - Repair and paint (complete) 231,15
