OPEL ASTRA SPORTS TOURER: 1JGP503

Limited Technical Inspection

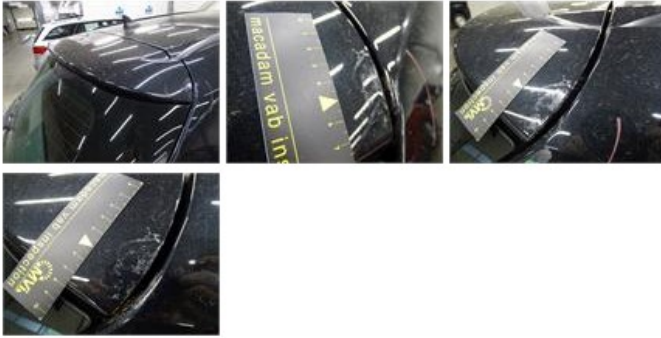
Rear spoiler, Chemical polution, LI - Repair and paint (complete)

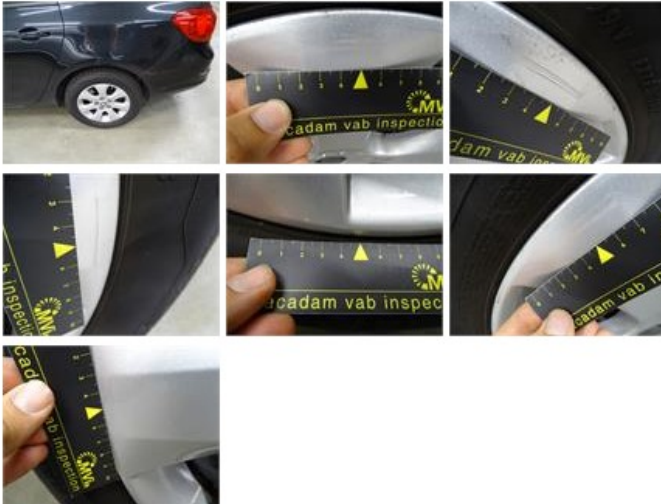
Alloy rim R L, Scratch(es), LI - Repair and paint (complete)

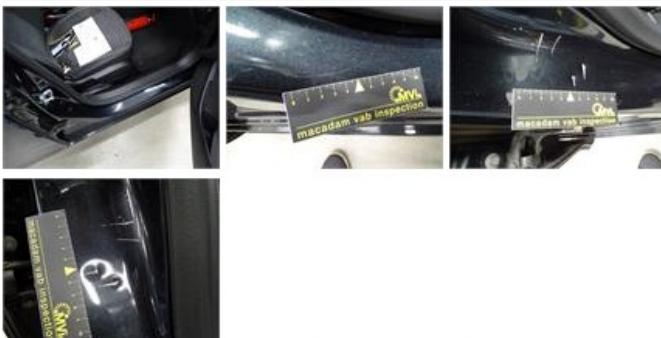
Rocker panel inner F R, Dent(s), LI - Repair and paint (complete)

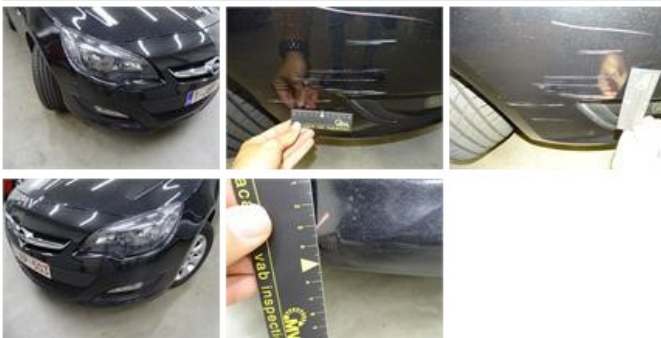
Bumper F, Scratch(es), LI - Repair and paint (complete)

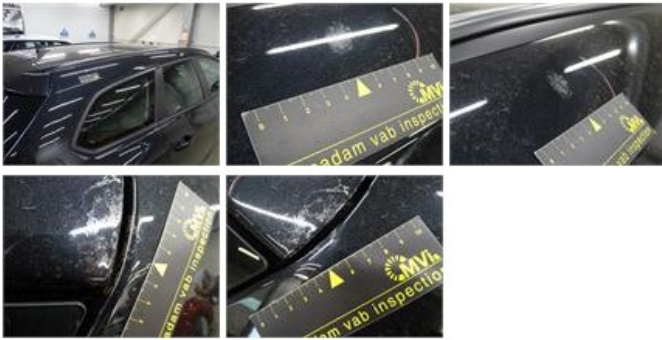
Roof pillar R, Chemical polution, LI - Repair and paint (complete) 220,18

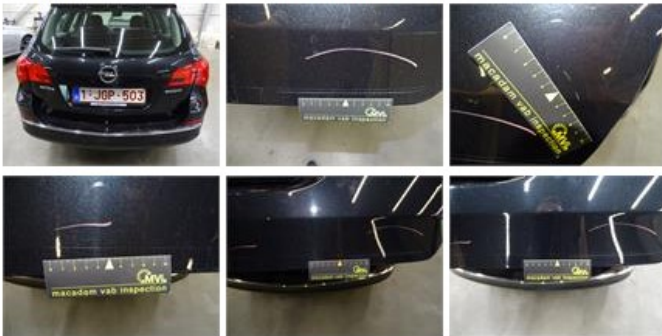
Tailgate, Scratch(es), LI - Repair and paint (complete) 301,68

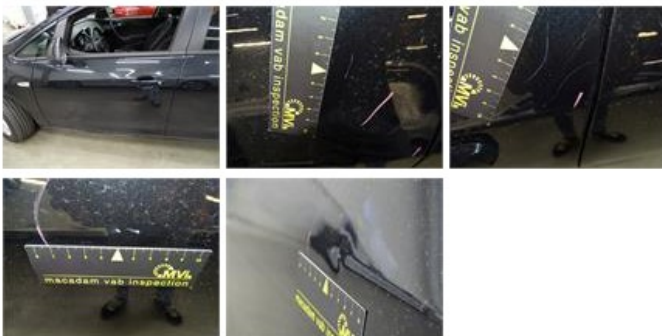
Door F L, Dent(s) and scratch(es), LI - Repair and paint (complete) 318,35

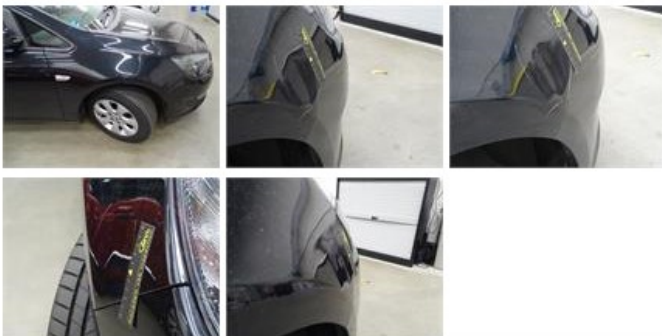
Wing F R, Dent(s), LI - Repair and paint (complete) 220,18

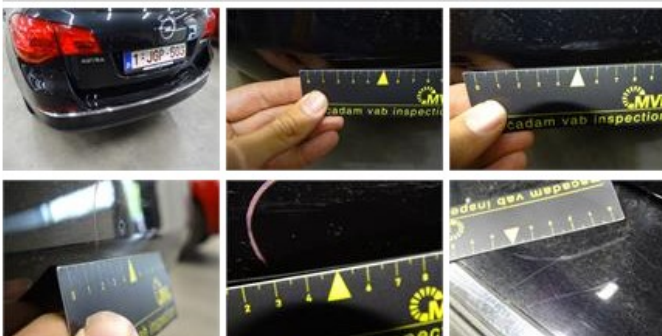
Bumper R, Dent(s) and scratch(es), LI - Repair and paint (complete) 211,80

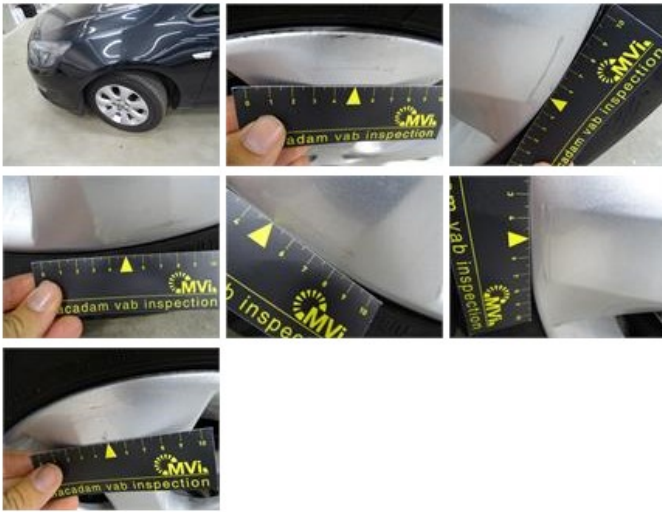
Alloy rim F L, Scratch(es), LI - Repair and paint (complete)
