OPEL COMBO: 1PFL547

Vinnumber:	W0L6ZYC1AH9596236	Versionname:	1.3 CDTI 66KW 2.0T SWB
First Registrationdate:	23/06/2016	Fiscalpower:	
Expertise Mileage:	49379	Power Kw:	66
Bodytype:	Transporter	Body color:	Black
Gearbox:	MAN 5 VIT	Paint type:	Metallic
Transmission:	Front	Rims summer:	Steel
Fueltype:	Diesel	Oil level:	OK
Battery functioning:	Yes	Parking lot:	LCV29
Number of doors:	4		
Number of seats:	2		
Number head rests:	2		
Rims summer:	Steel		
Category:	Light Commercial Vehicle		
Oil level:	OK		
Registration Certificate Car (BE):	Yes

Limited Technical Inspection

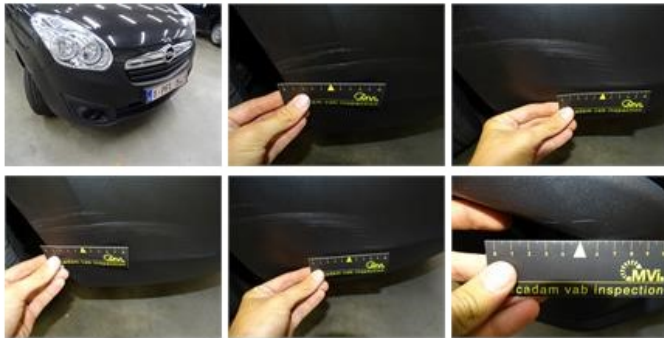
Bumper F, Scratch(es), Smart repair

110,64

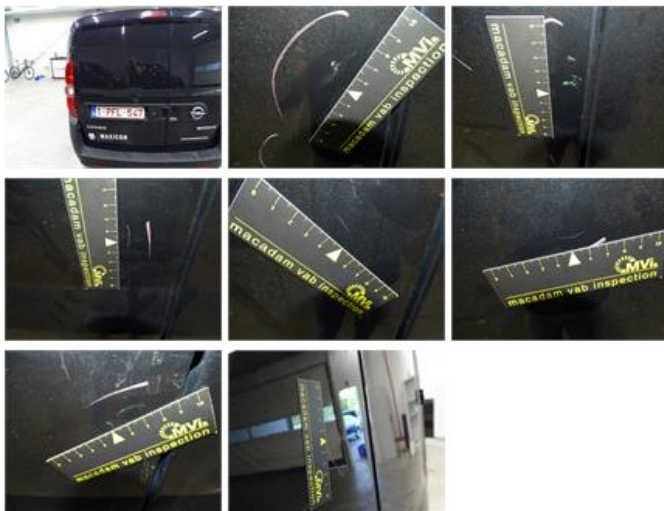
Tailgate, Scratch(es), LI - Repair and paint (complete)

362,02

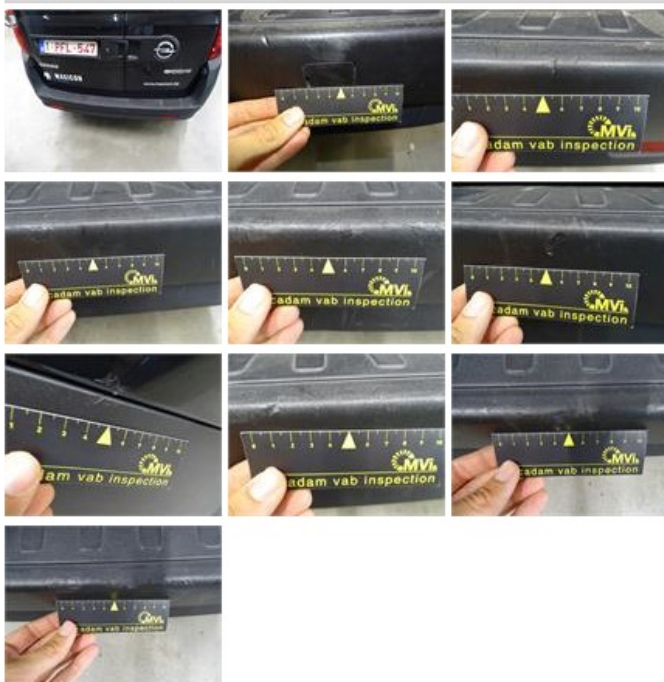
Bumper R, Scratch(es), Smart repair

110,64

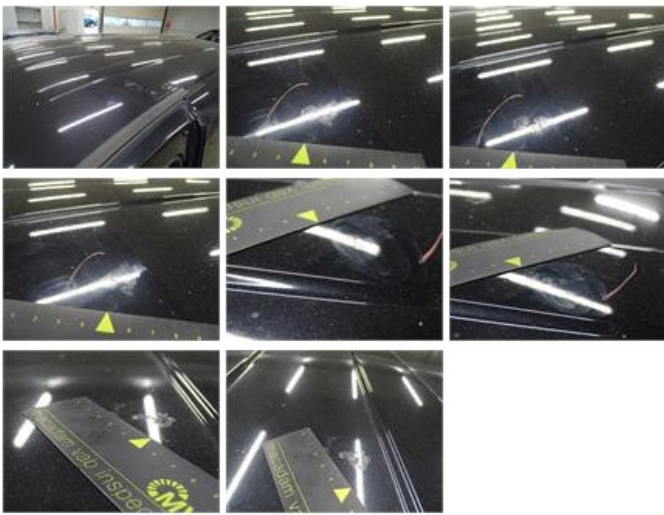
Roof, Chemical polution, LI - Repair and paint (complete)

361,13

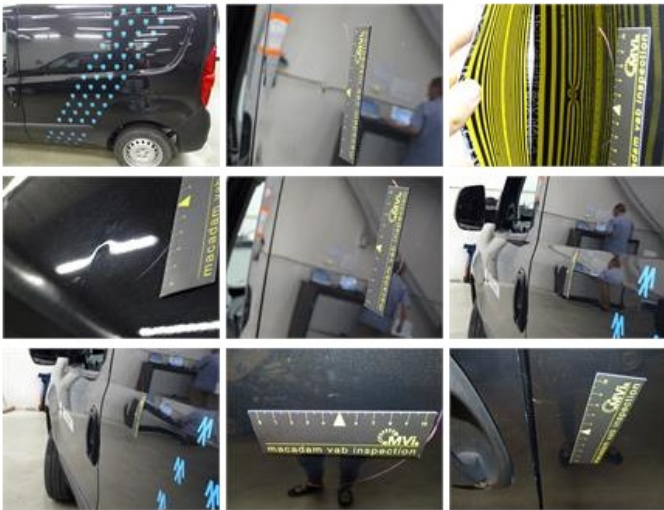
Wing R L, Dent(s), LI - Repair and paint (complete) 231,15
