**MERCEDES Sprinter 300: 1CQM184**

**Limited Technical Inspection**

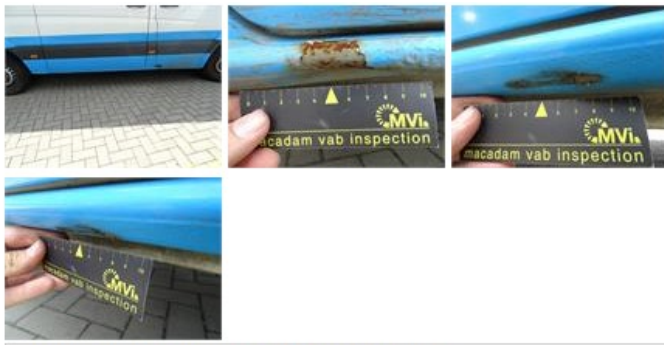
Total cost ex VAT	<b>1871,00</b>
Sill outer R, Dent(s) and scratch(es), LI - Repair and paint (complete)	<b>232,88</b>

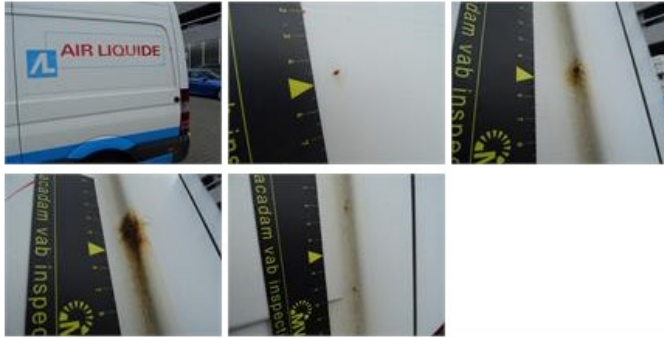
Wing R L, Rust, LI - Repair and paint (complete) 231,15

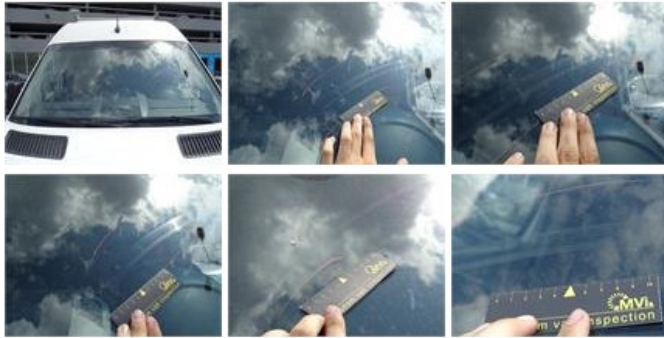
Windscreen, Scratch(es), E - Replace 395,40

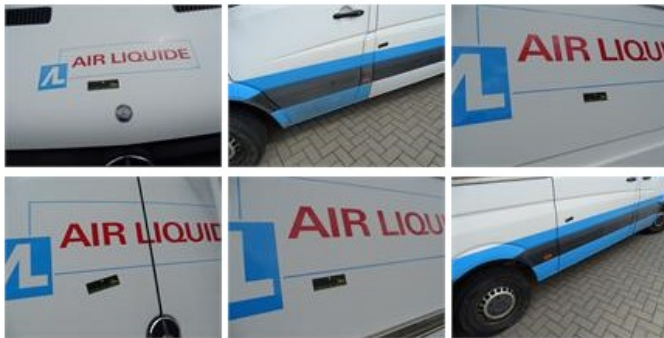
Bodywork, Not original part, Acceptable 0,00

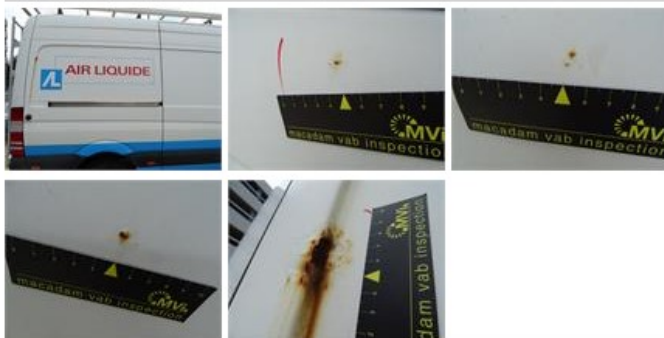
Wing R R, Rust, LI - Repair and paint (complete) 231,15

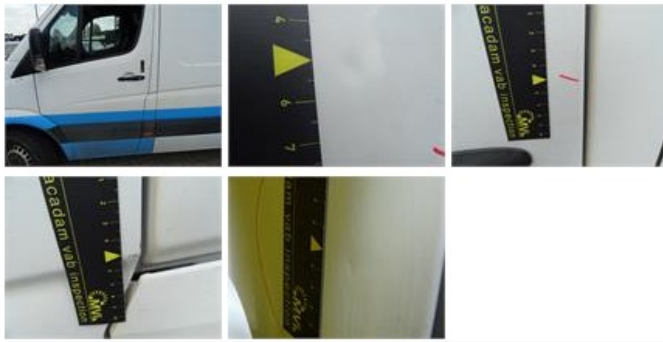
Base F L, Dent(s) and scratch(es), LI - Repair and paint (complete) 231,15

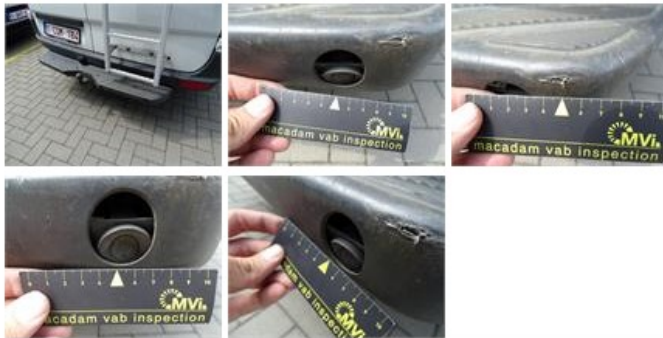
Bumper cover R M, Broken, Smart repair 110,64

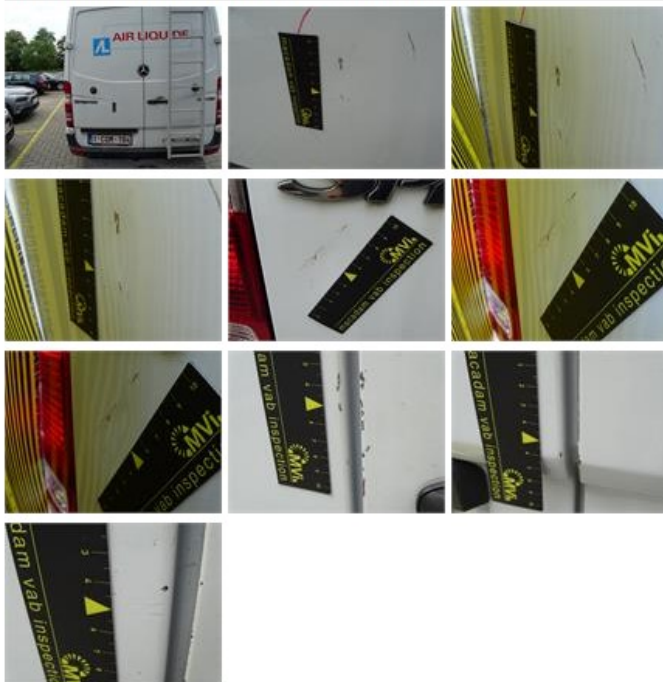
Tailgate, Dent(s) and scratch(es), LI - Repair and paint (complete) 362,02

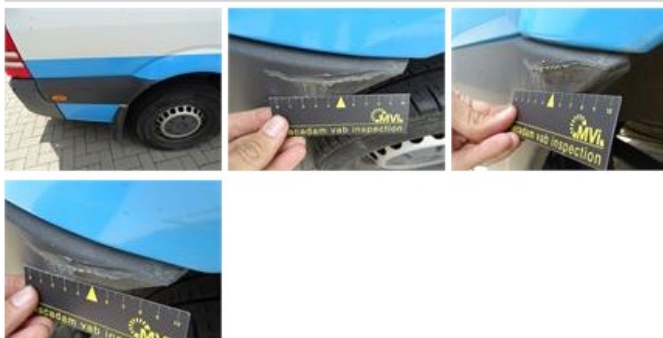
Wing trim R R, Deformed / Strained, E - Replace 69,00
