MINI Paceman: 1GRW162

Limited Technical Inspection

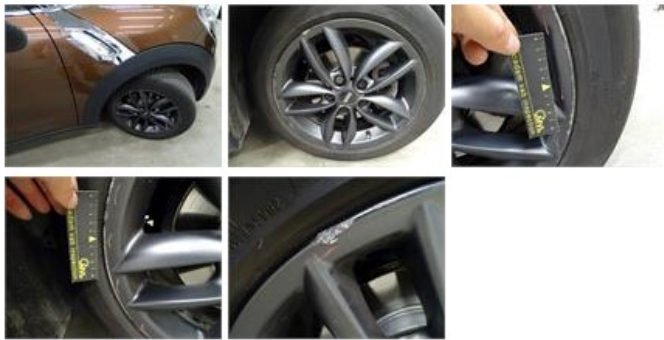
Alloy rim F R, Scratch(es), LI - Repair and paint (complete) 95,00

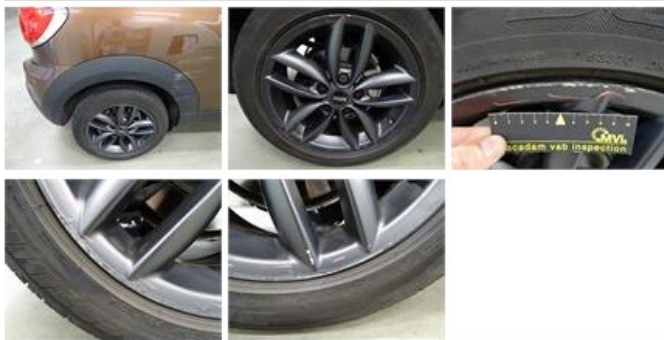
Alloy rim R R, Scratch(es), LI - Repair and paint (complete) 95,00

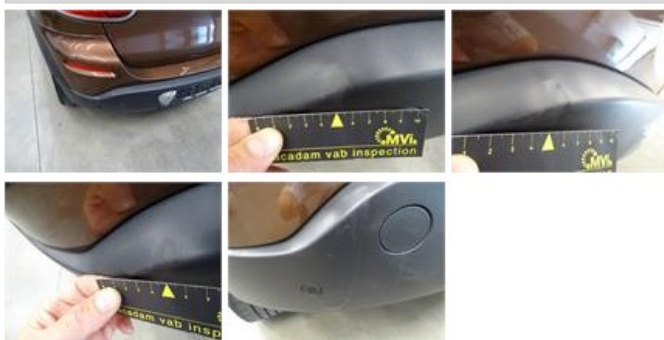
Bumper R, Dent(s), Smart repair 110,64

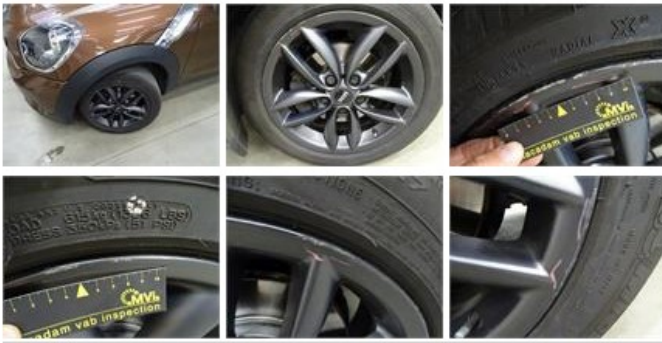
Alloy rim F L, Scratch(es), LI - Repair and paint (complete)
