OPEL ZAFIRA TOURER: 1KNC238

Limited Technical Inspection

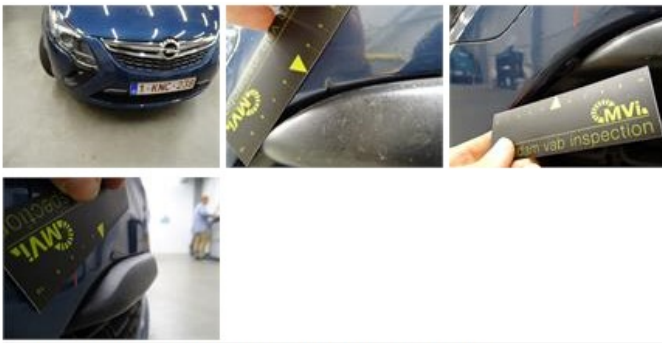
Total cost ex VAT	1816,78
Bumper F, Crack, LI - Repair and paint (complete)	211,80

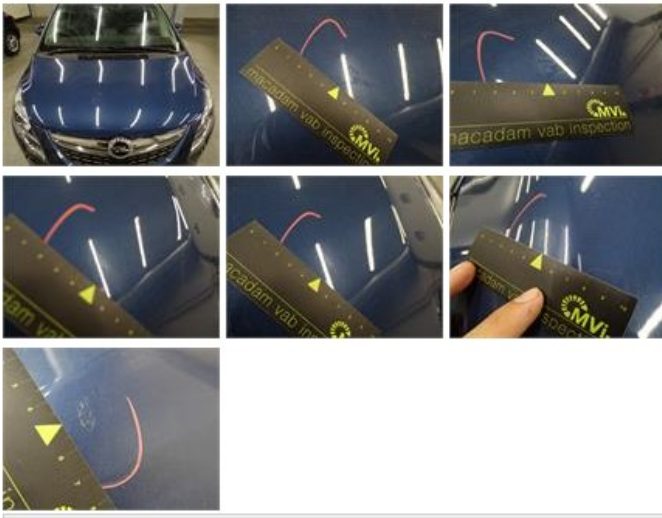
Bonnet, Chemical polution, LI - Repair and paint (complete)	290,08
---	--------

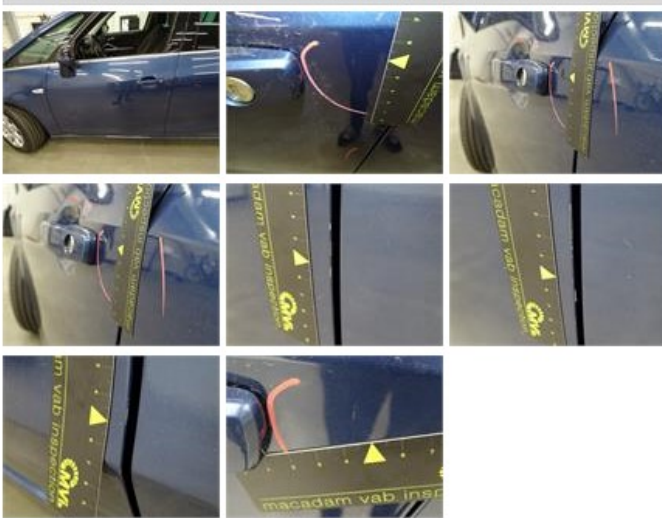
Rocker panel inner R L, Dent(s), Acceptable	0,00
<i>No pictures to display</i>	
Door R L, Scratch(es), Acceptable	0,00
<i>No pictures to display</i>	
Bumper R, Scratch(es), Acceptable	0,00
<i>No pictures to display</i>	
Roof pillar R, Chemical polution, Acceptable	0,00
<i>No pictures to display</i>	
Door F L, Dent(s) and scratch(es), LI - Repair and paint (complete)	318,35

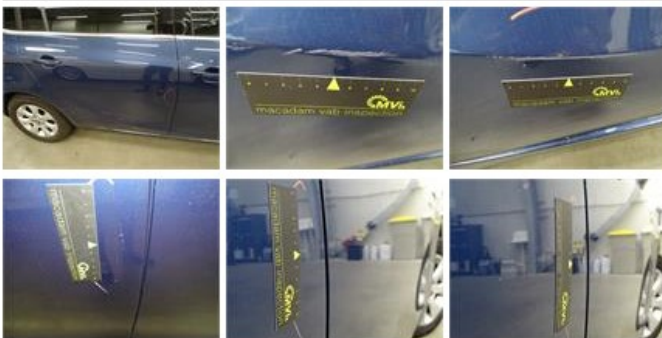
Door R R, Dent(s) and scratch(es), LI - Repair and paint (complete)	318,35
---	--------

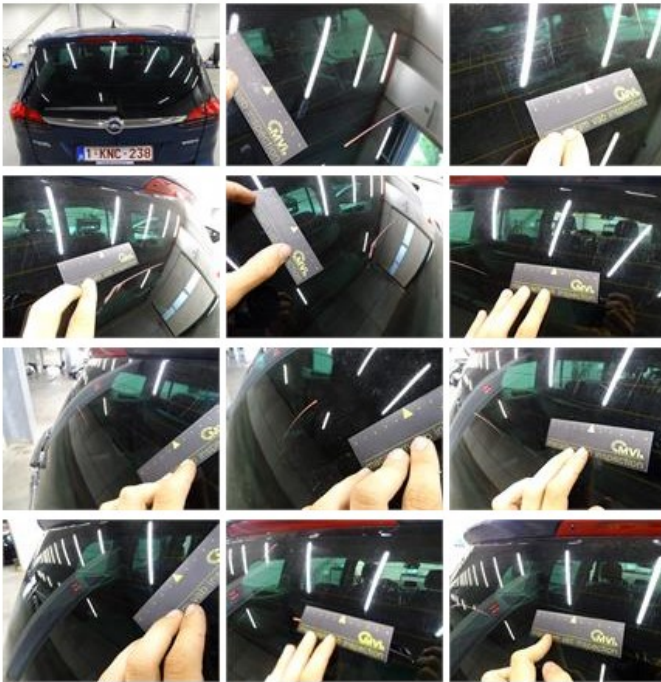
Rear window, Scratch(es), E - Replace

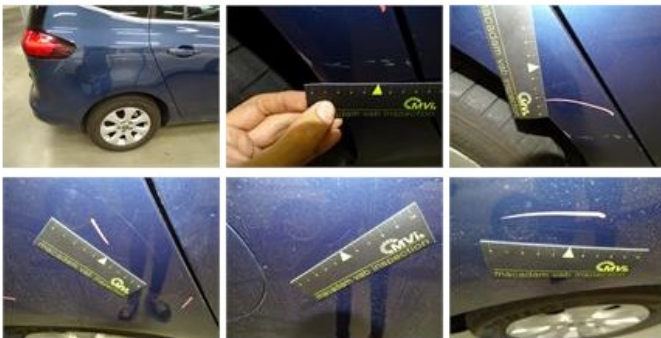
Wing R R, Scratch(es), LI - Repair and paint (complete)
