RENAULT ESPACE: 1RRJ501

Limited Technical Inspection

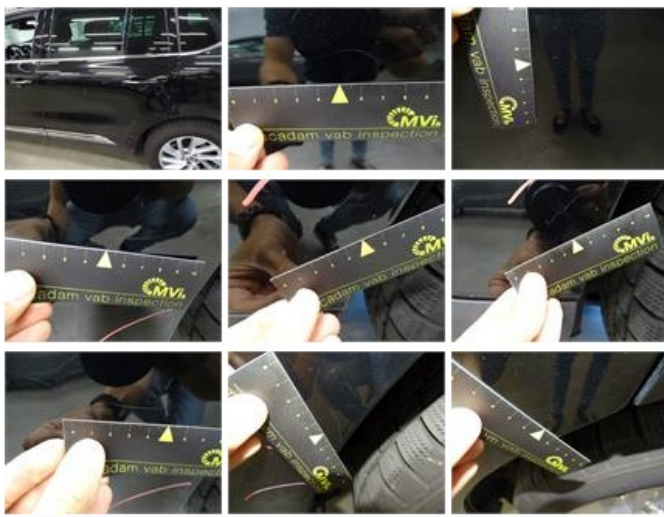
Total cost ex VAT	1033,18
Door R L, Scratch(es), LI - Repair and paint (complete)	382,02

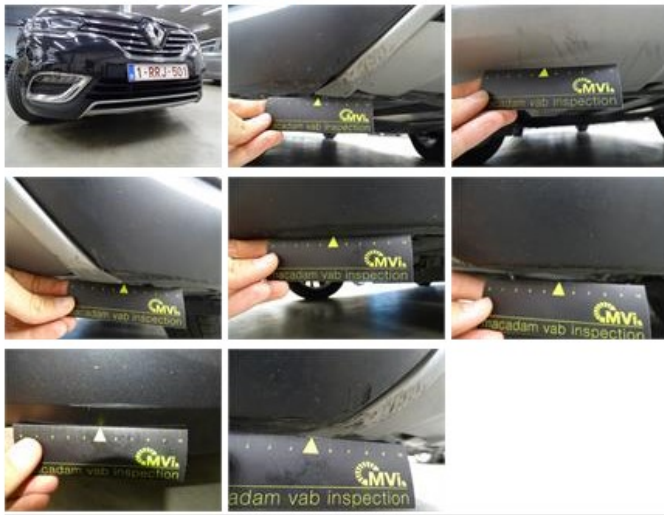
Bumper F M, Scratch(es), Smart repair

110,64

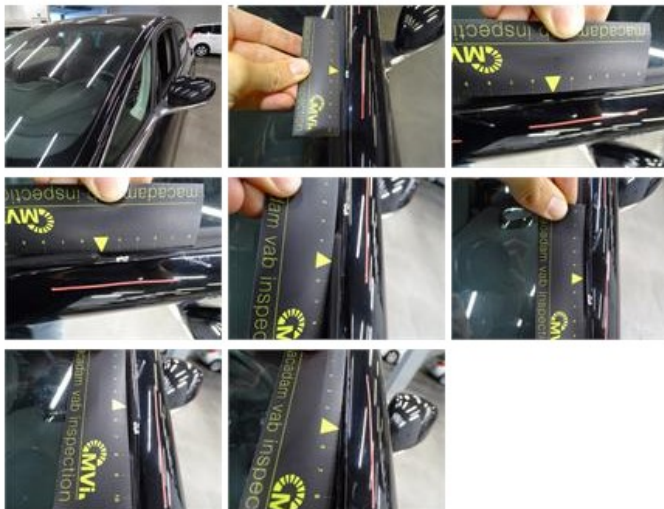
A-Pillar left, Scratch(es), LI - Repair and paint (complete)

198,76

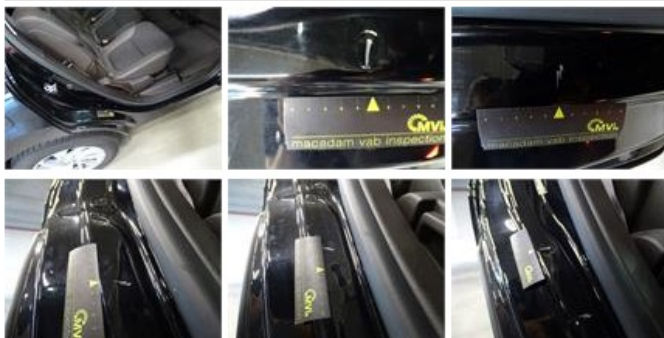
Rocker panel inner R R, Dent(s), LI - Repair and paint (complete)

115,56

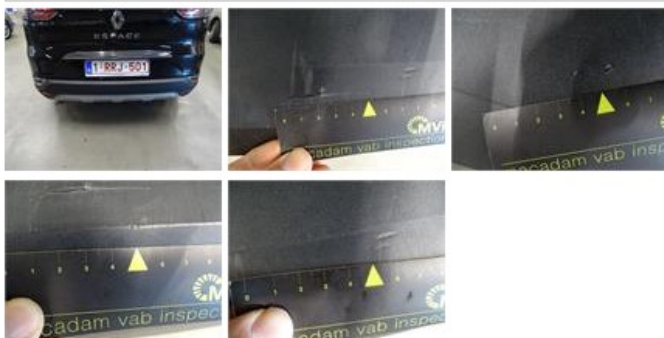
Bumper R, Scratch(es), Smart repair

110,64
