**PEUGEOT 308 SW: 1KSJ261**

**Limited Technical Inspection**

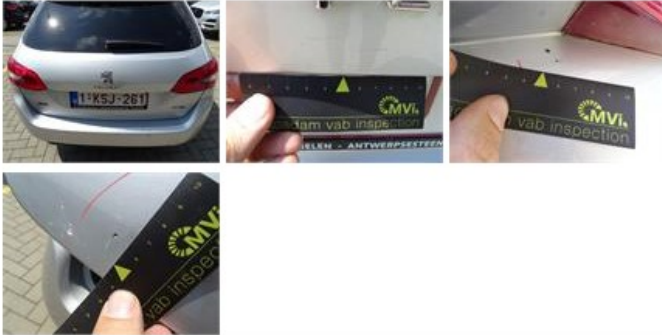
Tailgate, Scratch(es), LI - Repair and paint (complete) 301,68

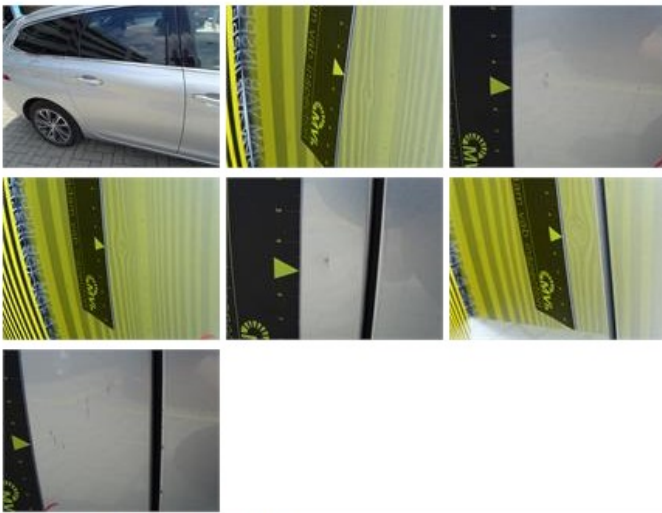
Door R R, Dent(s) and scratch(es), LI - Repair and paint (complete) 318,35

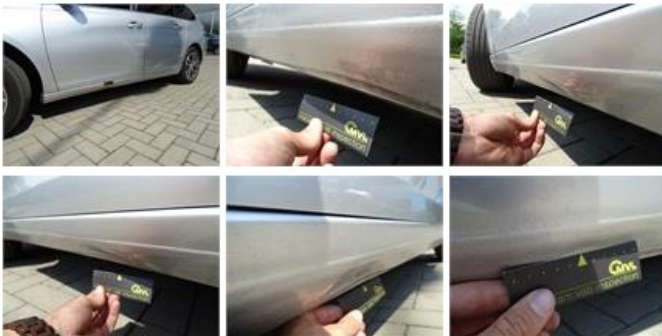
Sill outer L, Dent(s) and scratch(es), LI - Repair and paint (complete) 358,50

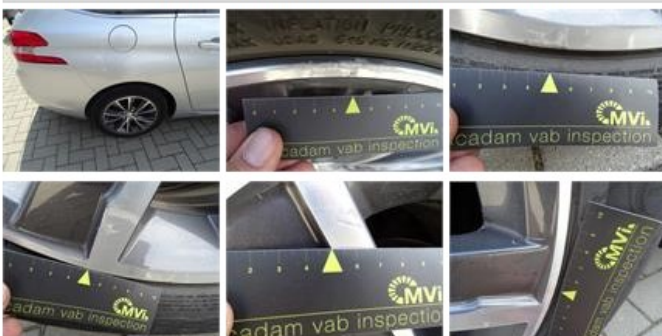
Alloy rim R R polished, Scratch(es), LI - Repair and paint (complete) 95,00

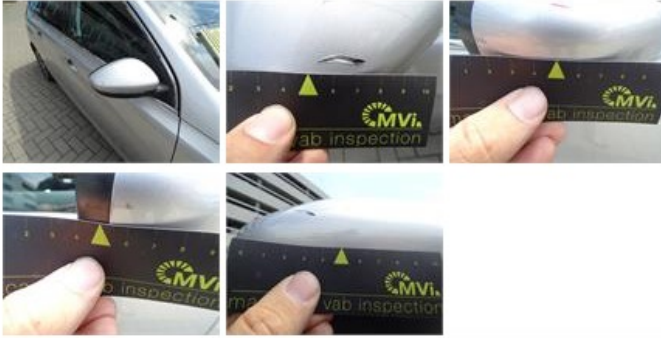
Rearview mirror housing R, Scratch(es), LI - Repair and paint (complete) 115,56

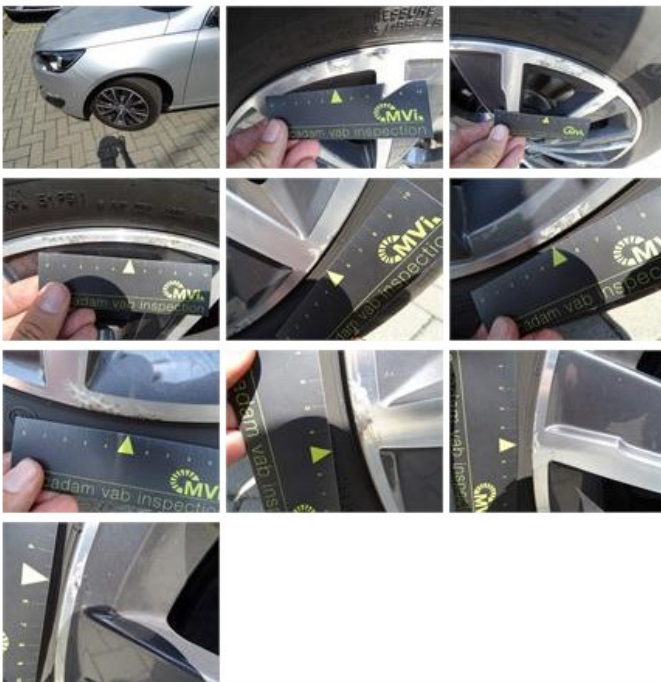
Alloy rim F L polished, Scratch(es), LI - Repair and paint (complete) 95,00

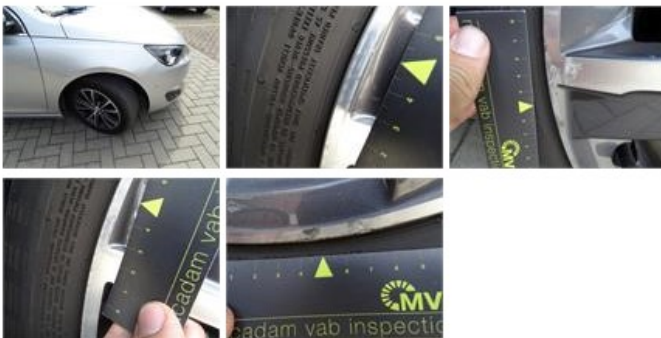
Alloy rim F R polished, Scratch(es), LI - Repair and paint (complete) 95,00

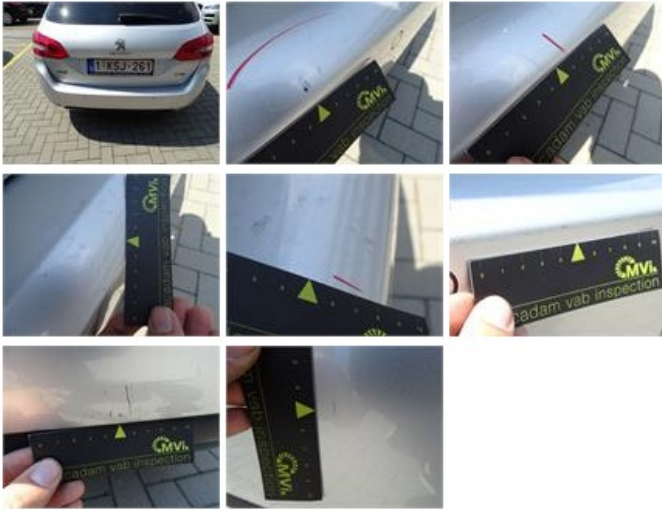
Bumper R, Scratch(es), LI - Repair and paint (complete)

211,80
