RENAULT CLIO: 1KNX714

Limited Technical Inspection

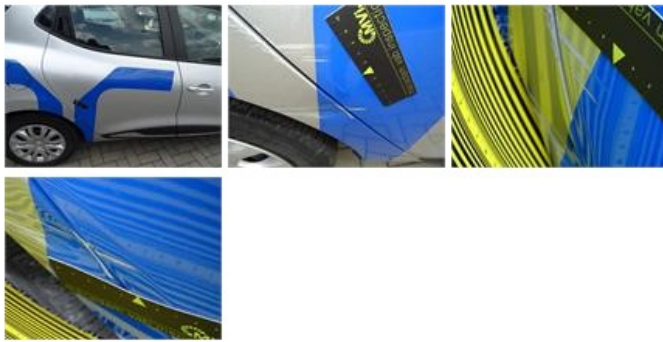
Door R R, Dent(s) and scratch(es), LI - Repair and paint (complete)

254,68

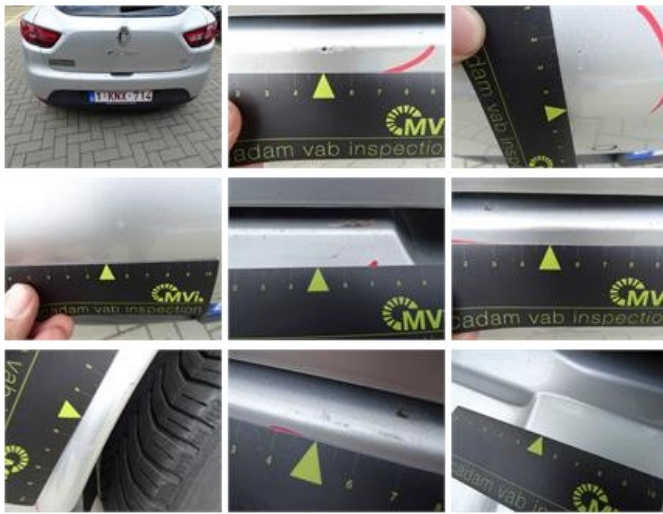
Bumper R, Scratch(es), LI - Repair and paint (complete)

169,44

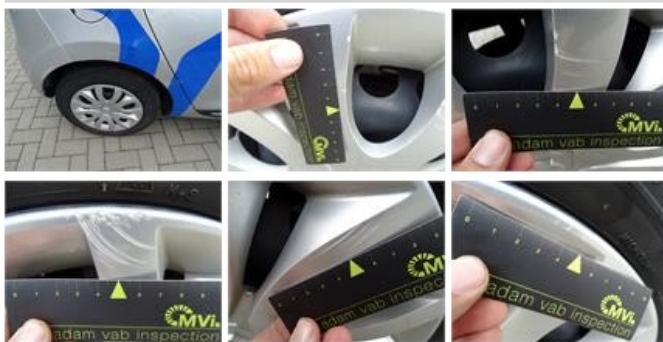
Wheel cover R R, Scratch(es), E - Replace

24,00

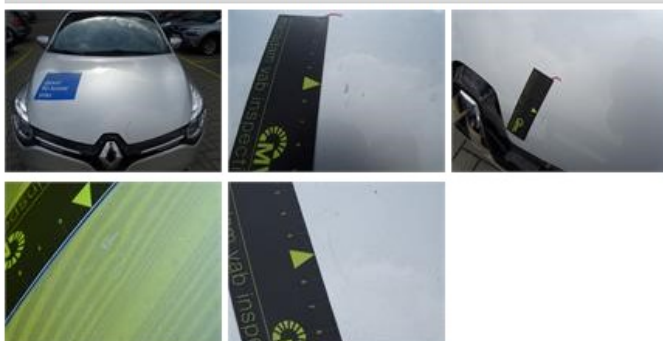
Bonnet, Dent(s) and scratch(es), LI - Repair and paint (complete)

232,06

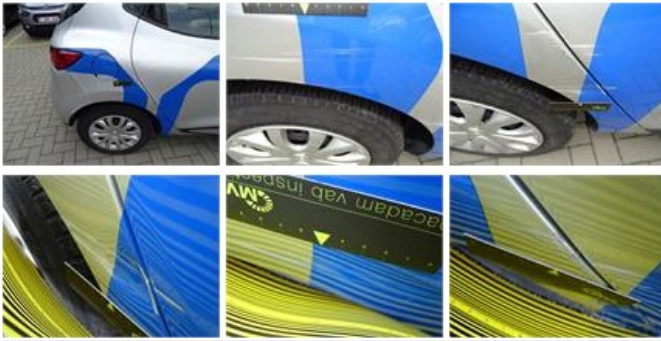
Wing R R, Dent(s) and scratch(es), LI - Repair and paint (complete) 246,56

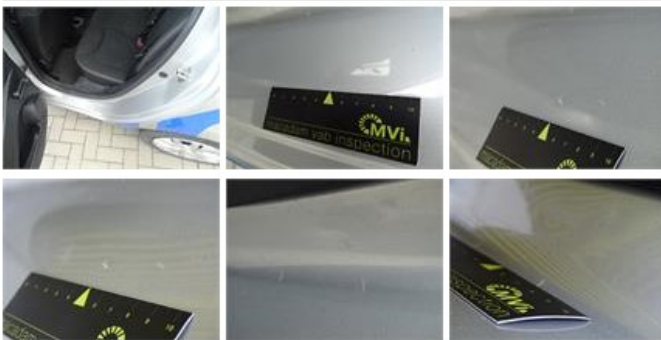
Rocker panel inner R L, Dent(s), LI - Repair and paint (complete) 115,56

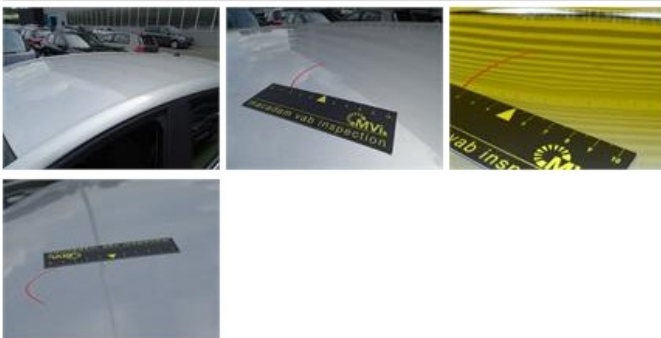
Roof, Dent(s), PDR - Paintless dent repair 82,80
