**VOLKSWAGEN Golf: 1GW1471**

**Limited Technical Inspection**

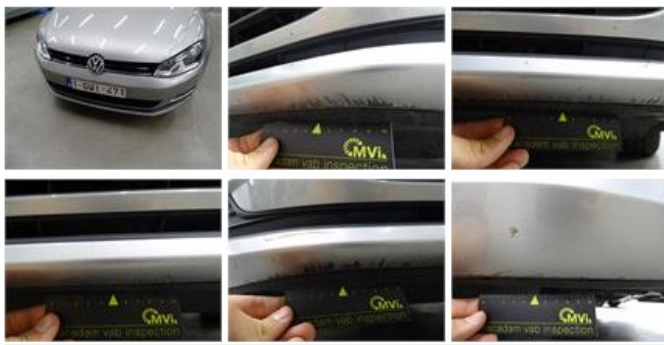
<b>Total cost ex VAT</b>	<b>2106,41</b>
<b>Bumper F, Scratch(es), LI - Repair and paint (complete)</b>	<b>211,80</b>

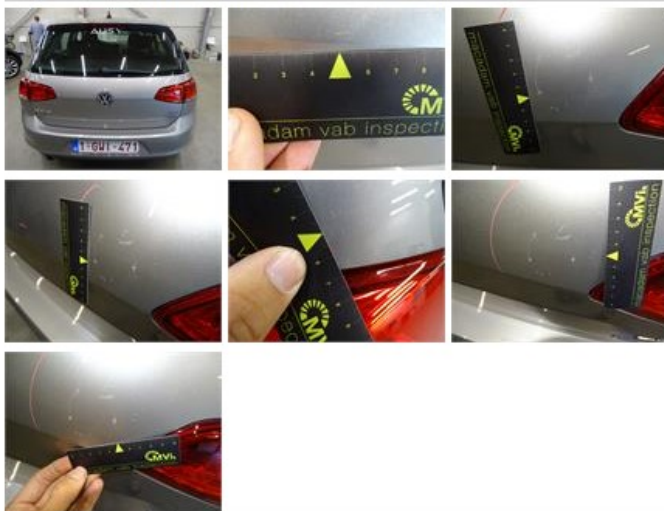
Tailgate, Scratch(es), LI - Repair and paint (complete)

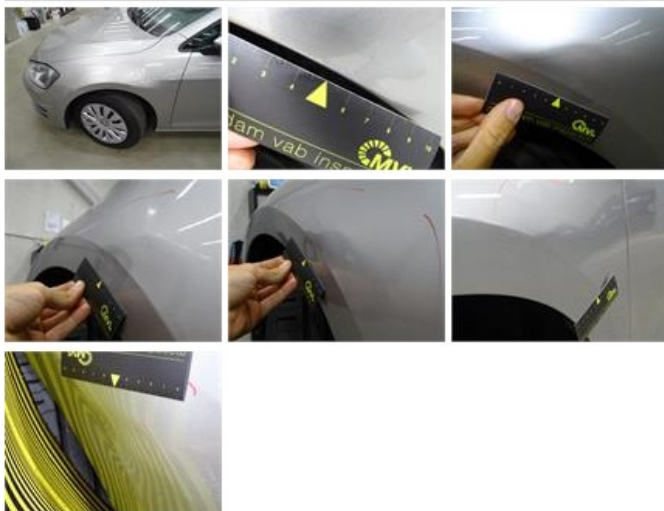
Wing F L, Dent(s) and scratch(es), LI - Repair and paint (complete)

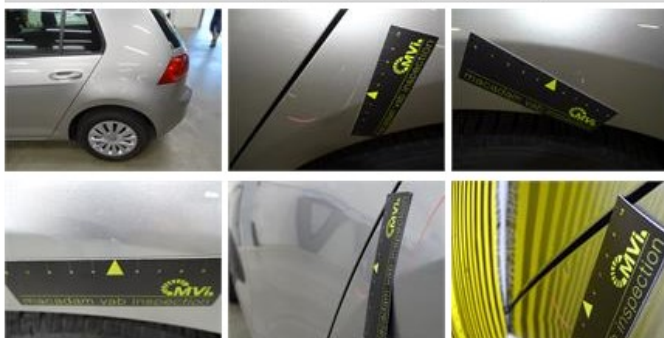
Wing R L, Dent(s) and scratch(es), LI - Repair and paint (complete)

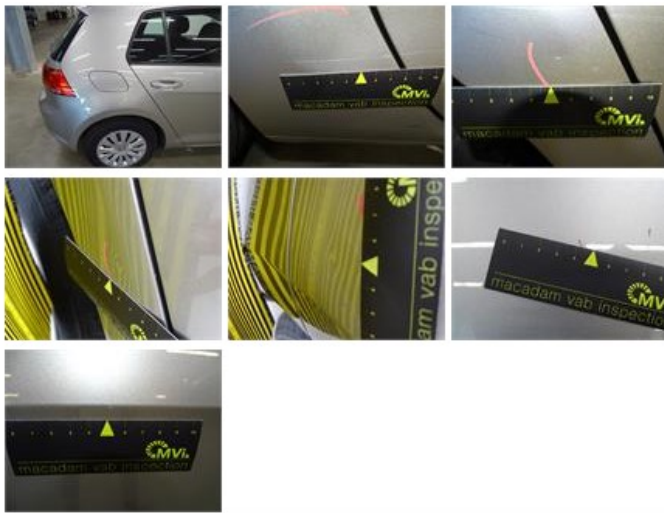
Wing R R, Dent(s) and scratch(es), LI - Repair and paint (complete)

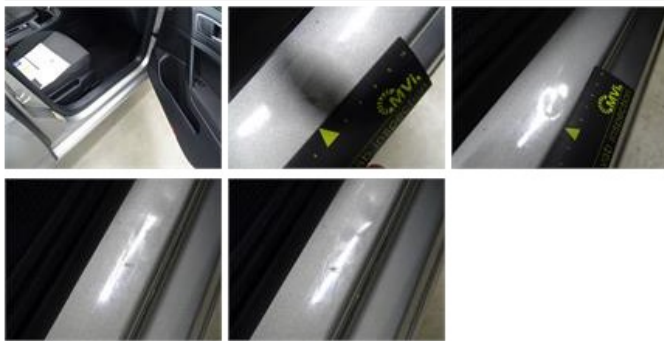
Rocker panel inner F R, Dent(s), LI - Repair and paint (complete) 115,56

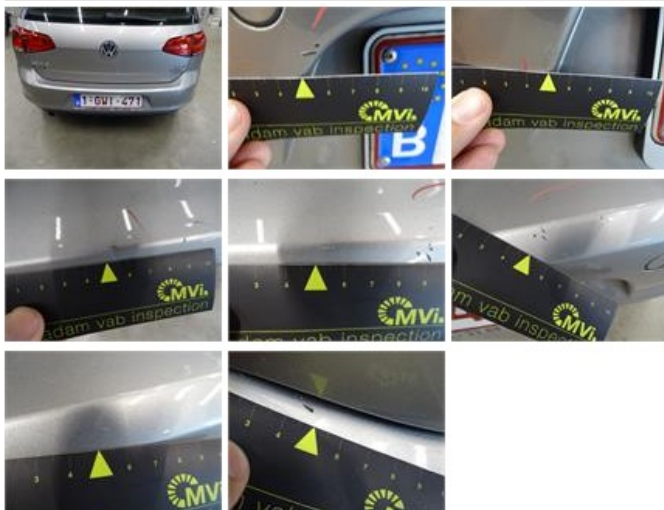
Bumper R, Scratch(es), LI - Repair and paint (complete) 211,80
