VOLKSWAGEN Golf: 1GIG466

Limited Technical Inspection

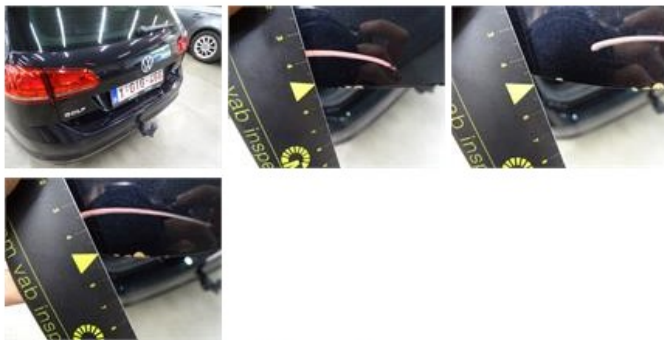
Tailgate, Bad repair, Acceptable 0,00

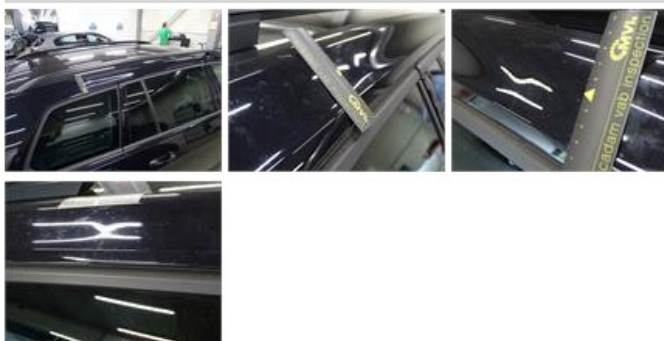
Roof pillar R, Dent(s), PDR - Paintless dent repair 63,00

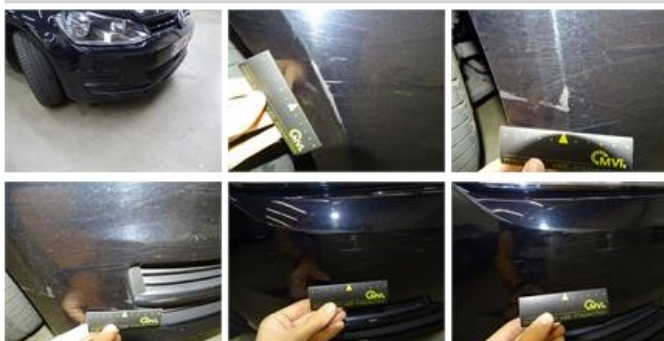
Bumper F, Scratch(es), LI - Repair and paint (complete) 211,80

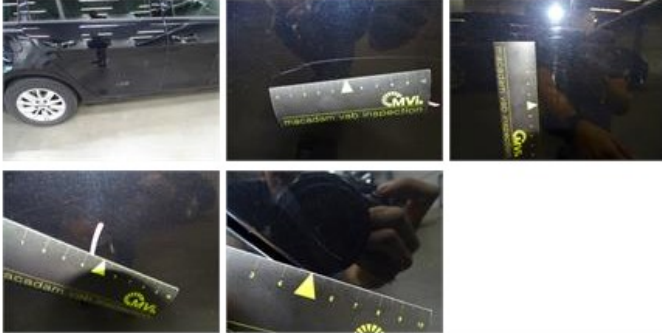
Door R R, Scratch(es), LI - Repair and paint (complete) 318,35

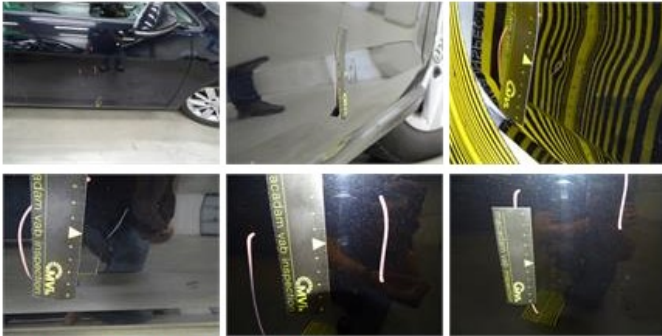
Door F R, Dent(s) and scratch(es), LI - Repair and paint (complete) 318,35
