VOLKSWAGEN Golf: 1FDU790

Limited Technical Inspection

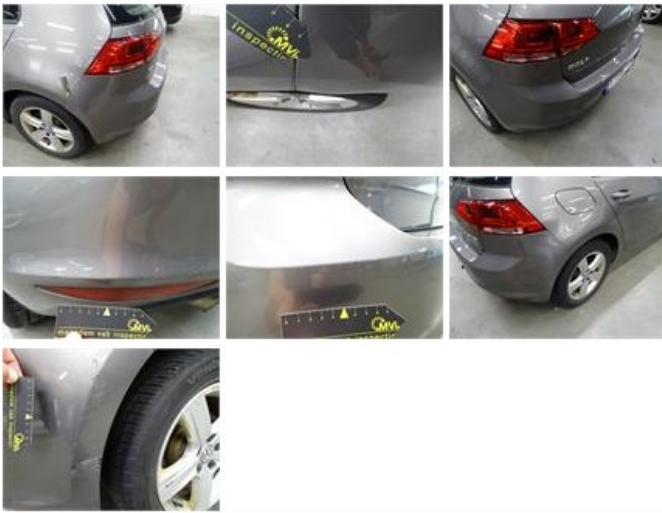
Bumper R, Dent(s) and scratch(es), LI - Repair and paint (complete)

259,80

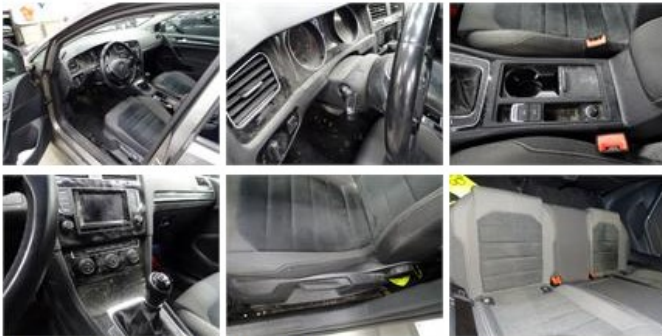
Interior, Dirty, Cleaning 50,00
