VOLKSWAGEN GOLF VII: 1WMF614

Limited Technical Inspection

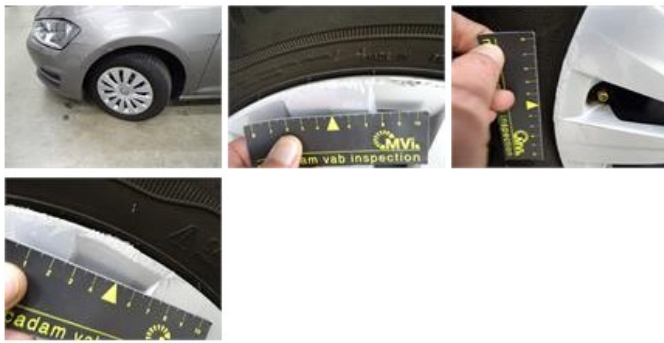
Wheel cover F L, Scratch(es), E - Replace	30,00
---	--------------

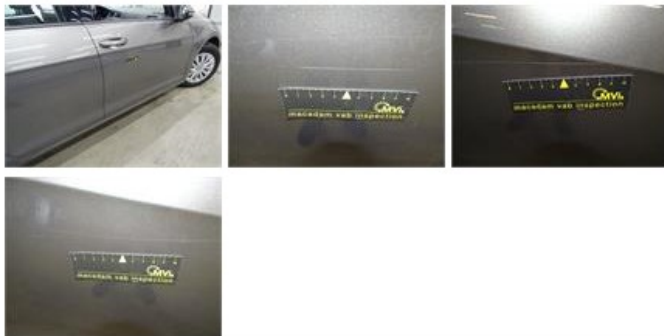
Registration Document, Missing, E - Replace	150,00
<i>No pictures to display</i>	
Door F R, Scratch(es), LI - Repair and paint (complete)	318,35

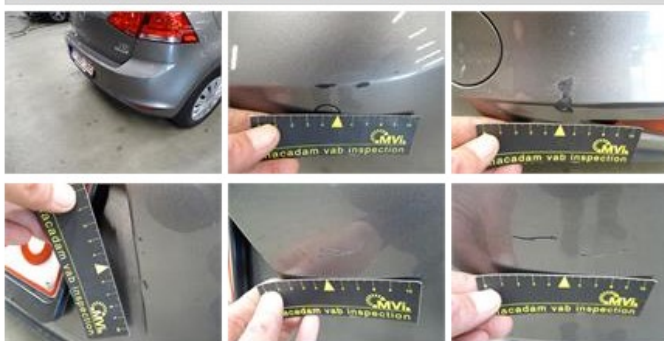
Wing R R, Scratch(es), Acceptable	0,00
<i>No pictures to display</i>	
Bumper F, Scratch(es), Acceptable	0,00
<i>No pictures to display</i>	
Bumper R, Scratch(es), LI - Repair and paint (complete)	211,80
