**SKODA OCTAVIA COMBI: 1PLC574**

Vinnumber:	<b>TMBJG9NE3H0030355</b>	Versionname:	<b>1.6 CRTDI 81KW GREENTEC AMBITION</b>
First Registrationdate:	<b>1/08/2016</b>	Fiscalpower:	
Expertise Mileage:	<b>103071</b>	Power Kw:	<b>81</b>
Bodytype:	<b>Break</b>	Body color:	<b>Grey</b>
Gearbox:	<b>MAN 5 VIT</b>	Paint type:	<b>Metalic</b>
Transmission:	<b>Front</b>	Rims summer:	<b>Aluminium</b>
Fueltype:	<b>Diesel</b>	Oil level:	<b>OK</b>
Battery functioning:	<b>Yes</b>	Parking lot:	<b>3314</b>
Number of doors:	<b>5</b>		
Number of seats:	<b>5</b>		
Number head rests:	<b>5</b>		
Rims summer:	<b>Aluminium</b>		
Category:	<b>Passenger Car</b>		
Oil level:	<b>OK</b>		
Registration Certificate Car (BE):	<b>Yes</b>

**Limited Technical Inspection**

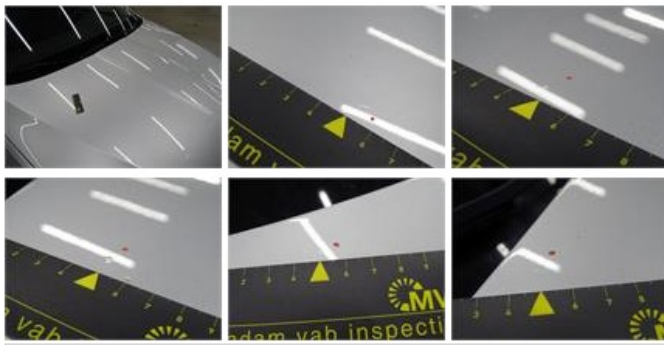
<b>Total cost ex VAT</b>	<b>95,00</b>
<b>Bonnet, Bad repair, Acceptable</b>	<b>0,00</b>

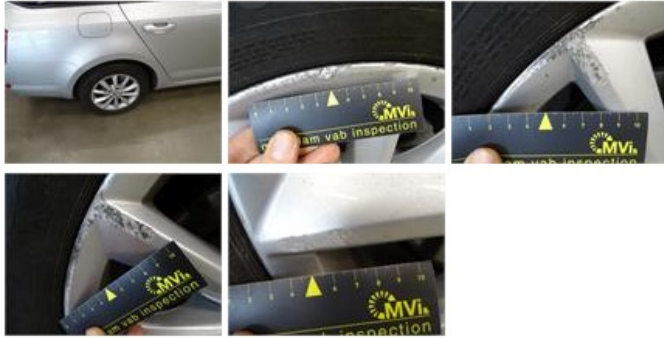
Alloy rim R R, Scratch(es), LI - Repair and paint (complete)

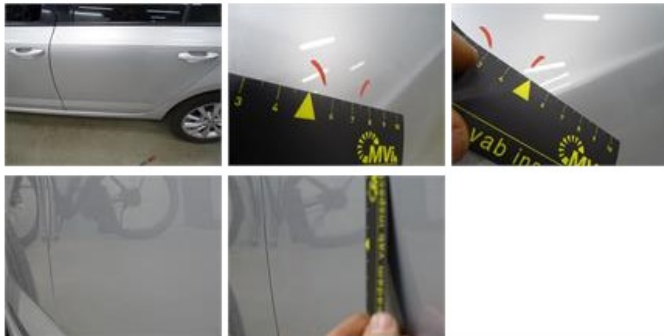
Door R L, Bad repair, Acceptable
