**VOLVO V40: 1NHF476**

**Limited Technical Inspection**

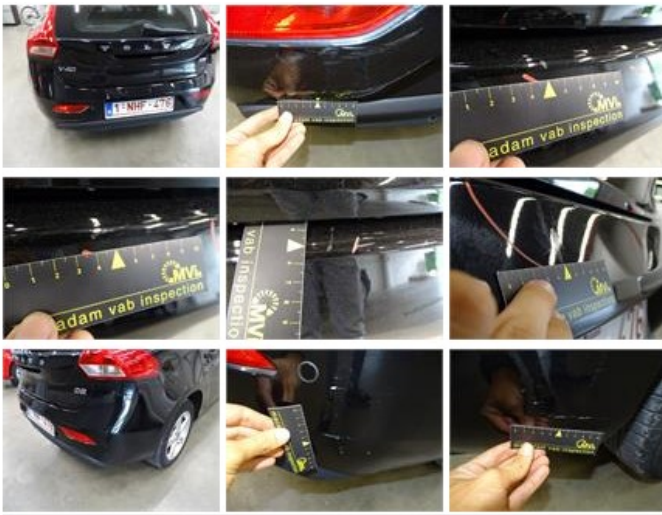
Bumper R, Dent(s) and scratch(es), LI - Repair and paint (complete) 211,80

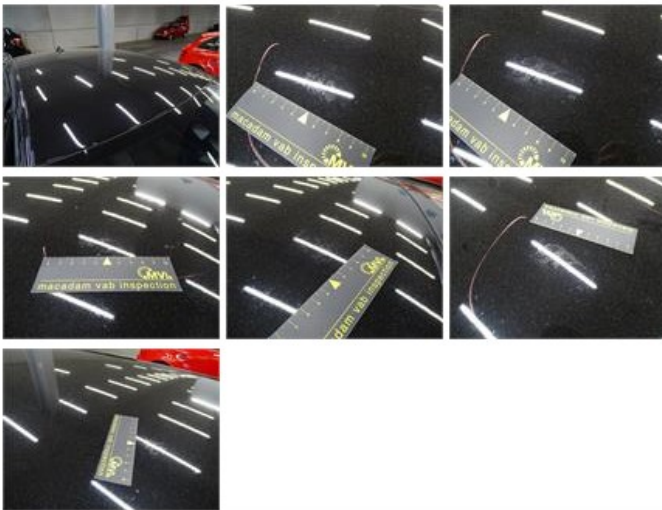
Roof, Chemical polution, LI - Repair and paint (complete)

481,50

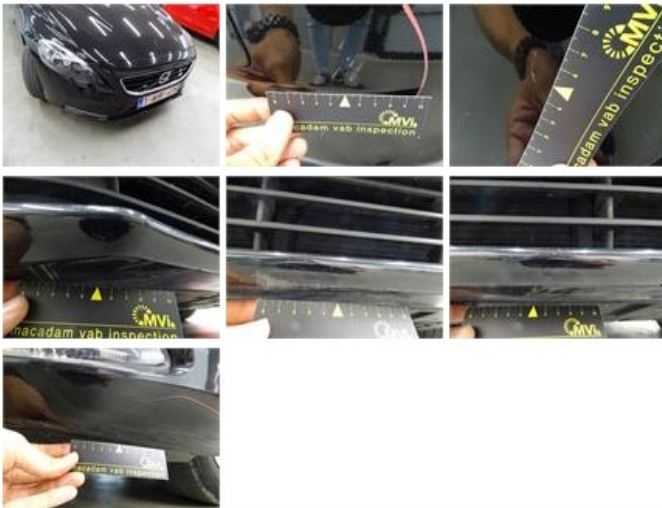
Bumper F, Scratch(es), LI - Repair and paint (complete)

211,80

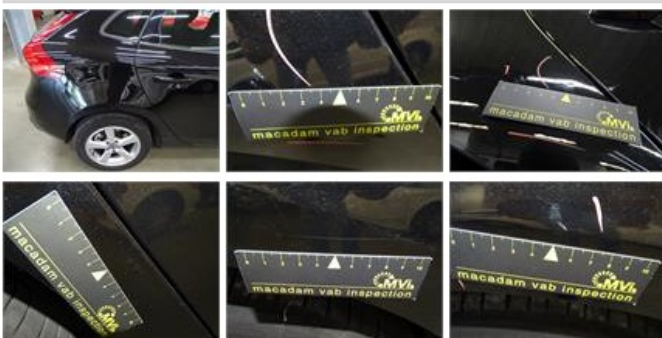
Wing R R, Dent(s) and scratch(es), LI - Repair and paint (complete)

308,20

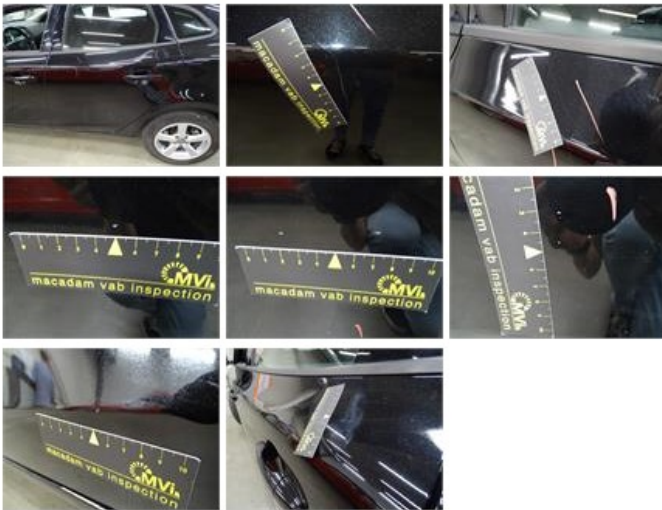
Door R L, Scratch(es), LI - Repair and paint (complete) 318,35

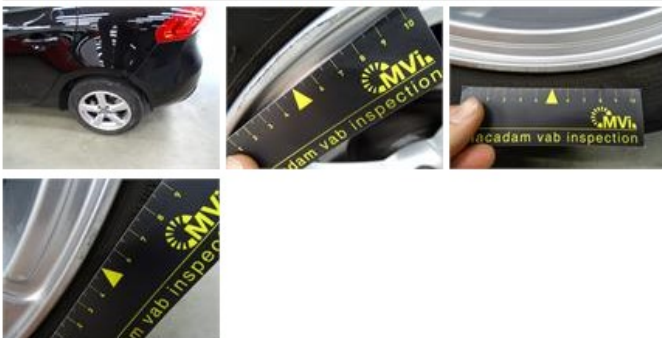
Alloy rim R L, Scratch(es), LI - Repair and paint (complete) 95,00

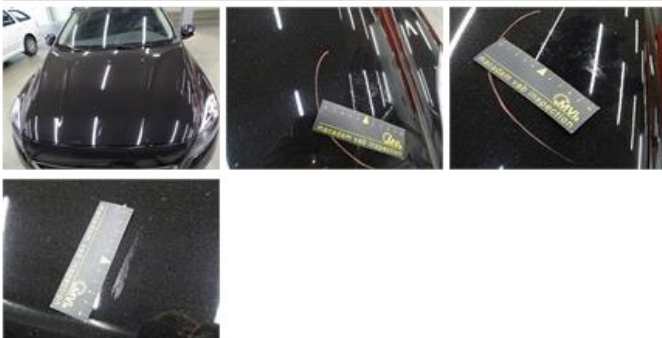
Bonnet, Chemical polution, LI - Repair and paint (complete) 290,08

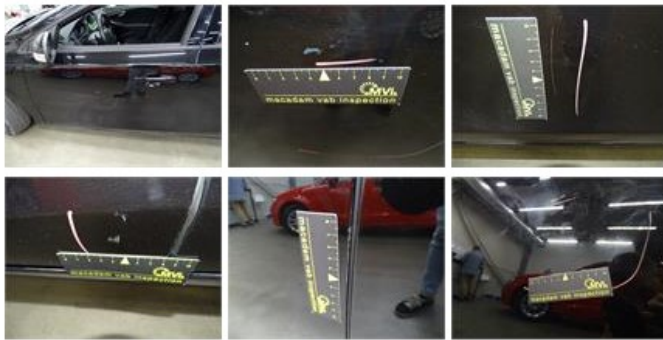
Door F L, Scratch(es), LI - Repair and paint (complete)

318,35

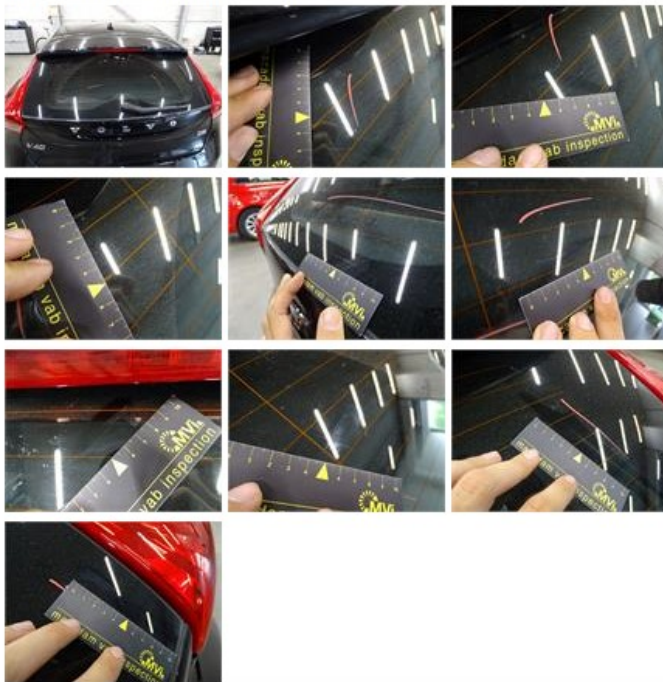
Rear window, Scratch(es), E - Replace

370,00

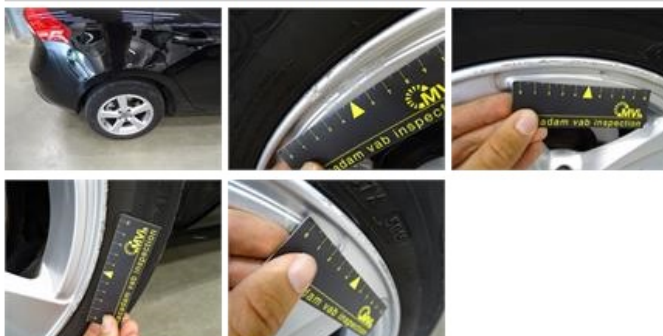
Alloy rim R R, Scratch(es), LI - Repair and paint (complete)

95,00
