**VOLKSWAGEN Golf: 1HDC647**

**Limited Technical Inspection**

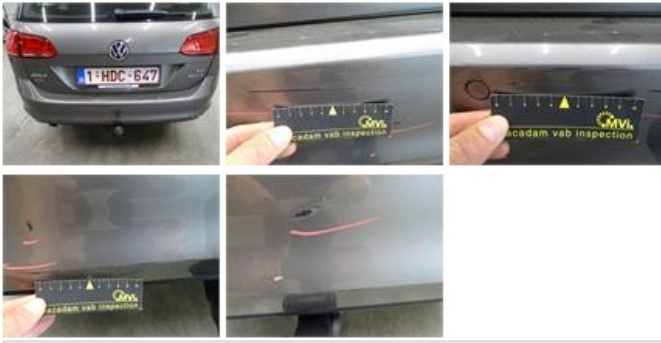
Bumper R, Scratch(es), LI - Repair and paint (complete)

211,80
