VOLKSWAGEN TOURAN: 1NUP943

Limited Technical Inspection

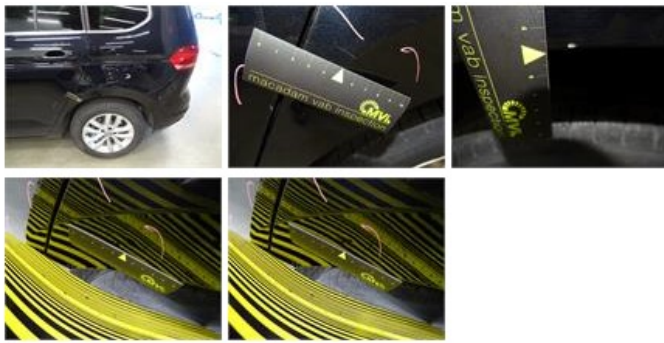
Total cost ex VAT	1606,60
Wing R L, Dent(s) and scratch(es), LI - Repair and paint (complete)	0,00

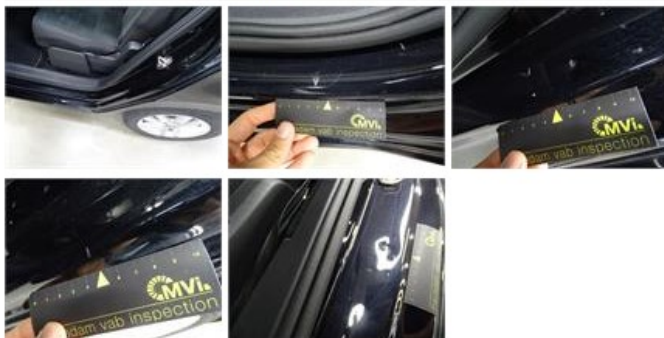
Rocker panel inner R L, Dent(s), LI - Repair and paint (complete) 115,56

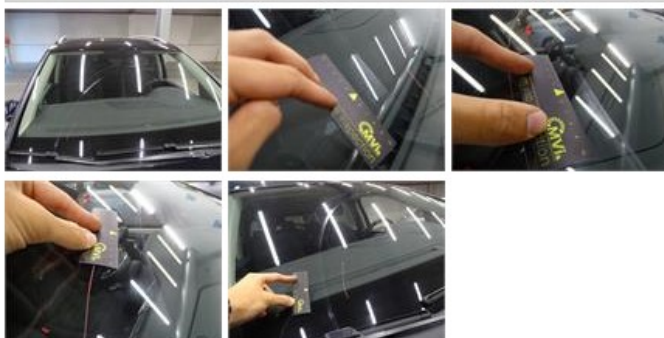
Windscreen, Scratch(es), E - Replace 0,00

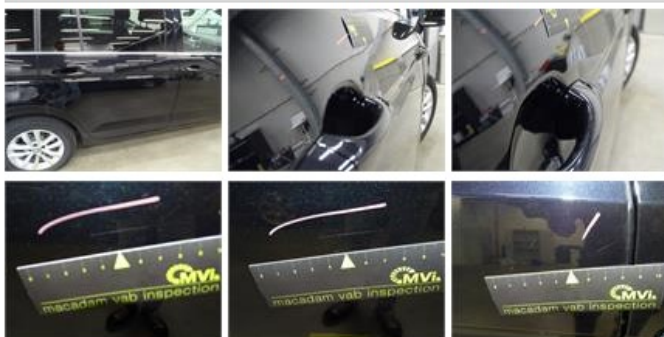
Door R R, Dent(s) and scratch(es), LI - Repair and paint (complete) 318,35

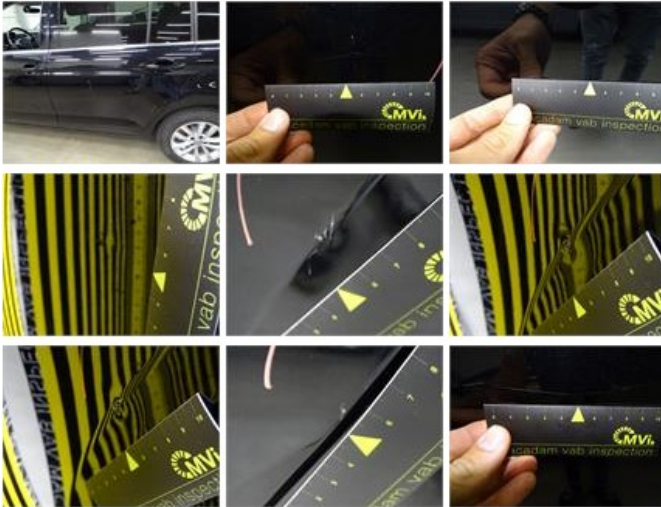
Door R L, Dent(s) and scratch(es), LI - Repair and paint (complete) 318,35

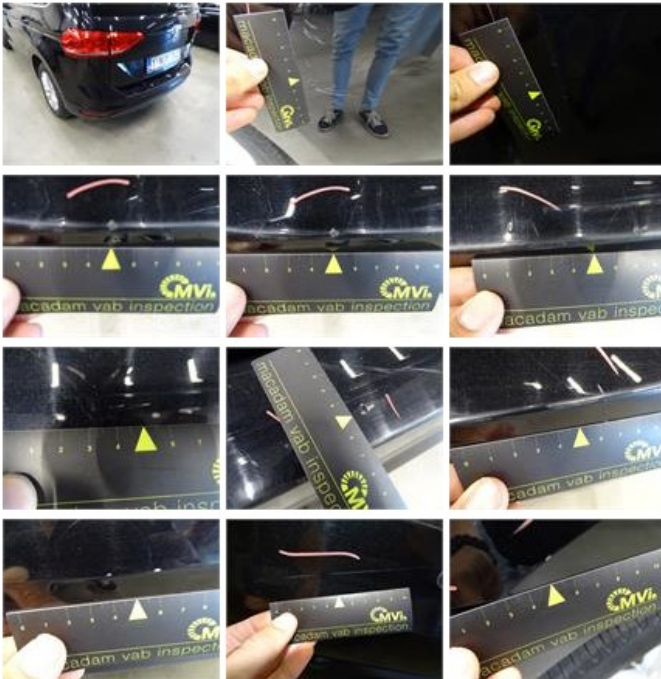
Bumper R, Scratch(es), LI - Repair and paint (complete) 211,80

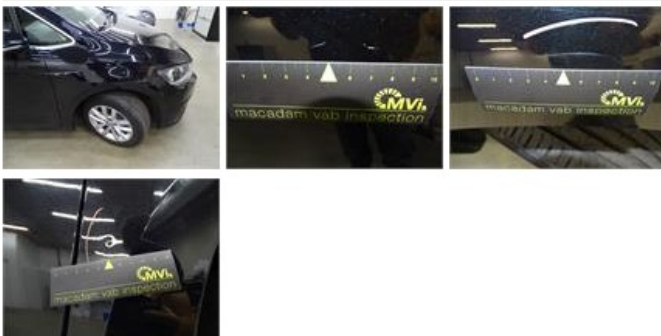
Wing F R, Dent(s) and scratch(es), LI - Repair and paint (complete) 220,18

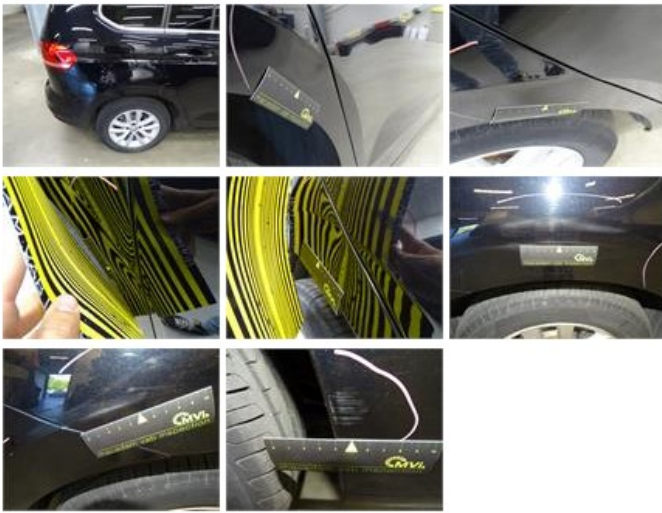
Wing R R, Dent(s) and scratch(es), LI - Repair and paint (complete) 0,00

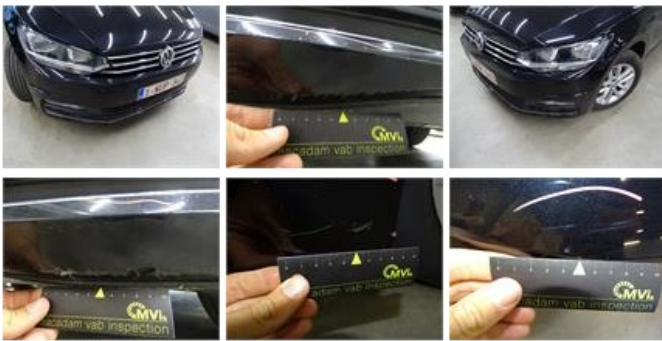
Alloy rim F R, Scratch(es), Acceptable	0,00
<i>No pictures to display</i>	
Door F R, Scratch(es), Acceptable	0,00
<i>No pictures to display</i>	
Bumper F, Scratch(es), LI - Repair and paint (complete)	211,80
